[Docket No. 96-CE-46-AD; Amendment 39-9884; AD 97-01-13]

**Airworthiness Directives; Cessna Aircraft Company 100, 200, 300, and 400 Series Airplanes**

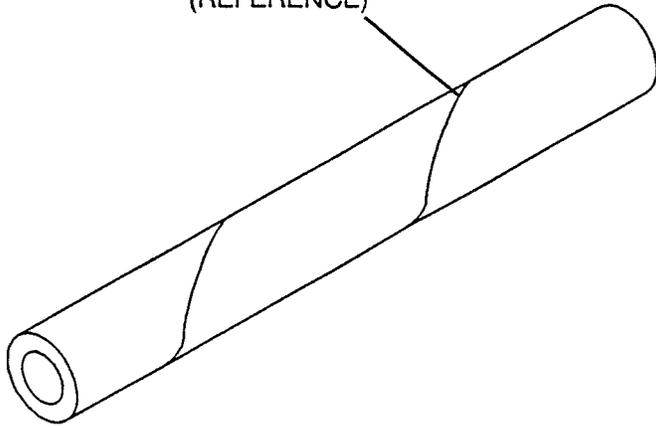
Note 2: Figure 1 of this AD is included to show the diagonal or spiral external reinforcement wrap on the hose that is referenced in the check required by paragraph (b) of this AD.

REINFORCEMENT  
WRAPPED IN ONLY ONE  
(DIAGONAL) DIRECTION  
(REFERENCE)

OLD STYLE S51-10 HOSE  
WITH REINFORCEMENT  
WRAPPED IN ONLY ONE  
(DIAGONAL) DIRECTION THE  
LENGTH OF THE HOSE  
(REMOVE AND REPLACE WITH  
REPLACEMENT STYLE HOSE)

(c) Prior to further flight after the check required by paragraph (b) of this AD, replace any Cessna P/N S51-10 that has a diagonal or spiral pattern external reinforcement wrap with a Cessna P/N S51-10 hose that has a criss-cross pattern external wrap. Accomplish this replacement in accordance with the ACCOMPLISHMENT INSTRUCTIONS of the applicable service bulletin in paragraph (b) of this AD.

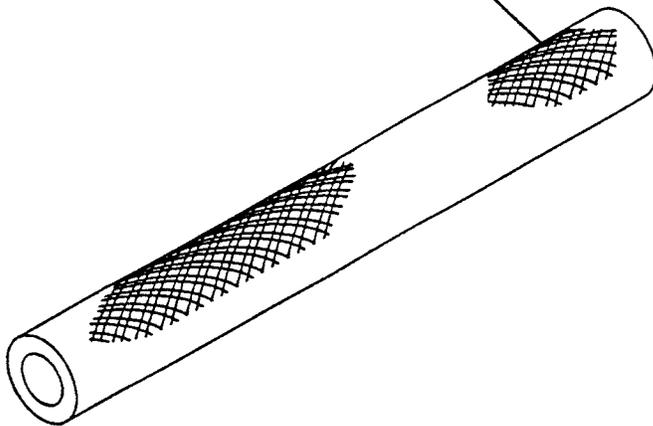
CRISSCROSS  
OR BRAIDED  
REINFORCEMENT  
(REFERENCE)

REPLACEMENT STYLE S51-10  
HOSE WITH A CRISS-CROSS  
OR BRAIDED REINFORCEMENT  
PATTERN
