[Docket No. 97-SW-22-AD; Amendment 39-10211; AD 97-24-04]

Airworthiness Directives; Eurocopter France (Eurocopter) Model SE 3130, SE 313B, SA 3180, SA 318B, and SA 318C Helicopters

97-24-04 Eurocopter France: Amendment 39-10211. Docket No. 97-SW-22-AD.

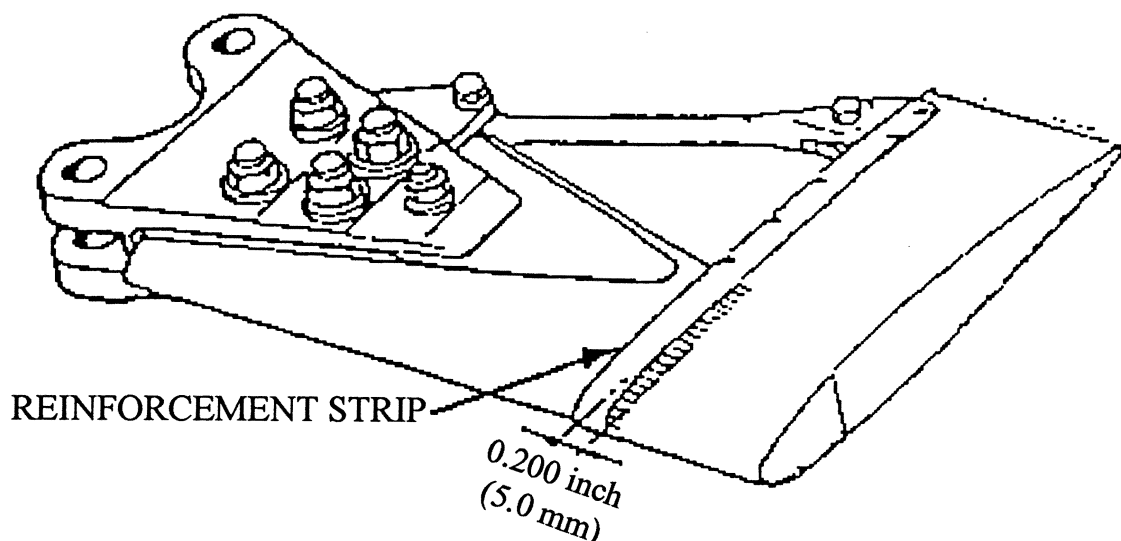
Figure 1

(1) For debonding in the area extending 5 mm (0.200 inch) from the strip reinforcing the inboard edge of the blade as shown in Figure 1. If there is any debonding of the reinforcement strip, replace the blade with an airworthy blade.
