NUCLEAR REGULATORY COMMISSION

Southern California Edison Company, et al.; San Onofre Nuclear Generating Station, Units 2 and 3; Issuance of Director's Decision Under 10 CFR 2.206

Director's Decision Under 10 CFR 2.206

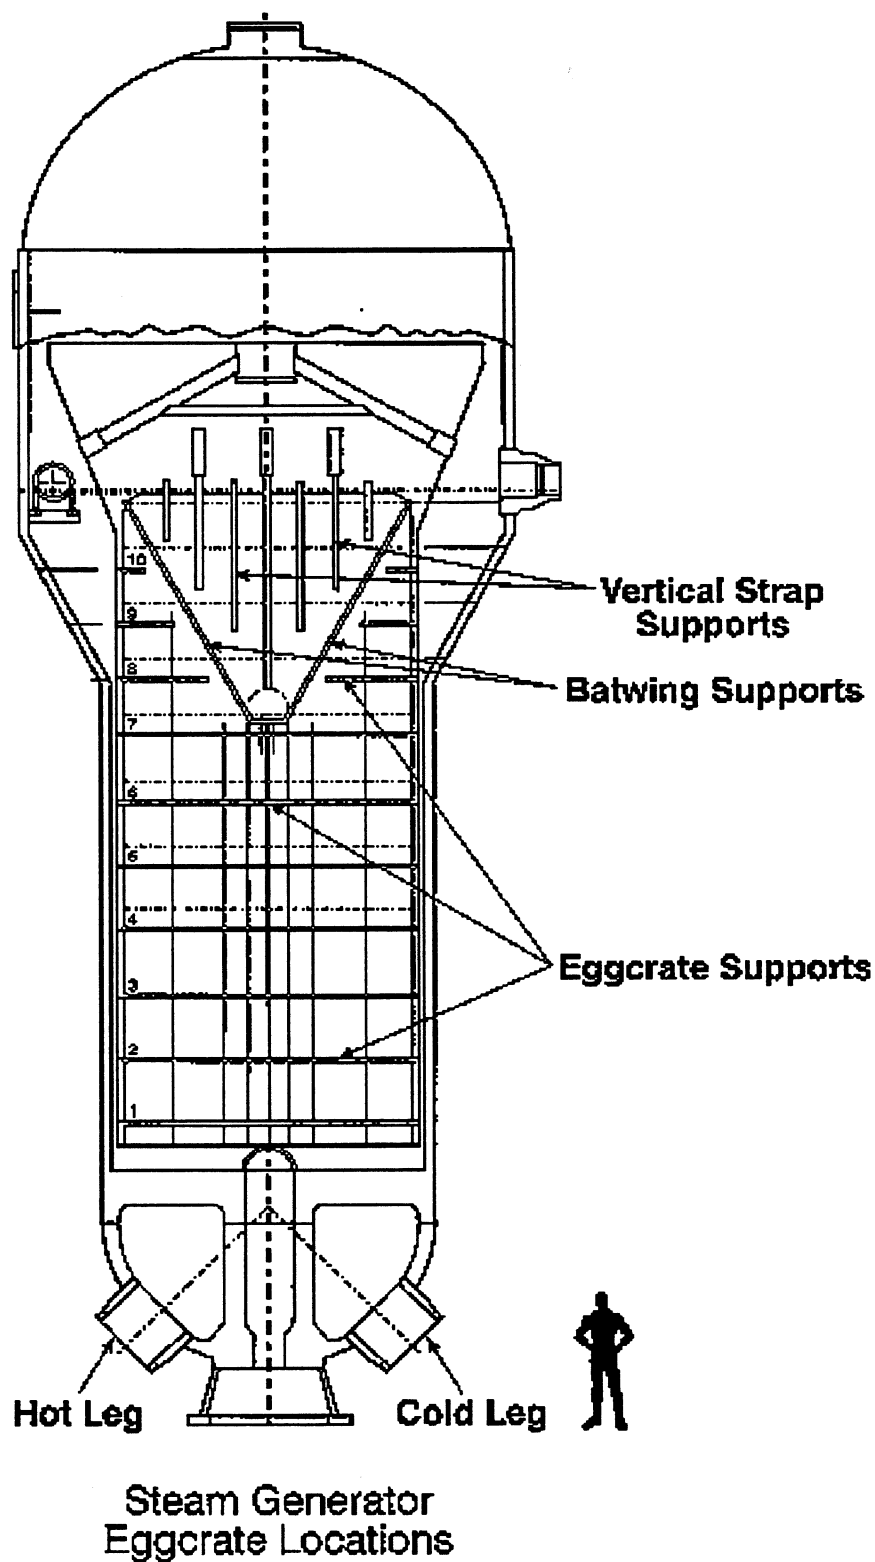
Figure 1

For the individual steam generator tube analysis, the licensee calculated the maximum loads that could occur assuming that adequate support was not available at two consecutive eggcrate levels (see Figure 1). The staff finds this assumption conservative and acceptable because the licensee has removed from service all tubes where two consecutive eggcrate levels were found degraded to the point where adequate support could not be assured.
