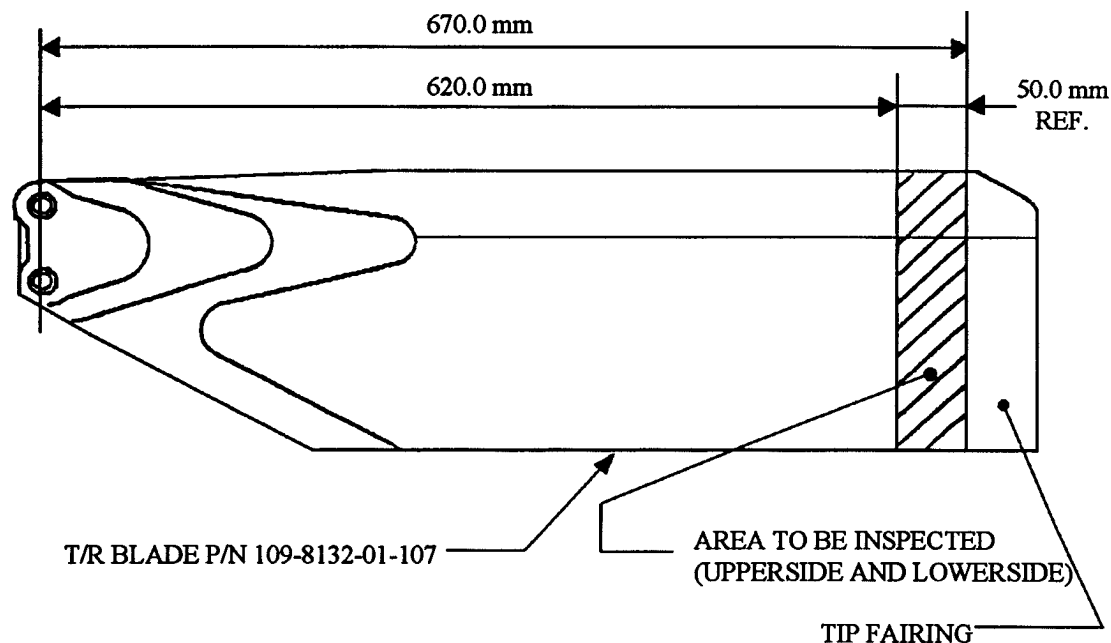
Figure 1

(a) Perform a one-time inspection of each tail rotor blade for debonds. The area to be

inspected is located in a spanwise band from 620.0 mm to 670.0 mm (24.4 to 26.4 inches), as measured outboard from the blade retention bolt centerline. Inspect the entire blade surface on both sides of each blade within this band (see Figure 1).

(b) Perform a tapping inspection to detect debonds within the blade surface area identified in paragraph (a) of this AD, using an aluminum hammer, P/N 109-3101-58-2, or equivalent. The presence of paint cracks on the tail rotor blade upper or lower surface in the tip fairing area at the 670.0 mm spanwise location (see Figure 1) may indicate that debonds exist.

(c) Any blade that does not meet the allowable debond criteria specified in the applicable maintenance manual must be replaced with an airworthy blade before further flight.
