[Docket No. 97-SW-42-AD; Amendment 39-11092; AD 99-07-07]

Airworthiness Directives; Eurocopter France Model SA 330J Helicopters

AD 99-07-07 Eurocopter France:

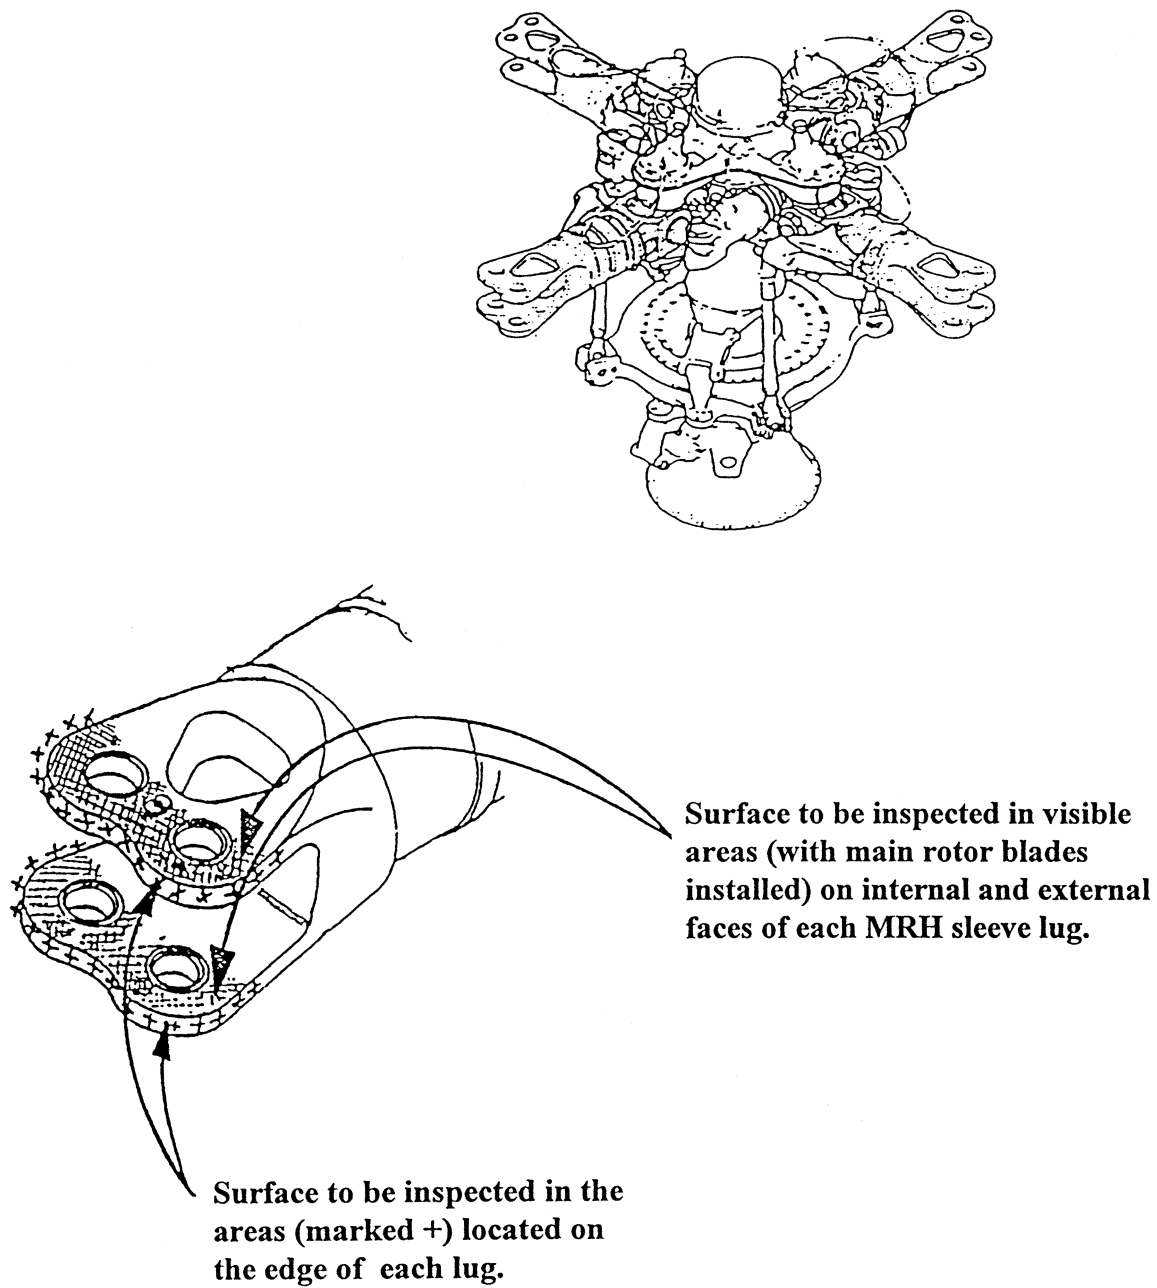
FIGURE 1

SUPPLEMENTARY INFORMATION: The Direction Generale De L'Aviation Civile (DGAC), the airworthiness authority for France, recently notified the FAA that an unsafe condition may exist on Eurocopter Model SA 330J helicopters. The DGAC advises of the discovery of a crack in the lower lug on the trailing edge of an SA 330J blade sleeve.

(a) Visually inspect each main rotor head sleeve lug (lug), without removing the main rotor blades, for cracks in the area indicated in Figure 1.

DETAIL OF AREAS TO BE INSPECTED

(b) If any crack is found in a lug, prior to further flight, replace the affected sleeve with an airworthy sleeve.
