[Docket No. 98-NM-231-AD]

Airworthiness Directives; Boeing Model 767 Series Airplanes Equipped With General Electric CF6-80C2 Series Engines

ACTION: Notice of proposed rulemaking (NPRM).

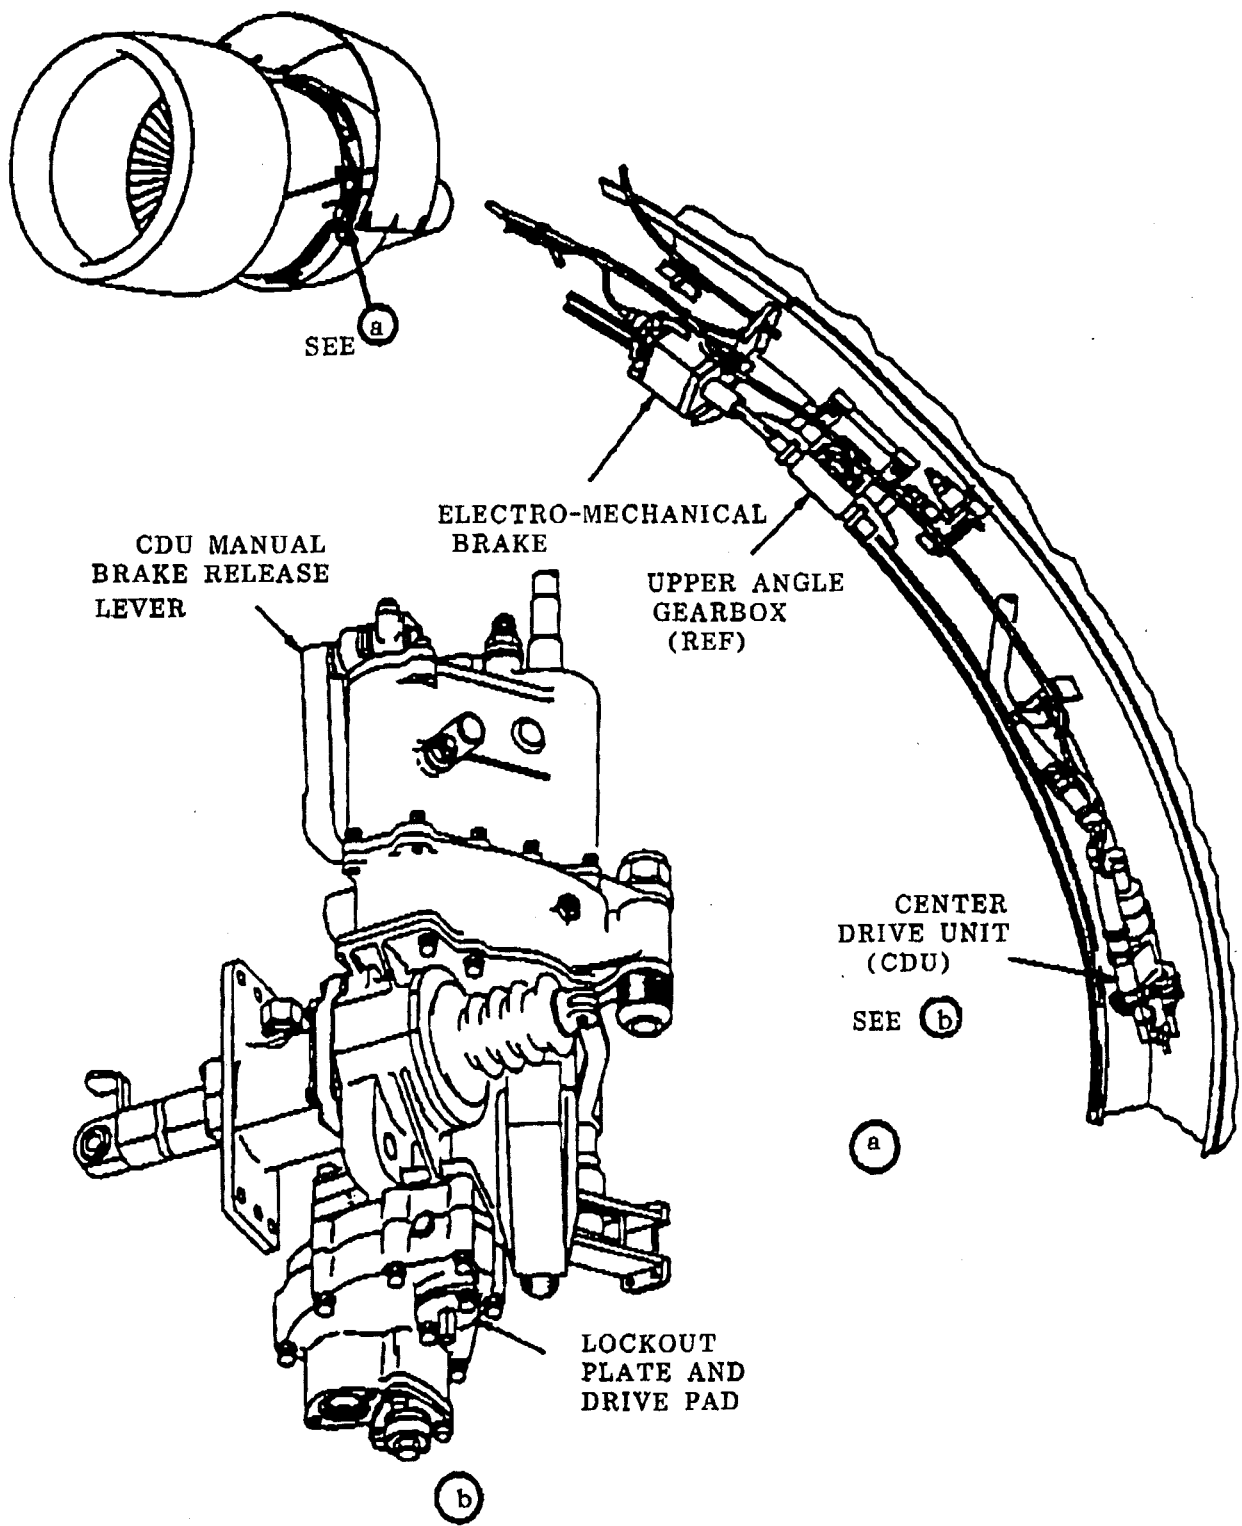
Electro-Mechanical Brake and CDU Cone Brake Torque Check
Figure 1

2. Electro-Mechanical Brake and CDU Cone Brake Torque Check (Fig. 1)

Note: The cone brake prevents movement in the extend direction only. If you try to measure the holding torque in the retract direction, you will get a false reading.

(2) If the flexshaft turns more than 450 degrees before you reach the specified torque, you must replace the long flexshaft between the CDU and the upper angle gearbox.

(3) If you do not get 90 pound-inches of torque, you must replace the electro-mechanical brake.

(a) If the torque is less than 15-pound-inches, you must replace the CDU.
