[Docket No. 98-SW-71-AD; Amendment 39-11204; AD 99-13-11]

Airworthiness Directives; Robinson Helicopter Company (Robinson) Model R44 Helicopters

SUMMARY: This amendment adopts a new airworthiness directive (AD), applicable to Robinson Model R44 helicopters, that requires installing a shutoff clamp on the auxiliary fuel tank sump drain tube (drain tube) and a placard decal to alert operators as to the proper use of the auxiliary fuel tank drain. This amendment is prompted by a report of fuel leaking from a drain tube opening in the area of the horizontal and vertical firewalls. The actions specified by this AD are intended to prevent fuel leaks from the drain tube that could cause a fire and subsequent loss of control of the helicopter.

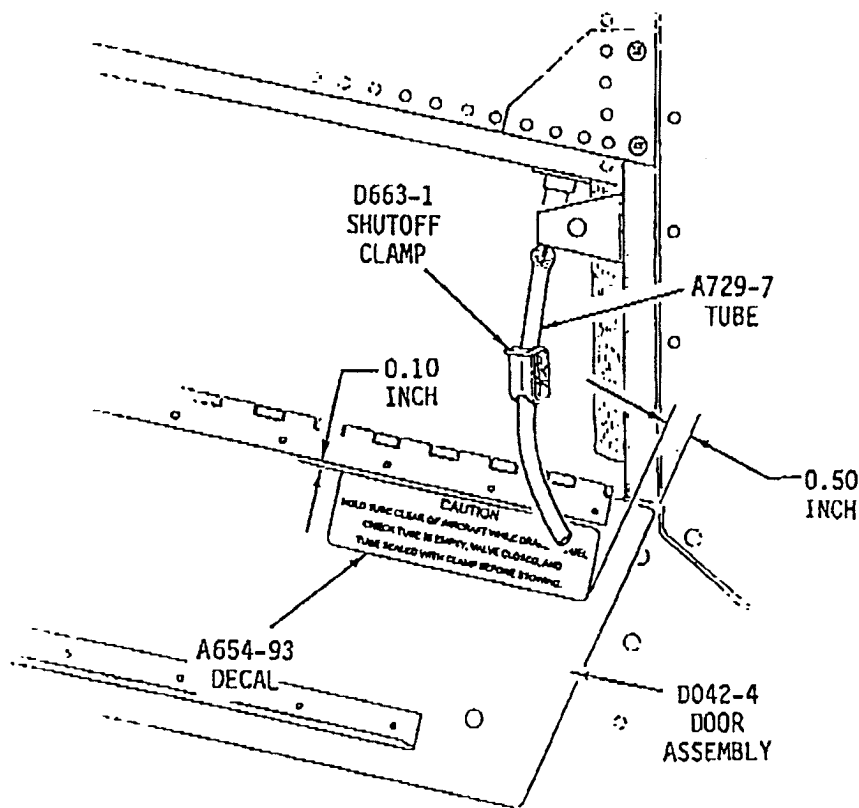
Figure 1

To prevent fuel leaks from the auxiliary fuel tank sump drain, which could cause a fire and subsequent loss of control of the helicopter, accomplish the following:

(a) Install a shutoff clamp, part number (P/N) D663-1, by sliding it onto the auxiliary fuel tank sump drain tube, P/N A729-7, as shown in Figure 1.

(b) Install placard decal, P/N A654-93, as shown in Figure 1.
