[Docket No. 99-SW-75-AD; Amendment 39-11651; AD 2000-06-10]

#### Airworthiness Directives; Bell Helicopter Textron Canada Model 407 Helicopters

**AD 2000-06-10 Bell Helicopter Textron Canada:** Amendment 39-11651. Docket No. 99-SW-75-AD.

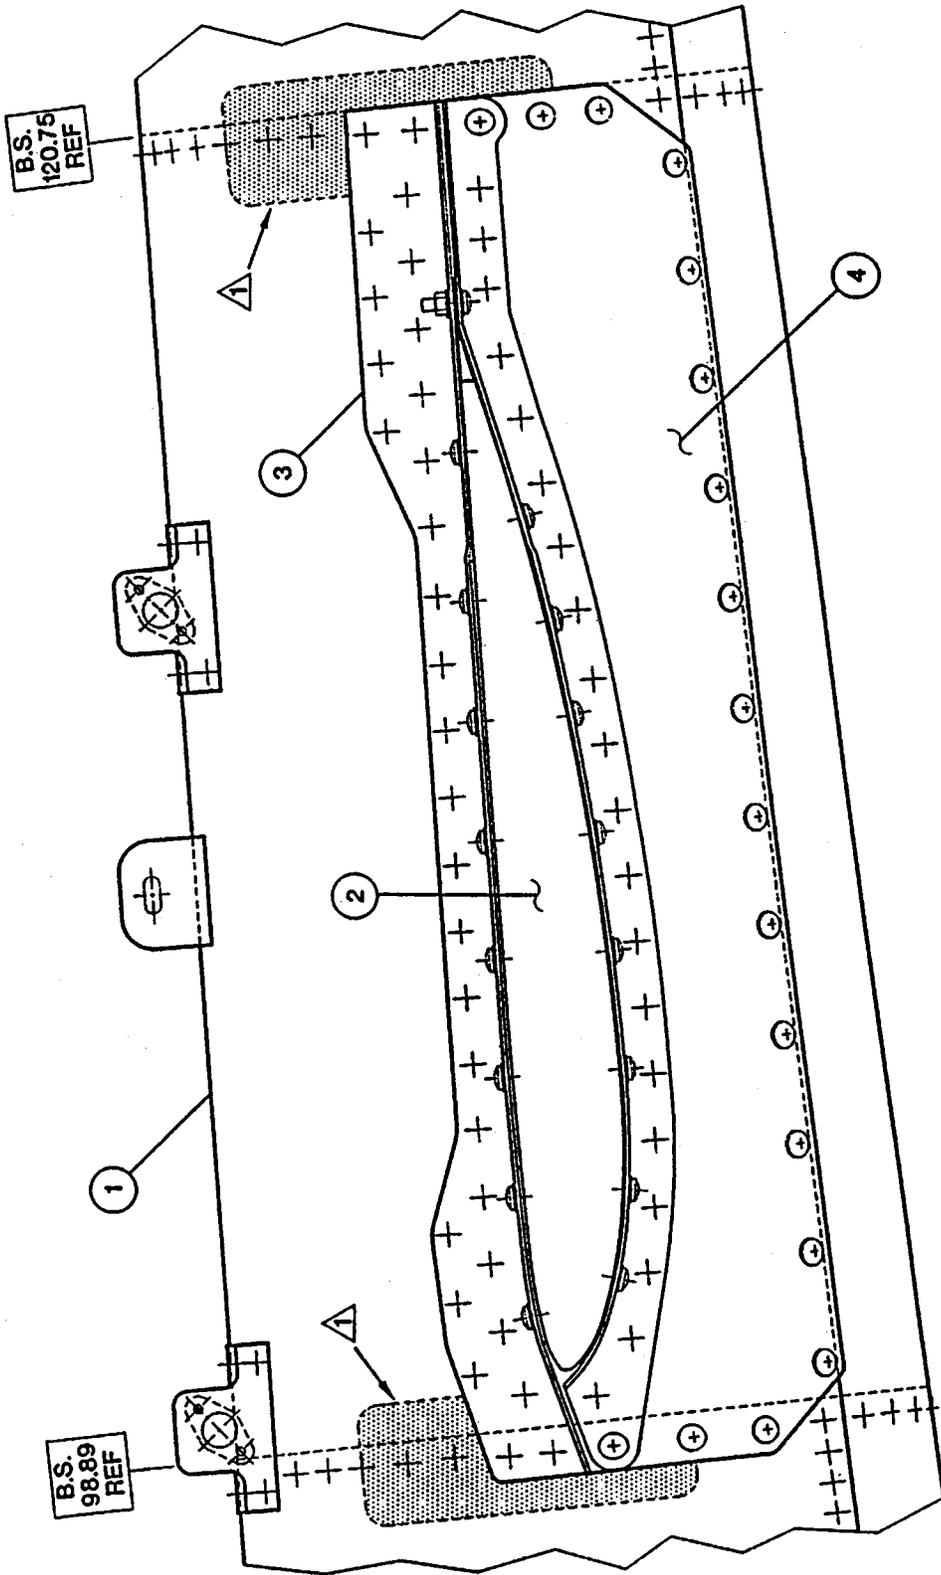
**Figure 1. Preflight Check of the Tailboom**

**SUPPLEMENTARY INFORMATION:** Transport Canada, the airworthiness authority for Canada, notified the FAA that an unsafe condition may exist on the BHTC Model 407 helicopters. Transport Canada advises that there have been several reports of cracks to the tail boom skin in the area of the horizontal stabilizer.

- 1. Examine these areas for cracks on left side of tailboom only.
- 2. Horizontal stabilizer not shown for clarity.

(a) Before further flight and thereafter before the first flight of each day, check the left side of the tail boom for a crack in the areas shown in Figure 1. If a crack is found, replace the tail boom with an airworthy tail boom before further flight.

(c) Within 25 hours time-in-service (TIS) and thereafter at intervals not to exceed 50 hours TIS, visually inspect any tail boom with 600 or more hours TIS for a crack using a 10X or higher magnifying glass, in accordance with the Accomplishment Instructions, Part II, of Bell Helicopter Textron Canada Alert Service Bulletin 407-99-26, dated April 13, 1999, except that you are not required to contact Bell Helicopter Product Support Engineering. If a crack is found, replace the tail boom with an airworthy tail boom before further flight.
