[Docket No. 99-SW-08-AD; Amendment 39-11657; AD 2000-07-03]

#### Airworthiness Directives; Robinson Helicopter Company Model R44 Helicopters

**AD 2000-07-03 Robinson Helicopter Company:** Amendment 39-11657. Docket No. 99-SW-08-AD.

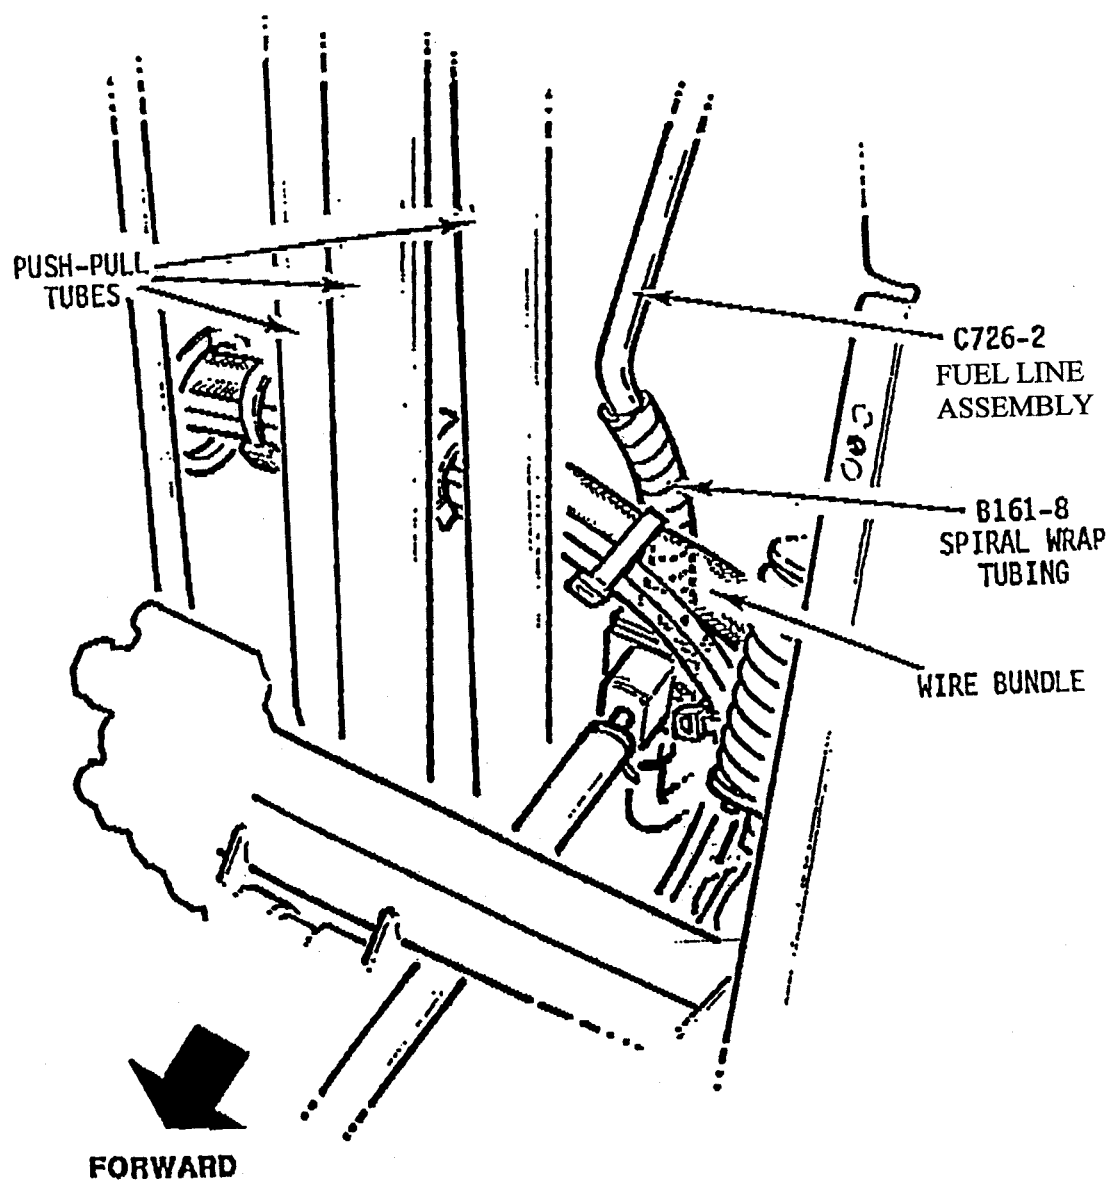
**FIGURE 1**

To prevent contact between the wire harness and the fuel line assembly, which could result in chafing of the wire harness and a potential fire hazard, accomplish the following:

(b) Inspect the wire harness, P/N C059, and the fuel line assembly, P/N C726-2, above the fuel shutoff valve for contact. If the wire harness contacts the fuel line assembly, inspect for chafing.

(c) If chafing has occurred between the wire harness and the fuel line assembly, replace the fuel line with an airworthy fuel line assembly. Torque the fuel line nuts to 110-130 in-lbs. Verify that clearance exists between the fuel line assembly and the wire harness.

(d) Install a 3-inch section of spiral wrap tubing, P/N B161-8, on the fuel line assembly as shown in Figure 1. Push the spiral wrap tubing down until it is against the fuel line fitting.
