[Docket No. 2000-NM-93-AD; Amendment 39-11711; AD 2000-09-03]

#### Airworthiness Directives; Boeing Model 747-400 Series Airplanes Equipped With General Electric CF6-80C2 Series Engines

#### Appendix 1.—Thrust Reverser CDU Cone Brake Test

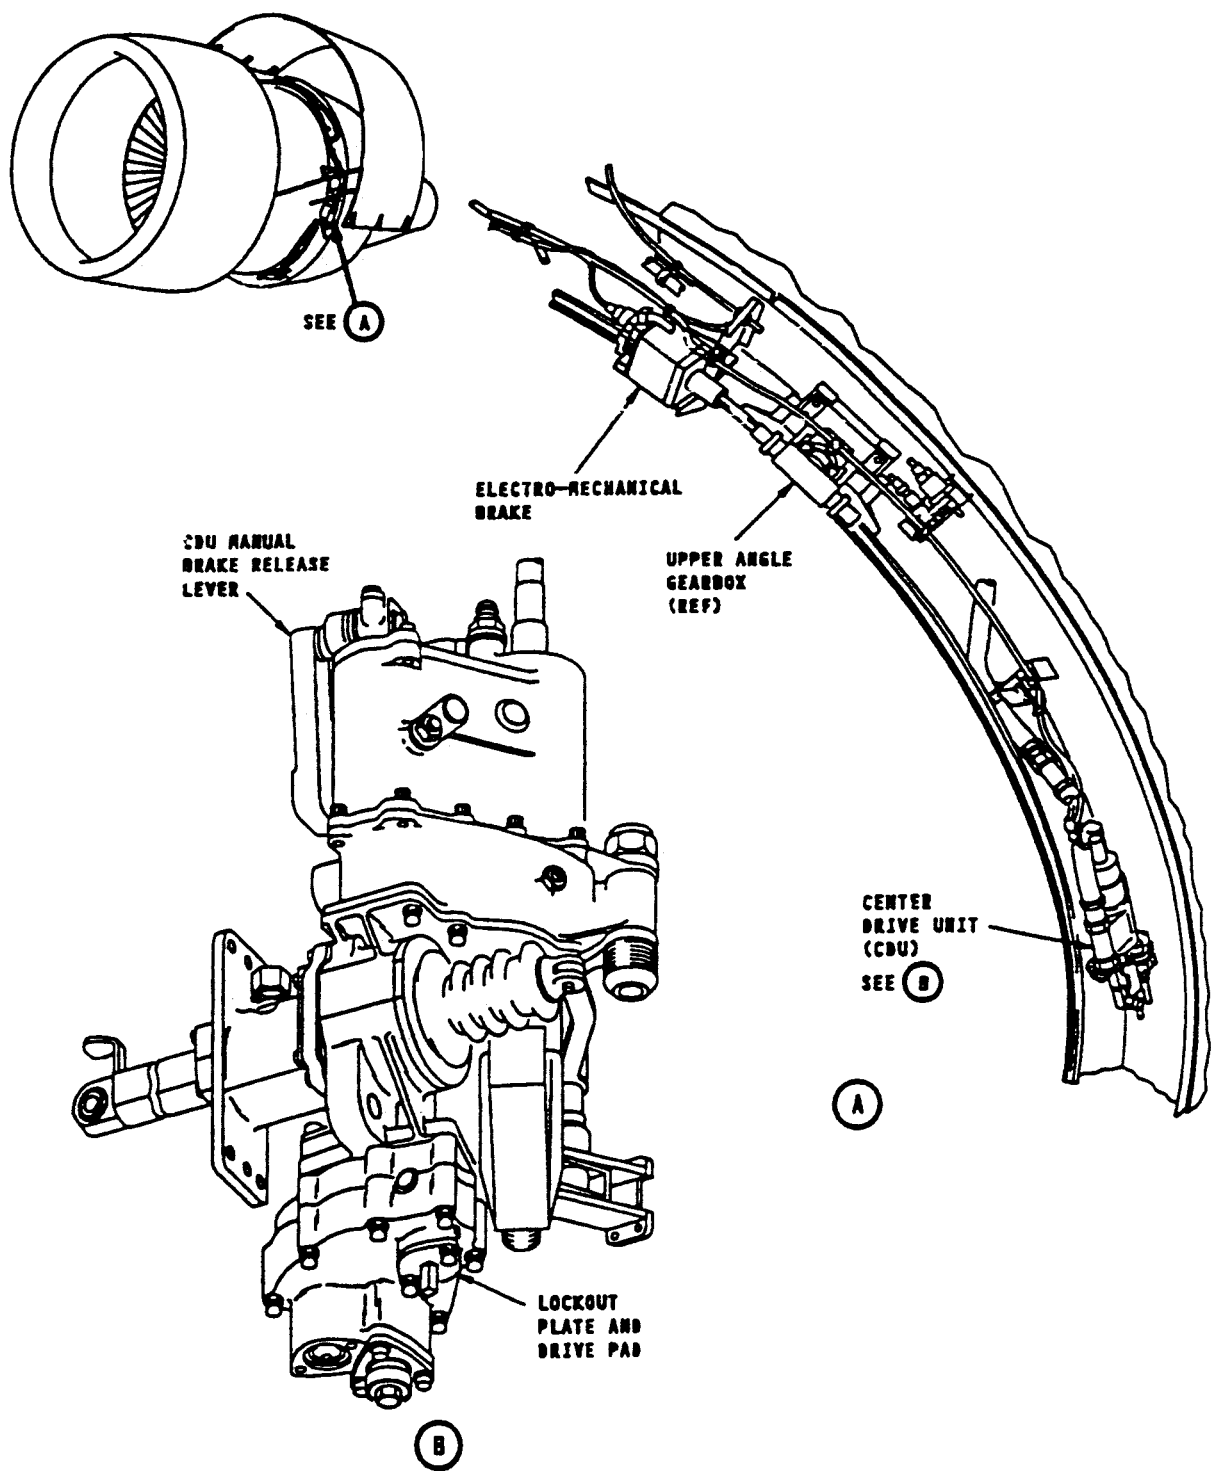
Electro-Mechanical Brake and CDU Cone Brake Torque Check  
Figure 1

- Completion of the functional test of the CDU cone brake as referenced in the existing AD is ineffective for Model 747-400 series airplanes having a third locking system installed on the thrust reversers. The test for those airplanes

requires an additional step to unlock the electro-mechanical brake prior to accomplishment of the functional test of the cone brake of the center drive unit. This step was omitted from the functional test described in the service bulletins and referenced in paragraph (a) of the existing AD. Therefore, Appendix 1 (including Figure 1) has been added to this AD to provide accurate instructions for airplanes that have a third locking system installed. Paragraph (a) of this AD has been revised to reference Appendix 1 (including Figure 1) as the appropriate source of service information for those airplanes.

**Note:** The cone brake prevents movement in the extend direction only. If you try to measure the holding torque in the retract direction, you will get a false reading.

2. CDU cone brake check (Figure 1):

**CAUTION:** DO NOT USE MORE THAN 100 POUND-INCHES OF TORQUE WHEN YOU DO THIS CHECK. EXCESSIVE TORQUE WILL DAMAGE THE CDU.

(7) Turn the torque wrench to try to manually extend the translating cowl until you get at least 15 pound-inches.

(8) If the torque is less than 15 pound-inches, you must replace the CDU.
