[Docket No. 2000-NM-94-AD; Amendment
39-11712; AD 2000-09-04]

Airworthiness Directives; Boeing Model 767 Series Airplanes Equipped with General Electric Model CF6-80C2 Series Engines

ACTION: Final rule; request for
comments.

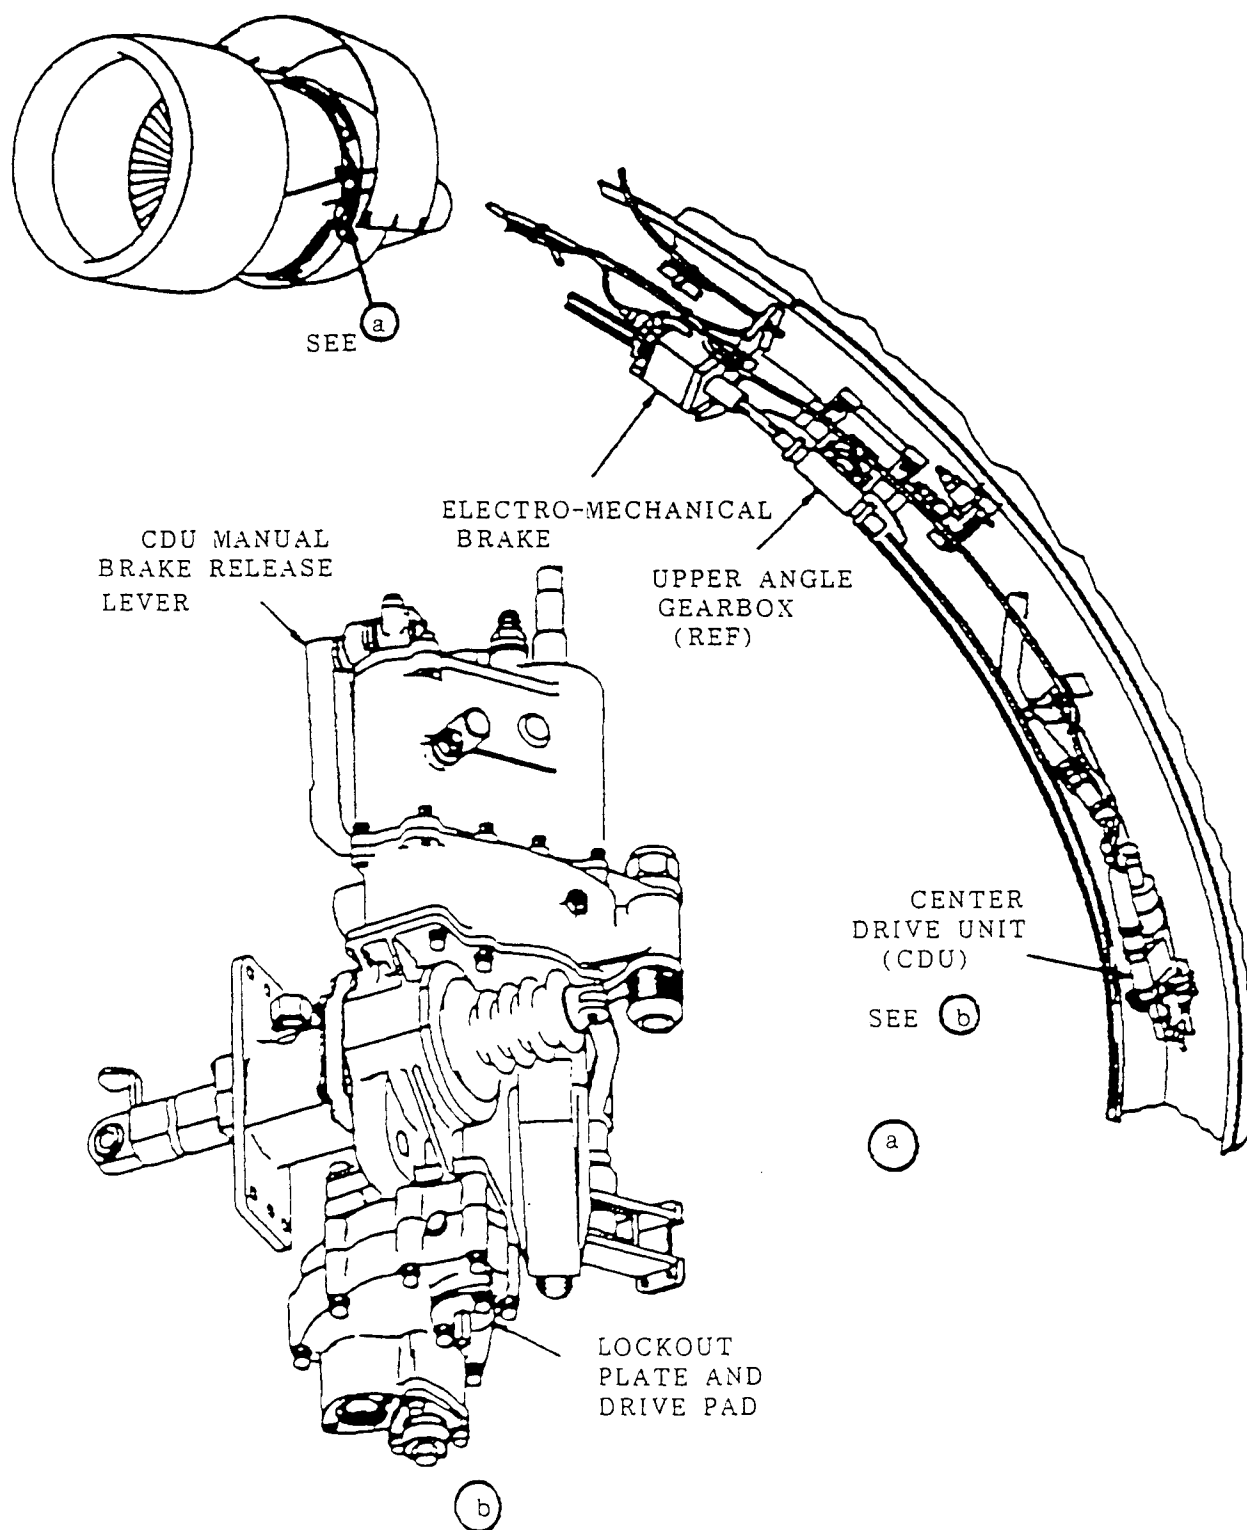
Electro-Mechanical Brake and CDU Cone Brake Torque Check
Figure 1

(1) The electro-mechanical brake system is working correctly if the torque is reached before you turn the wrench 450 degrees (1 1/4 turns).

(2) If the flexshaft turns more than 450 degrees before you reach the specified torque, you must replace the long flexshaft between the CDU and the upper angle gearbox.

(3) If you do not get 90 pound-inches of torque, you must replace the electro-mechanical brake.

(1) If the wrench does not return to within 30 degrees of initial starting point, you must

replace the long flexshaft between the CDU and upper angle gearbox.

(a) If the torque is less than 15-pound-inches, you must replace the CDU.
