[Docket No. 99-SW-86-AD; Amendment 39-11737; AD 2000-10-13]

Airworthiness Directives; Eurocopter France Model SA-365N, SA-365N1, AS-365N2 and AS-365N3 Helicopters

AD 2000-10-13 Eurocopter France:

Amendment 39-11737. Docket No. 99-SW-86-AD.

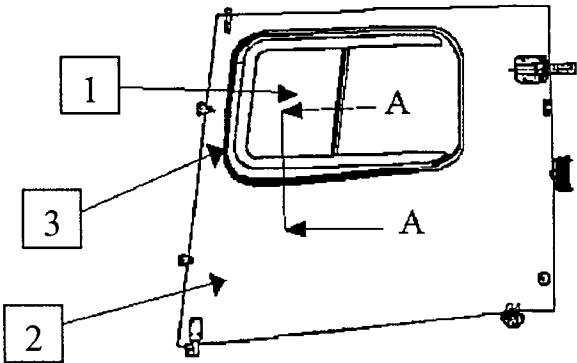
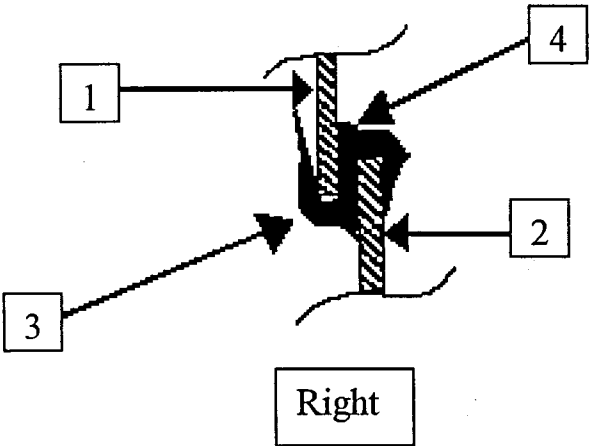
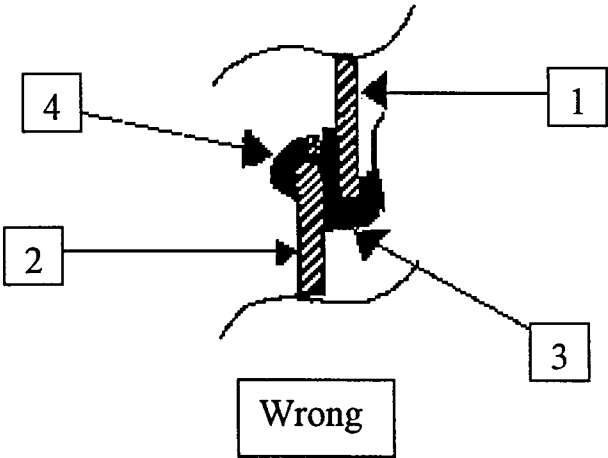
Figure 1

(a) Visually inspect each window panel in any enlarged sliding door (door) for correct positioning on the inside of the door. See Figure 1.

(2) If a window is installed on the outside, before further flight, remove the window and reinstall using a new seal.

- 1 - Window
- 2 - Door Structure
- 3 - Seal
- 4 - Sealant

a. From inside the door, cut the seal (see Figure 1, item 3). Push the window out and remove remnants of the seal from the window panel and door structure.

b. Remove all traces of the sealing compound (see Figure 1, item 4) with methyl ethyl ketone (MEK), acetone, or equivalent.

d. Fit the new seal to the window panel. The joint will be located in the lower center of the window panel. The clearance between the seal and the window panel should not exceed 0.04 inch.

e. Insert a 0.01-inch diameter cord (rip cord works well) into the seal slot. Position the cord such that the cord ends are on the top center of the panel).

f. Press the window panel and seal assembly against the door from the inside.

g. Gently pull outward on the cord ends, allowing the outer edge of the seal to pull over the door structure. Continue pulling cord around the window panel until complete.

h. Apply PR1222 sealant between the seal and the door structure. Wipe off any excess sealant.
