[Docket No. 99-SW-43-AD; Amendment 39-11738; AD 2000-10-14]

Airworthiness Directives; Bell Helicopter Textron Canada (BHTC) Model 222, 222B, 222U, and 230 Helicopters

AD 2000–10–14 Bell Helicopter Textron Canada: Amendment 39–11738. Docket No. 99–SW–43–AD.

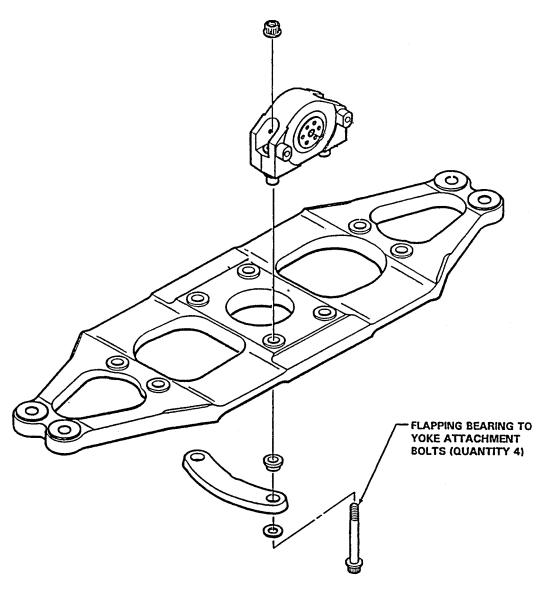
FIGURE 1

(a) Remove one bolt at a time and inspect each bolt located as shown in Figure 1.

- (ii) Visually inspect each bolt and discard those that have thread damage, shank wear, or corrosion.
- (iii) Apply corrosion preventative compound MIL–C–16173 GR2, or equivalent, to the shank of the bolt only.
 - (iv) Install, torque, and lockwire each bolt.
- (v) Coat each bolt head and nut with corrosion preventative compound MIL–C– 16173 GR1 or equivalent.
