[Docket No. 99-SW-62-AD; Amendment 39-11766; AD 2000-11-18]

Airworthiness Directives; Eurocopter France Model SA-365C, C1, C2, N, and N1; AS-365N2 and N3; and SA-366G1 Helicopters

2000-11-18 Eurocopter France:

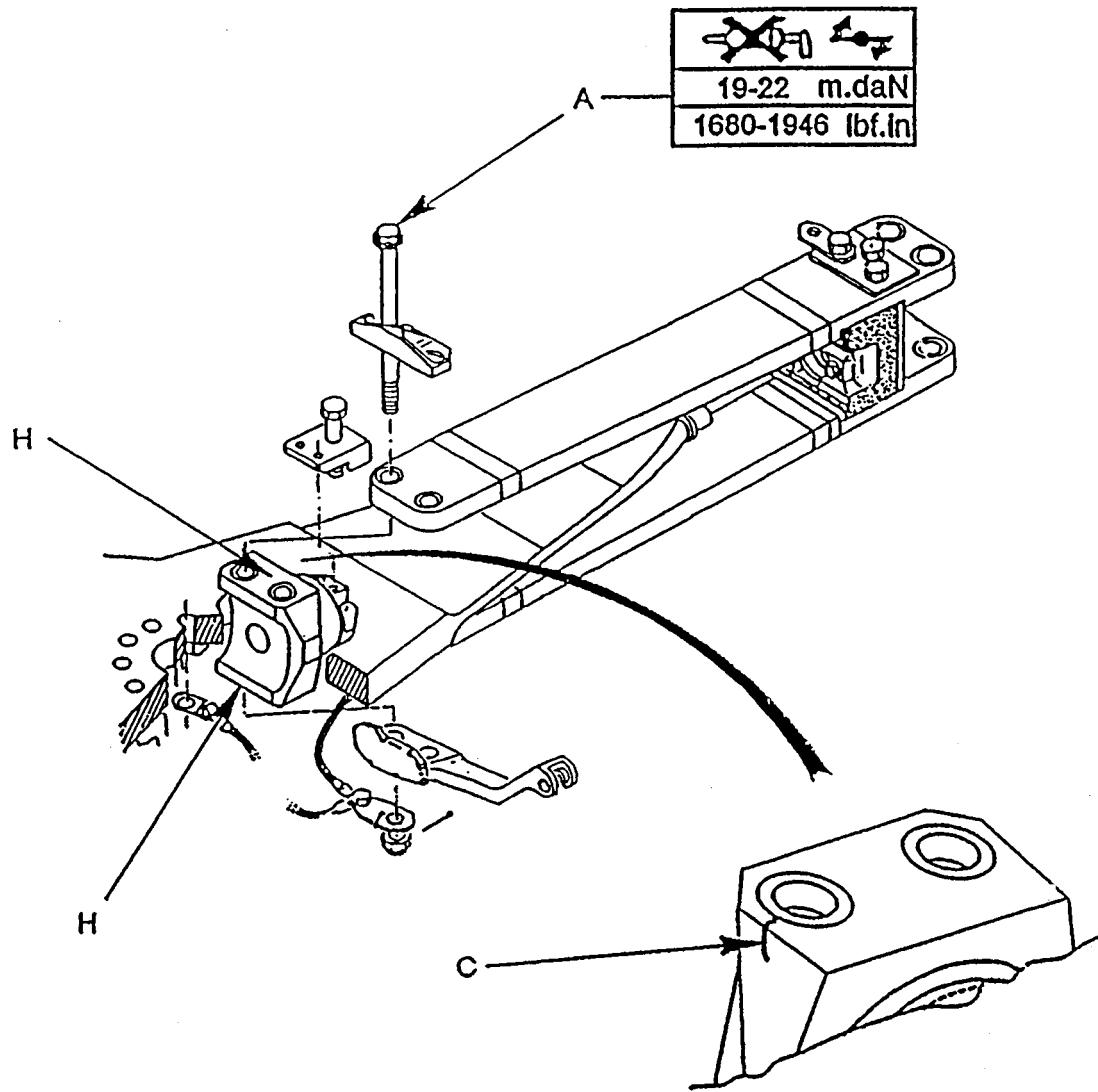
Figure 1

To prevent loosening of the main rotor hub blade attach beam spherical thrust bearing bolts (bolts), cracks in the metal components, failure of a spherical thrust bearing (bearing), and subsequent loss of control of the helicopter, accomplish the following:

(a) Inspect the tightening torque of the bolts as indicated by "A" in Figure 1.

(1) If tightening torque is equal to or less than 12 m.daN (88.4 lb-ft), remove the bearing and conduct a dye penetrant inspection for cracks on the two contact surfaces identified as "H" in Figure 1.

(i) If a crack is detected, replace the bearing with an airworthy bearing.

(2) If the tightening torque is greater than 12 m.daN (88.4 lb-ft), then tighten the torque to 19-22 m.daN (140-162.2 lb-ft).
