[Docket No. 98-SW-69-AD; Amendment 39-11528; AD 2000-02-09]

Airworthiness Directives; Agusta S.p.A. (Agusta) Model AB412 Helicopters

AD 2000-02-09 Agusta: Amendment 39-11528. Docket No. 98-SW-69-AD.

Applicability: Model AB412 helicopters with rescue hoist, part number BL10300-60 or BL10300-59, installed, certificated in any category.

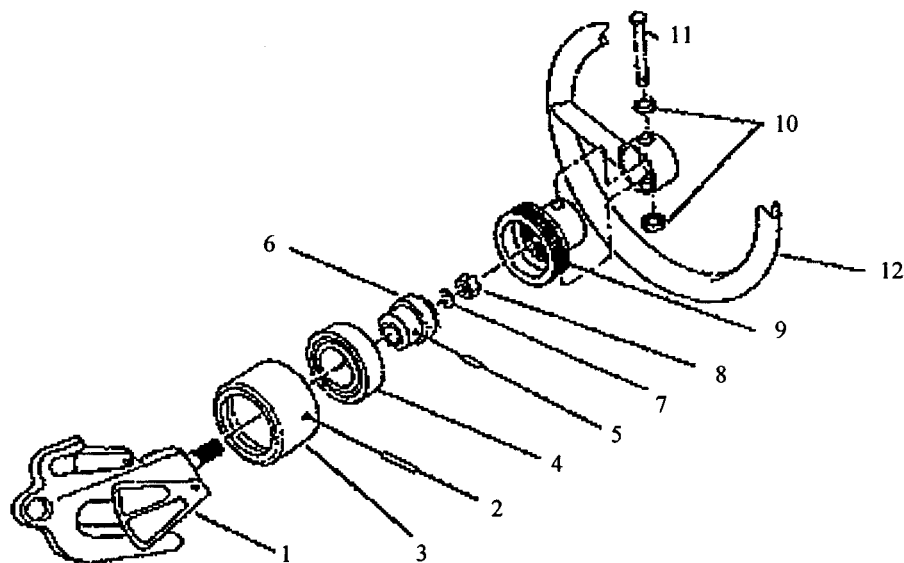
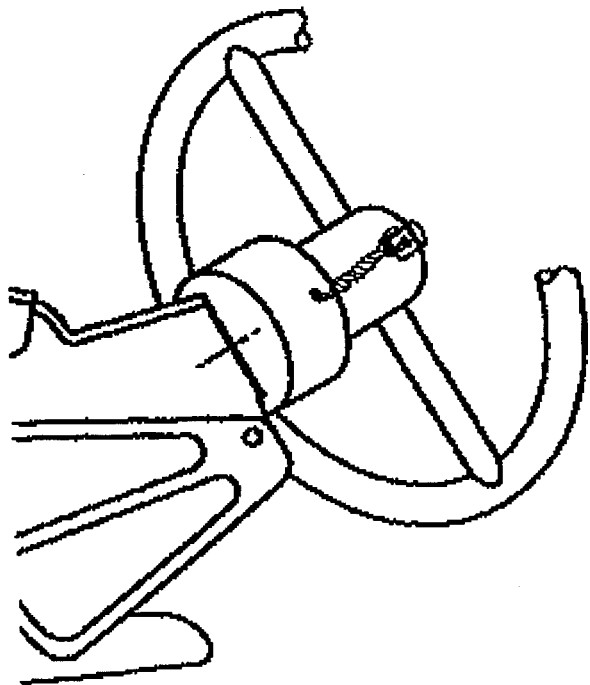
Figure 1

To prevent separation of the rescue hoist hook assembly from the helicopter due failure of the rescue hoist hook assembly retention pin (retention pin), accomplish the following:

(4) Inspect the rescue hoist hook to ensure it rotates freely relative to the housing (number 3 on Figure 1).

(2) Remove the safety wire and remove and discard the retention pin. Retain the two washers, P/N AN960C816L, for reuse (Figure 1).

(3) Install a zero-hours time-in-service (TIS) retention pin, P/N BL2395, and the two washers, P/N AN960C816L, (Figure 1). Safety wire the retention pin to the hook assembly using safety wire, P/N MS 20995C32.

(3) Inspect the pin, P/N NAS516C4-6 or P/N MS171524, installed on the housing, P/N BL1357-1, and verify the absence of any rotation between the housing and the adapter, P/N BL1355, (Figure 1).

(1) Referring to Figure 1, remove the safety wire and the retention pin. Retain the two washers, P/N AN960C816L, for re-use.

Inspect the retention pin for scratches or deformations. If a scratch or deformation is found, replace the retention pin with an airworthy retention pin.

(2) Install the retention pin and the two washers, P/N AN960C816L, (Figure 1). Safety wire the retention pin to the hook assembly using safety wire, P/N MS20995C32.
