[Docket No. 2000–SW–33–AD; Amendment 39–11881; AD 2000–17–07]

#### **Airworthiness Directives; Eurocopter France Model EC120B Helicopters**

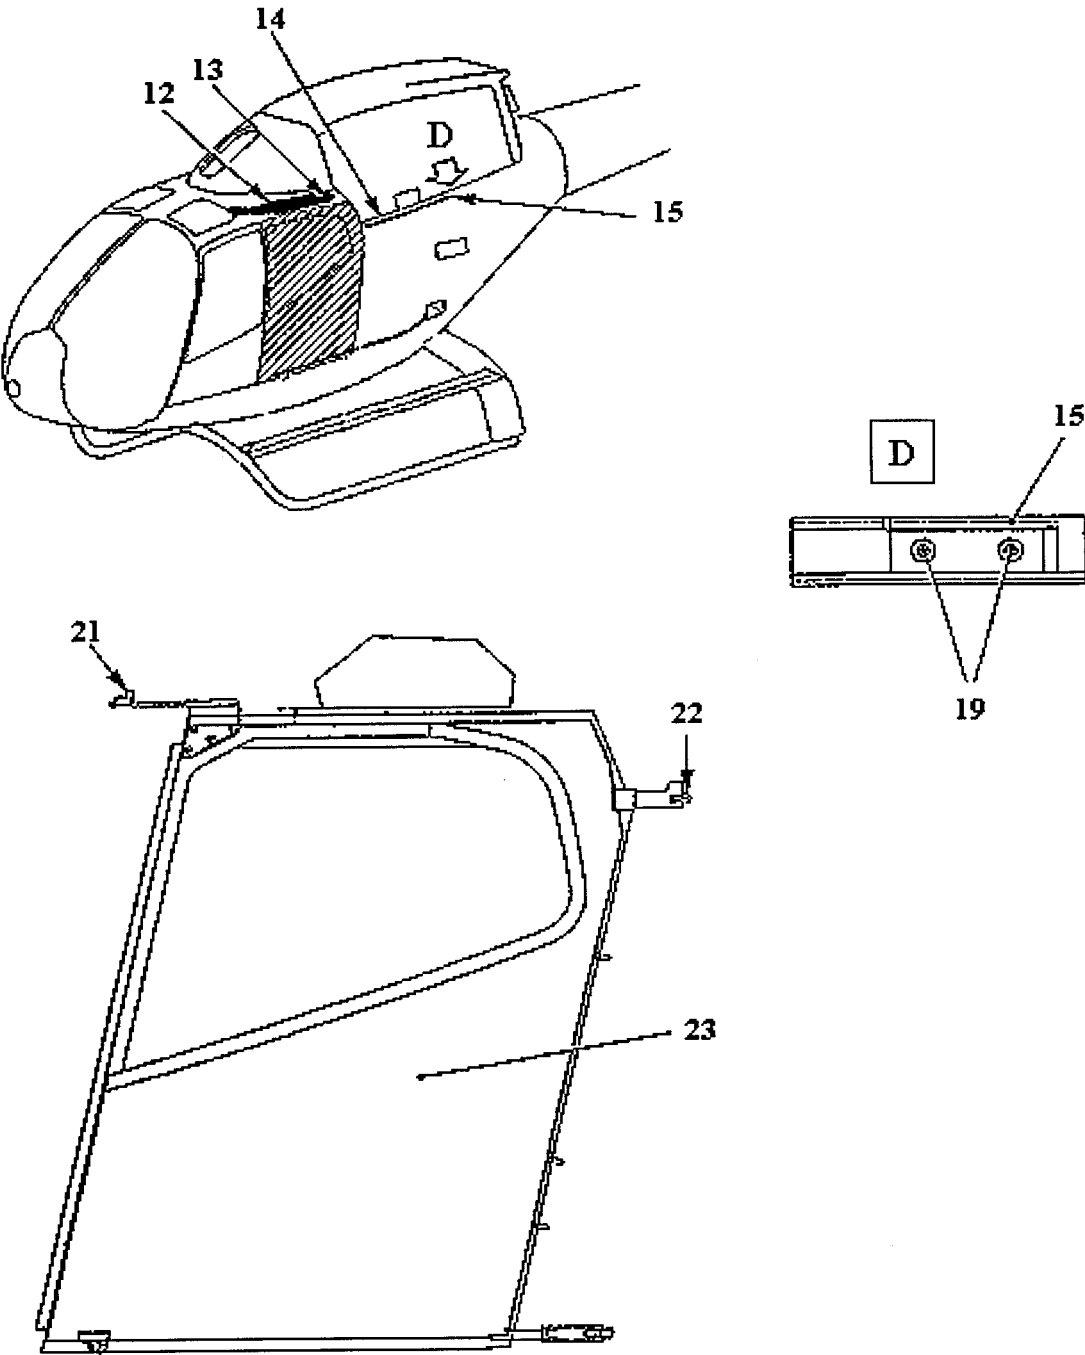
Figure 1

(a) Adjust the cabin sliding door (23) (see Figure 1) in accordance with the following:

(10) If the roller (21) is completely inside the rail (12) with a minimum clearance of 3 mm from the aft end of the rail (12), the cabin door is properly adjusted and no further action is required by this AD.

(1) Loosen the screws (19) and the stop (15).

(2) Open and push the cabin sliding door aft until the roller goes past the locking pin (13) while keeping the roller (21) inside the rail (12).

(3) Move the cabin sliding door forward to bring the roller (21) into contact with the locking pin (13).

(4) Move the stop (15) as far forward as possible toward the nose of the aircraft.

(5) Mark the location of the stop (15) with respect to the rail (14).

(6) Unlock the cabin sliding door and move it forward to gain access to the screws (19).

(7) Hold the stop (15) aligned with the rail (14), and secure the stop (15) and the screws (19) at the location previously marked.

(8) Ensure that the pin (13) locking mechanism (pin) locks the cabin sliding door in the open position. If the pin does not lock the door in the open position, before further flight, repair or replace the pin with an airworthy pin.

(9) Bring the roller (22) into contact with the stop (15) of the rail (14).

(11) If the roller (21) is less than 3 mm from the aft end of the rail (12), before further flight, repeat steps (1) through (10) until a minimum clearance of 3 mm is obtained.
