**Airworthiness Directives; Boeing Model 767 Series Airplanes Equipped With General Electric Model CF6-80C2 Series Engines**

**2000-02-20 Boeing:** Amendment 39-11538. Docket 98-NM-231-AD. Supersedes AD 95-13-12 R1, Amendment 39-9528.

##### Thrust Reverser Electro-Mechanical Brake and CDU Cone Brake Test

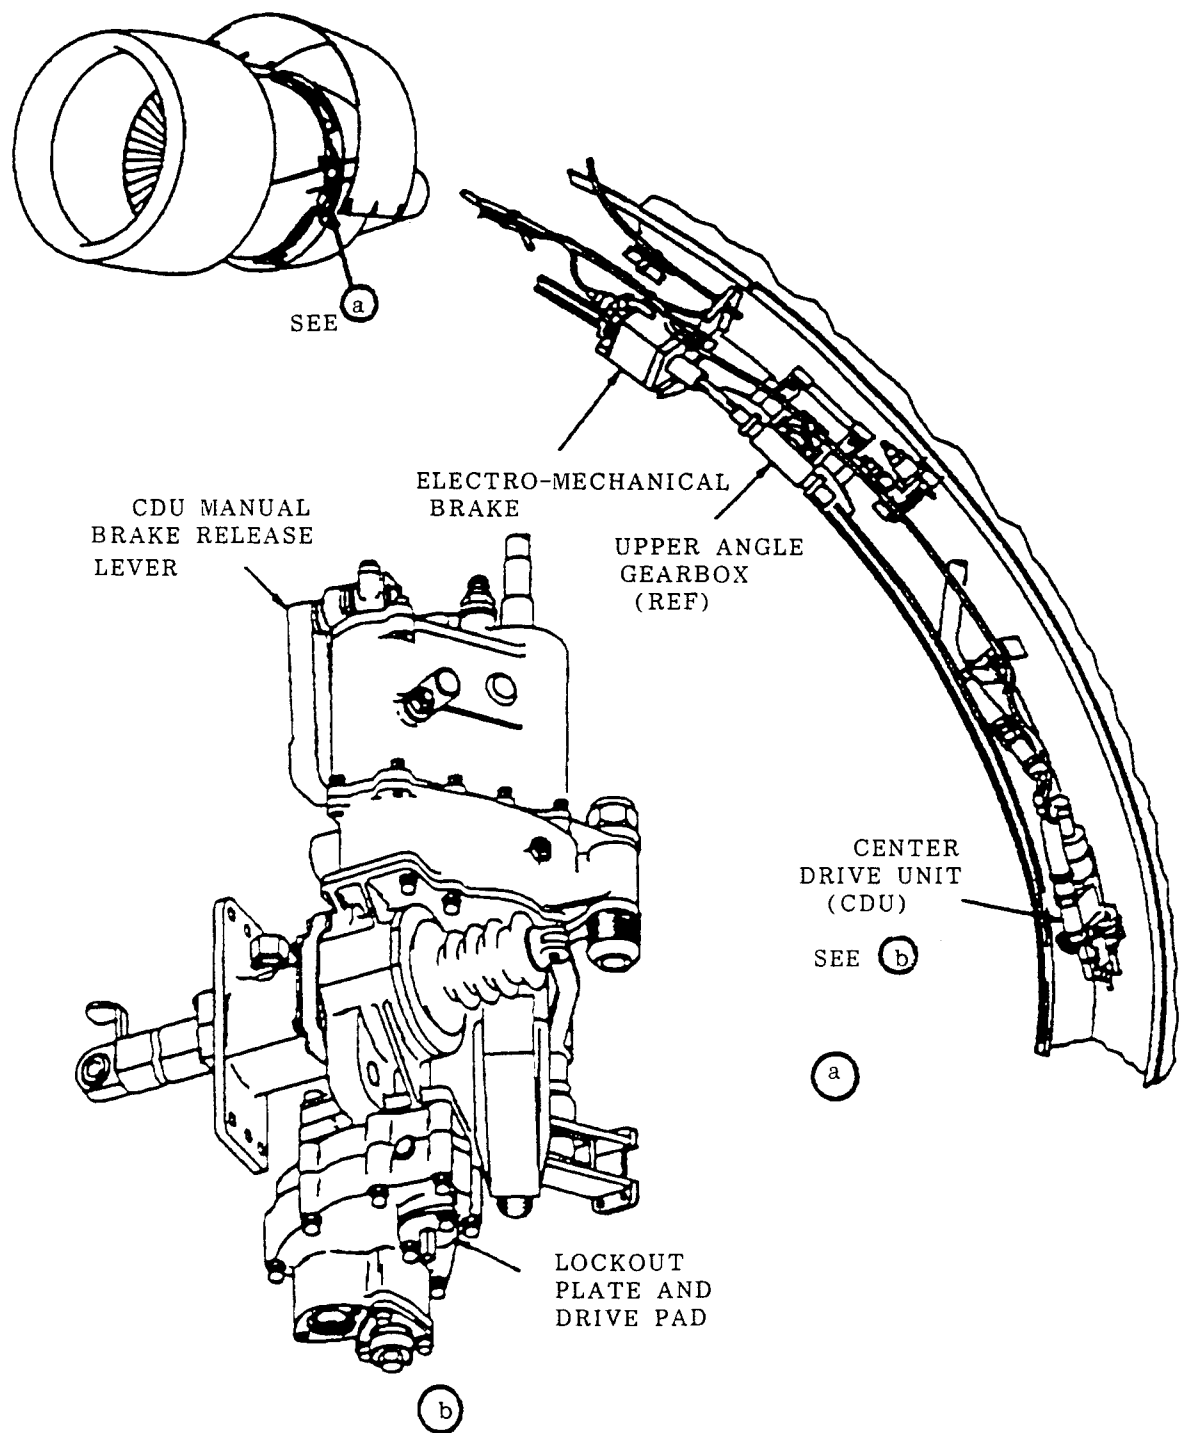
Electro-Mechanical Brake and CDU Cone Brake Torque Check  
Figure 1

(1) The electro-mechanical brake system is working correctly if the torque is reached before you turn the wrench 450 degrees (1 1/4 turns).

(2) If the flexshaft turns more than 450 degrees before you reach the specified torque, you must replace the long flexshaft between the CDU and the upper angle gearbox.

(3) If you do not get 90 pound-inches of torque, you must replace the electro-mechanical brake.

(1) If the wrench does not return to within 30 degrees of initial starting point, you must replace the long flexshaft between the CDU and upper angle gearbox.

(a) If the torque is less than 15-pound-inches, you must replace the CDU.
