DEPARTMENT OF TRANSPORTATION

Denial of Motor Vehicle Defect Petition, DP00–001

Appendix—Petition Analysis—DP00–001

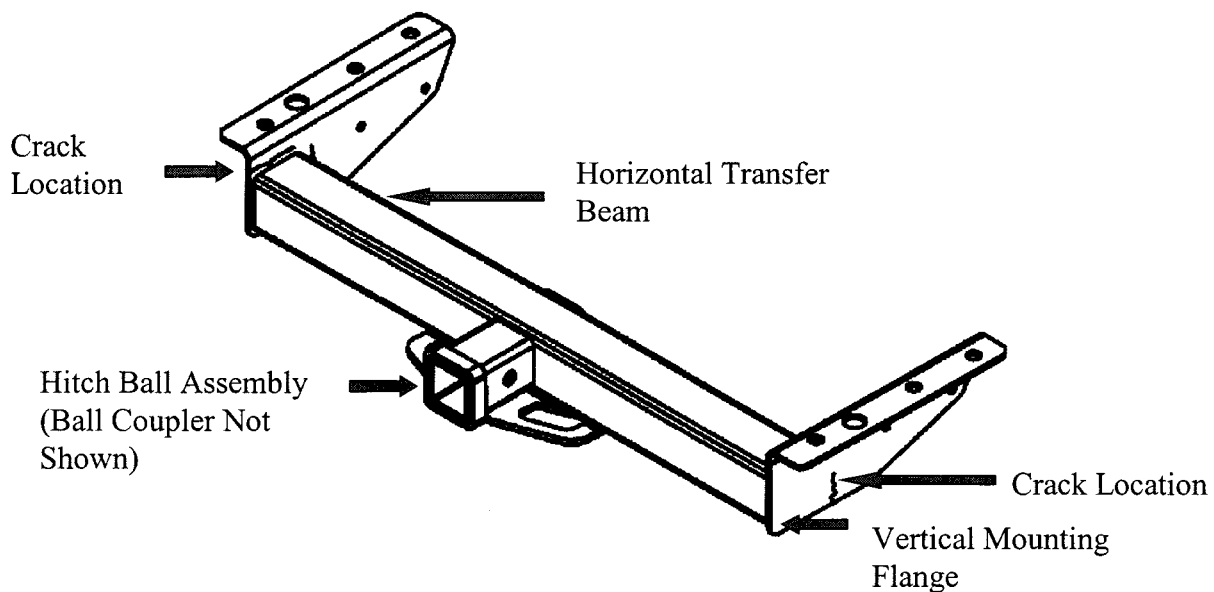
Figure 1. Typical Class III/IV towing Hitch Receiver

Figure 1 shows a diagram of a typical frame mounted Class III/IV type hitch receiver.

and (3) the vertical mounting flanges for attachment to the vehicle frame. Note that the diagram also shows the typical crack patterns found as reported by the petitioner.
