14 CFR Part 39

[Docket No. 2000–SW–60–AD]

Airworthiness Directives; Bell Helicopter Textron, Inc., Model 412 Helicopters

ACTION: Notice of proposed rulemaking (NPRM).

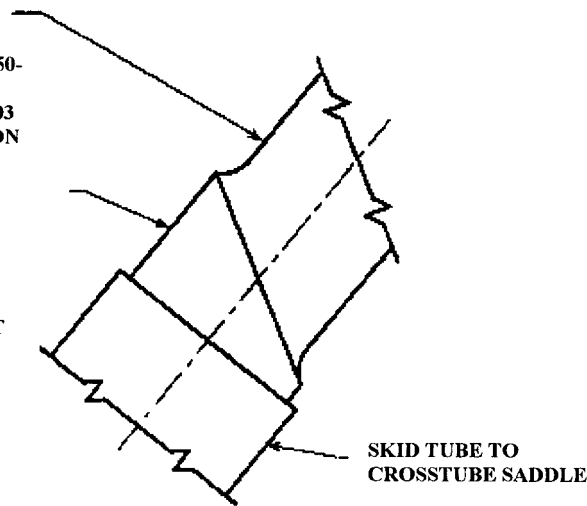
FIGURE 1

THE FACTORY HAS INK
STAMPED THE SUBASSEMBLY
AND SYNTHETIC P/N 412-050-
044-101, -101A, OR -103 IN THIS
GENERAL AREA.

CROSSTUBE ASSEMBLY P/N 412-050-
045-107 HAS THE NEXT LOWER
(SUBASSEMBLY) P/N 412-050-044-103
VIBRO-ETCHED IN THIS LOCATION
FROM THE FACTORY. THE S/N IS
POSITIONED UNDER THE P/N.

VIBRO-ETCH 412-050-011-107 FM
AND A COMPANY CONTROLLED
S/N IN THIS AREA AS REQUIRED
TO TRACK REMAINING HIGH AFT
CROSSTUBE LIFE. VIBRO-
ETCHING DEPTH SHALL NOT
EXCEED 0.005 INCH.

(3) Vibro-etch the P/N on the crosstube assembly adjacent to the skid tube saddle in accordance with Figure 1 for any crosstube assembly not displaying a visible P/N. Identify the crosstube assembly as P/N 412-050-011-107 FM.

(4) Vibro-etch a serial number (S/N) on the crosstube assembly below the P/N in accordance with Figure 1. The S/N must be unique for each crosstube assembly.
