#### 14 CFR Part 39

[Docket No. 2001-SW-53-AD; Amendment 39-13079; AD 2003-05-03]

#### Airworthiness Directives; Bell Helicopter Textron Canada Model 407 Helicopters

**SUMMARY:** This amendment adopts a new airworthiness directive (AD) for the specified Bell Helicopter Textron Canada (Bell) model helicopters that requires preflight checking and repetitively inspecting for a crack in certain tailbooms that have not been redesigned and replacing the tailboom if a crack is found; modifying and re-identifying certain tailbooms and installing an improved horizontal stabilizer assembly; and assigning a 5,000 hour time-in-service (TIS) life limit. This amendment is prompted by cracking discovered in other areas of certain tailbooms and introduction of a redesigned tailboom with a chemically milled skin, which does not require the current inspections. The actions specified by this AD are intended to prevent separation of the tailboom and subsequent loss of control of the helicopter.

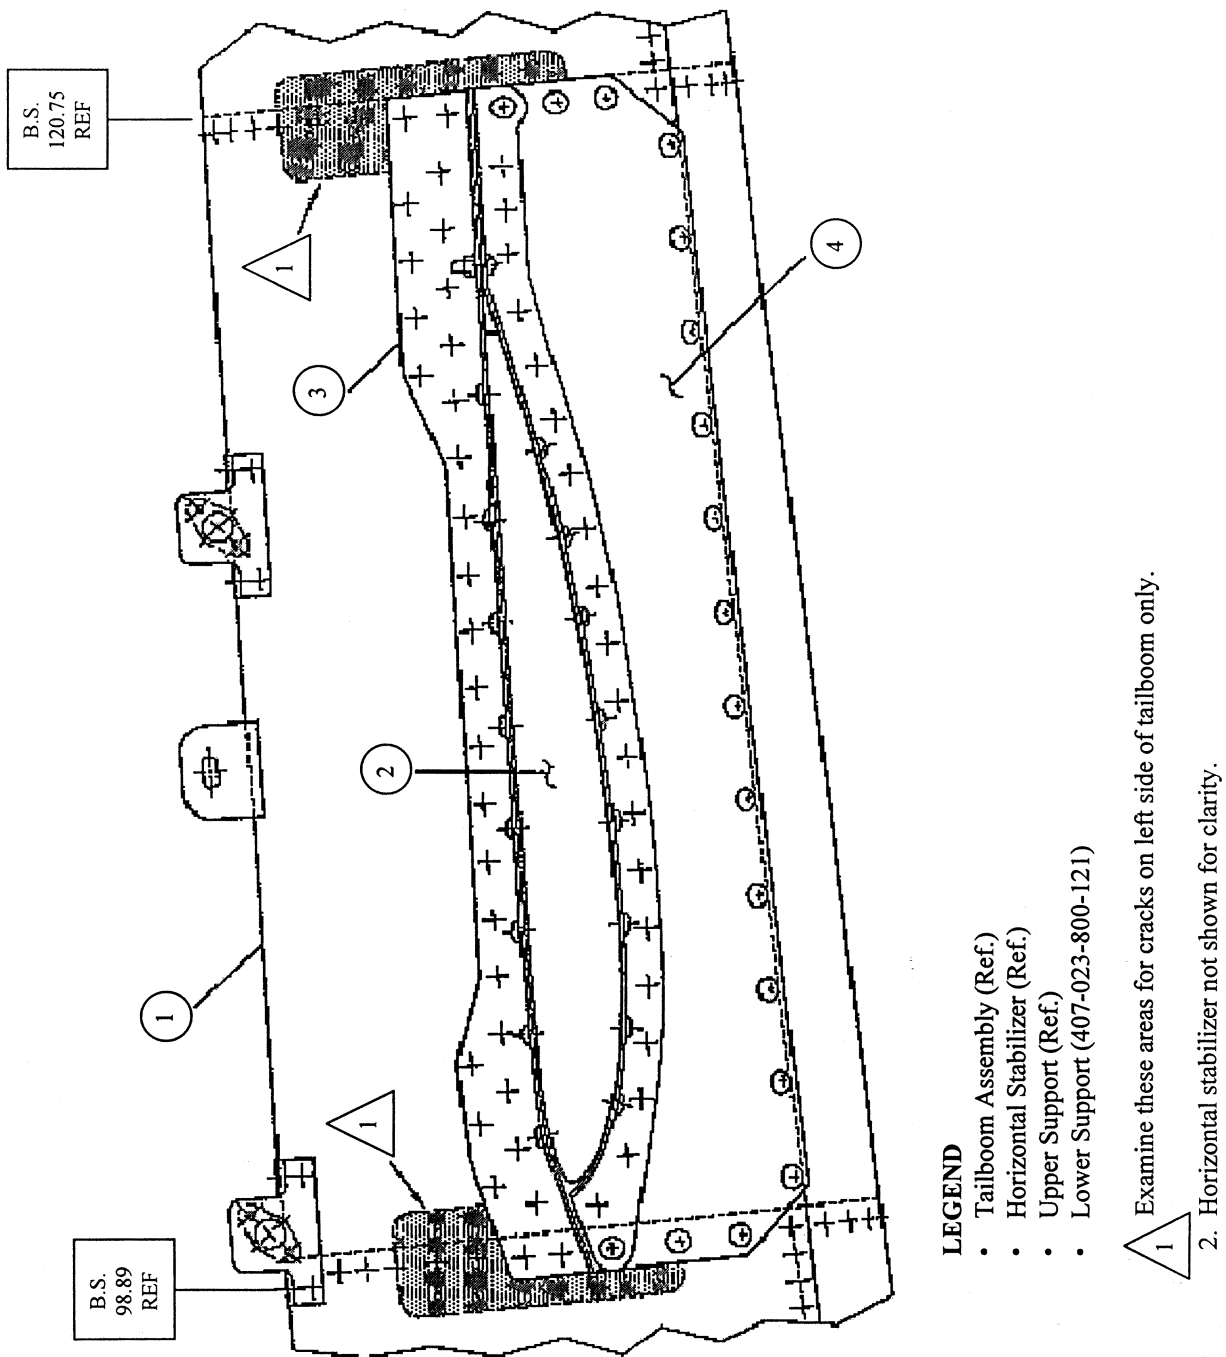
Figure 1. Preflight Check of the Tailboom

| Applicable tailboom | Compliance time | Actions | In accordance with |
|---|---|---|---|
| (a) Tailboom, P/N 407-030-801-101 and -105, that have not been modified in accordance with Bell ASB 407-01-048, Revision B, dated April 25, 2002. | Before the first flight of each day | Visually check the tailboom for cracks. An owner/operator (pilot) holding at least a private pilot certificate may perform the visual check required by this paragraph, but must enter compliance with this paragraph into the helicopter records in accordance with 14 CFR 43.11 and 91.417(a)(2)(v). | Figure 1 of this AD. |

| Applicable tailboom | Compliance time | Actions | In accordance with |
|---|---|---|---|
| (f) All applicable part-numbered tailbooms. | Before further flight ..... | If a crack is found, replace the tailboom. | The applicable maintenance manual. |
