[Docket No. 2002-SW-14-AD; Amendment 39-13015; AD 2003-01-04]

#### Airworthiness Directives; Bell Helicopter Textron, Inc. Model 204B, 205A, 205A-1, 205B and 212 Helicopters

**2003-01-04 Bell Helicopter Textron, Inc.:**  
Amendment 39-13015. Docket No. 2002-SW-14-AD.

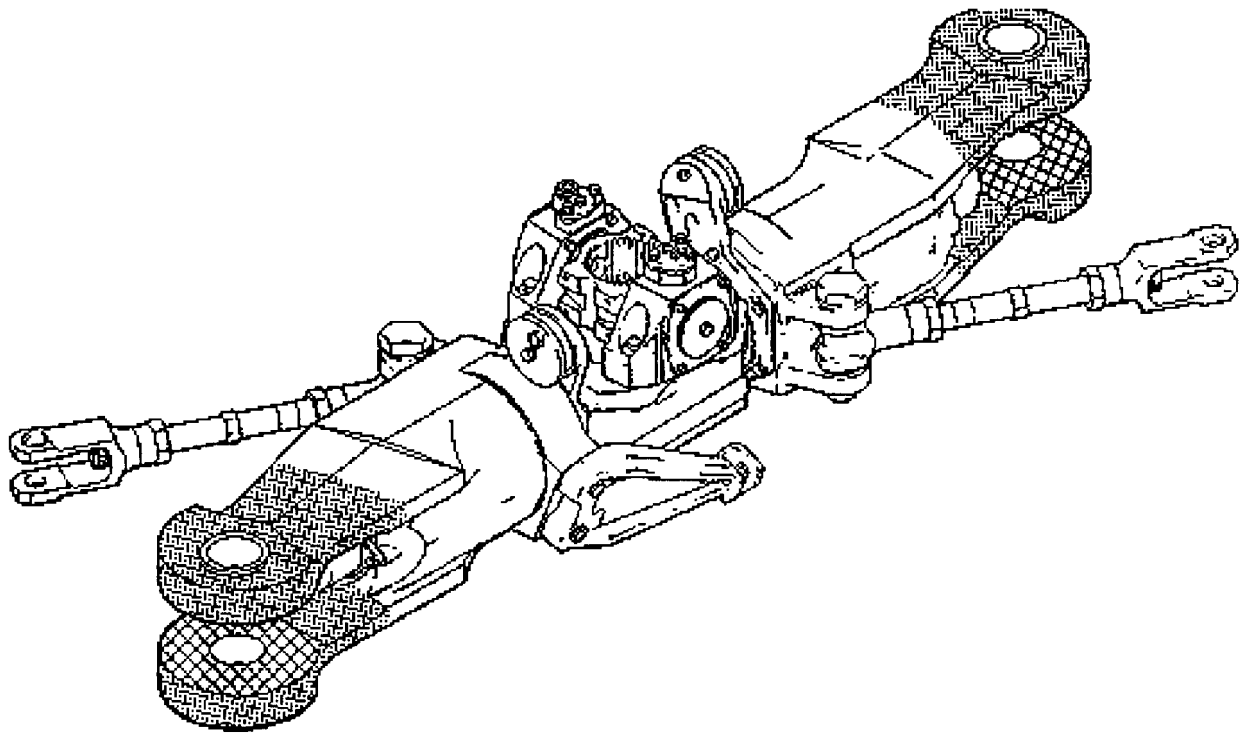
**Figure 1. Inspection of Main Rotor Hub Grip Tangs**

(2) Using a 10-power or higher magnifying glass, visually inspect the exposed surfaces of the upper and lower tangs of each grip for a crack. Pay particular attention to the lower surface of each lower grip tang from the main rotor blade bolt-bushing flange to the leading and trailing edge of each grip tang. See Figure 1 as follows:

INSPECT BUFFER PAD  
FOR DELAMINATION (IF  
INSTALLED)

AREA TO BE INSPECTED  
UPPER AND LOWER  
TANGS ALL EXPOSED  
SURFACES

(2) Inspect each grip buffer pad on the inner surfaces of each grip tang for delamination (see Figure 1 of this AD). If there is any delamination, remove the buffer pad and inspect the grip surface for corrosion or other damage.

(1) Replace with an airworthy grip any grip with a crack.

(2) Replace with an airworthy grip or repair, if within maximum repair damage limits, any grip with any corrosion or other damage.
