[Docket No. 2001-SW-40-AD; Amendment 39-13022; AD 2002-13-05 R1]

Airworthiness Directives; MD Helicopters, Inc. Model 369D, 369E, 369F, and 369FF Helicopters

ACTION: Final rule.

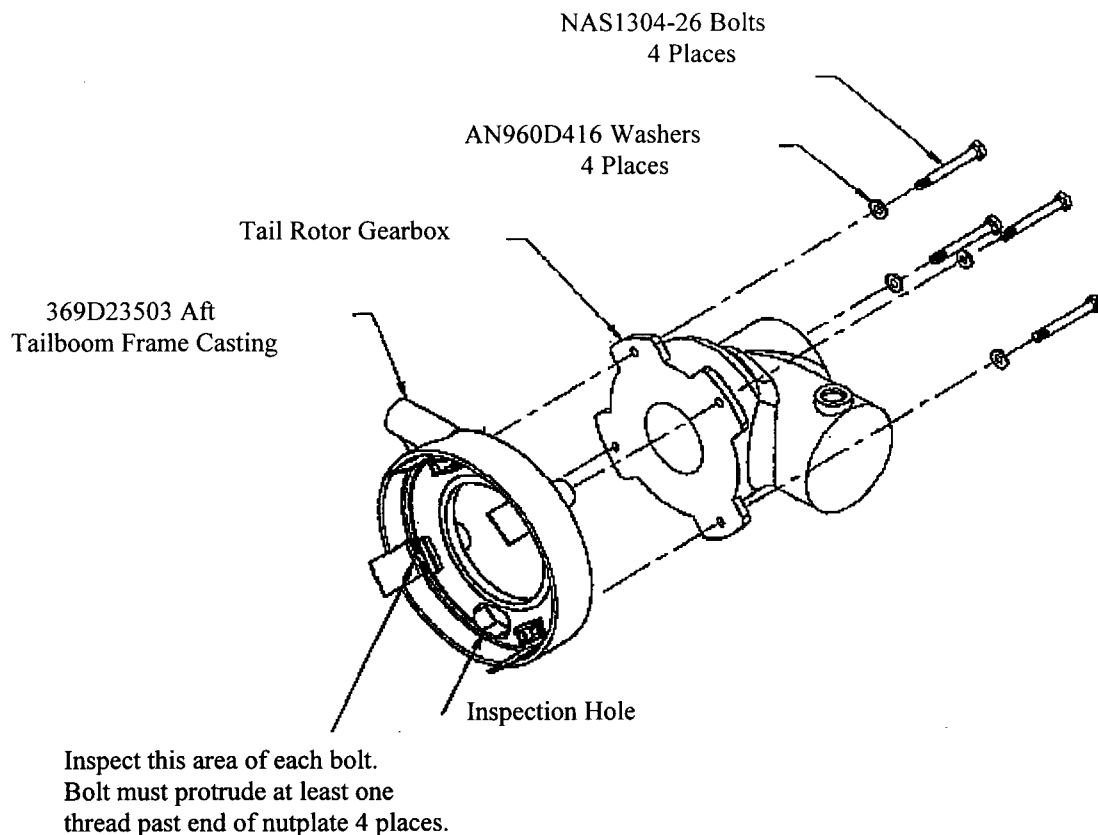
Figure 1 - Inspection Location

concern was valid. We are now reducing the applicability of AD 2002-13-05 to include only certain tailboom S/N's and parts that are modified in accordance with either STC SH5055NM or SH4801NM. We are also correcting the P/N for the washer to P/N AN960D416 in Figure 1 of this AD and clarifying that a slippage mark needs to be reapplied to each bolt regardless of the outcome of the required torque test.

Compliance: Required as indicated, unless accomplished previously.
To prevent loss of the tail rotor gearbox due to attaching bolts of inadequate grip length and subsequent loss of control of the helicopter, accomplish the following:
(a) Within 25 hours time-in-service (TIS):
(1) For each tail rotor gearbox attaching bolt (bolt):
(i) Determine the part number (P/N).
(ii) If the P/N cannot be determined or if the bolt is not P/N NAS1304–26, before

further flight, replace the bolt with bolt, P/N NAS1304–26.
(iii) Torque the bolt to 100–110 in-lbs and apply a slippage mark.
(2) Remove the tailboom control rod and determine the number of bolt threads protruding from each nutplate on the internal surface of the aft tailboom frame casting, P/N 369D23503, as shown in Figure 1 of this AD. At least one thread must protrude. If more than four threads protrude, add an additional washer, P/N AN960D416, under the bolt head. Torque the bolt to 100–110 in-lbs, and reapply a slippage mark. *See Figure 1:*

(b) Between 2 and 10 hours TIS after accomplishing the requirements of paragraph (a) of this AD, inspect the torque on each bolt by applying 100 in-lbs. If any bolt movement occurs, retorque the bolt to 100–110 in-lbs. Reapply a slippage mark to the bolt regardless of the outcome of the torque test. Reinspect the torque between 2 and 10 hours TIS thereafter until no bolt movement occurs.
