[Docket No. 2003–SW–20–AD; Amendment 39–13181; AD 2003–08–53]

Airworthiness Directives; Eurocopter France Model SA–365N1, AS365–N2, AS 365 N3, and SA–366G1 Helicopters

2003-08-53 Eurocopter France:

Amendment 39-13181. Docket No. 2003-SW-20-AD. Supersedes AD 2000-10-08, Amendment 39-11732, and 2000-10-08R1, Amendment 39-12452, both Docket No. 99-SW-34-AD.

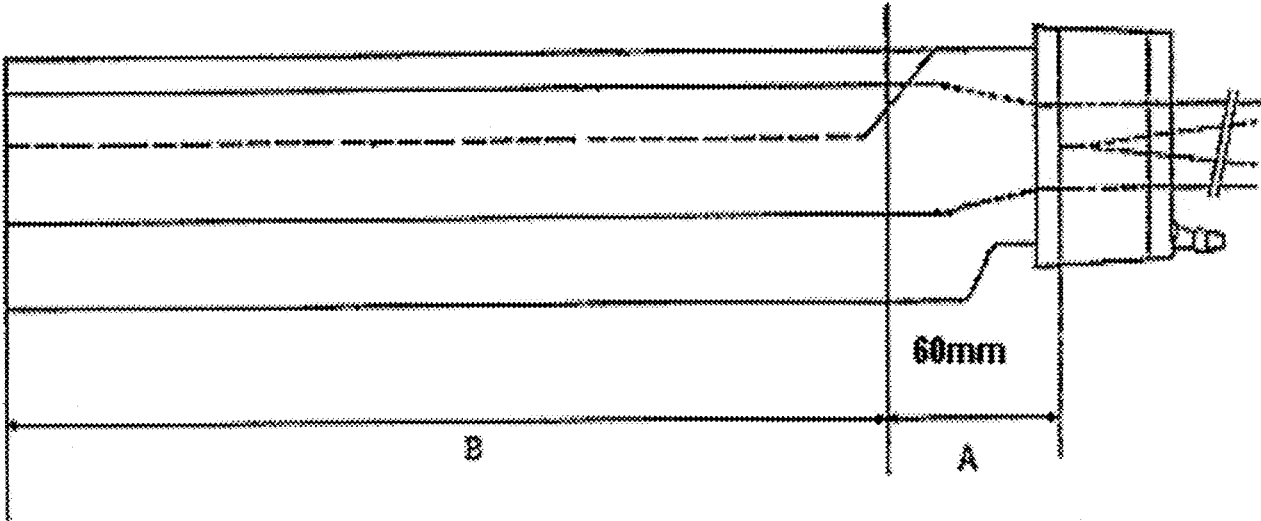
(a) Within 10 hours time-in-service (TIS) and thereafter before the first flight of each day, visually check each blade for a crack, blister, or wrinkling. An owner/operator (pilot), holding at least a private pilot certificate, may perform the visual check and must enter compliance into the aircraft maintenance records in accordance with 14 CFR sections 43.11 and 91.417(a)(2)(v)). See Figure 1 as follows:

(b) If a crack, blister, or wrinkling is found as a result of the visual check, accomplish the following before further flight (see Figure 1 of this AD):

(1) Zone A: If a blister is detected on the blade suction face, conduct a tapping test inspection on the whole blade for bonding separation.

(2) Zone B: If a crack, wrinkling, or a blister is found, replace the blade with an airworthy blade before further flight.

(i) For blades, P/N 365A33-2131-all dash numbers, 365A12-0010-all dash numbers, and 365A12-0020-00, and -01, if bonding separation or a crack is found, replace the blade with an airworthy blade before further flight.

(ii) For blades, P/N 365A12-0020-02, and -03, if bonding separation exceeds 900 mm² in a 30 x 30 mm square or if there is a crack, replace the blade with an airworthy blade before further flight.

(2) Thereafter, at intervals not to exceed 25 hours TIS, conduct a tapping test inspection for bonding separation on blades, P/N 365A12-0020-02 or 365A12-0020-03, in Zone A as depicted in Figure 1 of this AD.

(3) Thereafter, at intervals not to exceed 100 hours TIS or 200 cycles, whichever occurs first, conduct a tapping test inspection for bonding separation on blades, P/N 365A12-0020-02 or 365A12-0020-03, in Zone B as depicted in Figure 1 of this AD. If a crack, wrinkling, or a blister is found, replace the blade with an airworthy blade before further flight.
