[Docket No. 2003-SW-10-AD]

Airworthiness Directives; Eurocopter France Model AS355E, F, F1, F2, and N Helicopters

ACTION: Notice of proposed rulemaking (NPRM).

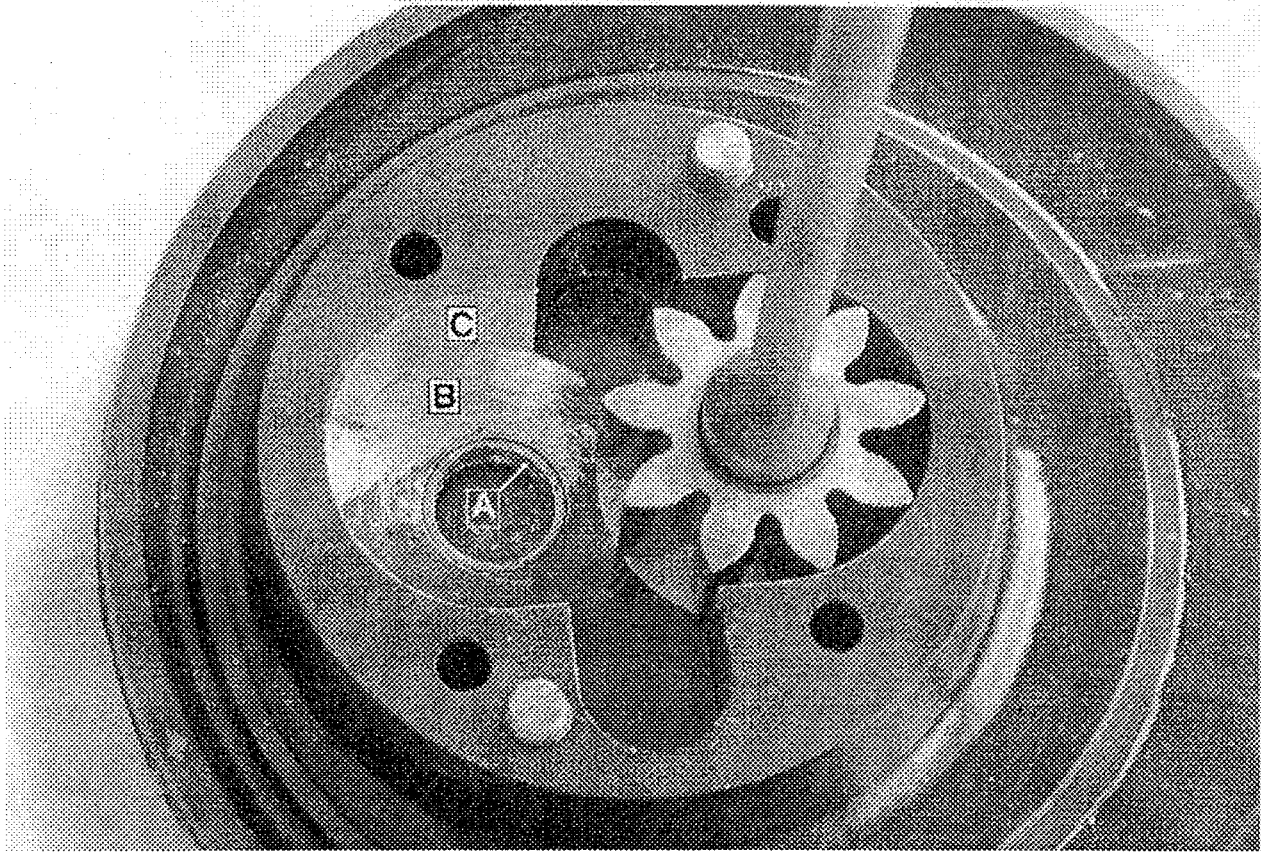
Figure 1

- (1) Crank pin play,
- (2) Out of round bronze bushing (A of Figure 1),
- (3) Offset of the driven gear pinion,
- (4) Metal chips, or
- (5) Wear (C of Figure 1).

Note 2: If wear is present in the B area only as depicted in Figure 1, replacing the MGB and the pump is not required.

(d) While inspecting the pump, if you find any of the following, replace the MGB and the pump with an airworthy MGB and pump before further flight:
