[Docket No. 2002–NM–128–AD; Amendment 39–13269; AD 2003–16–16]

Airworthiness Directives; Boeing Model 747–400 Series Airplanes Equipped With General Electric Model CF6–80C2 Series Engines

ACTION: Final rule.

2003-16-16 Boeing: Amendment 39-13269. Docket 2002-NM-128-AD. Supersedes AD 2000-09-03, Amendment 39-11711.

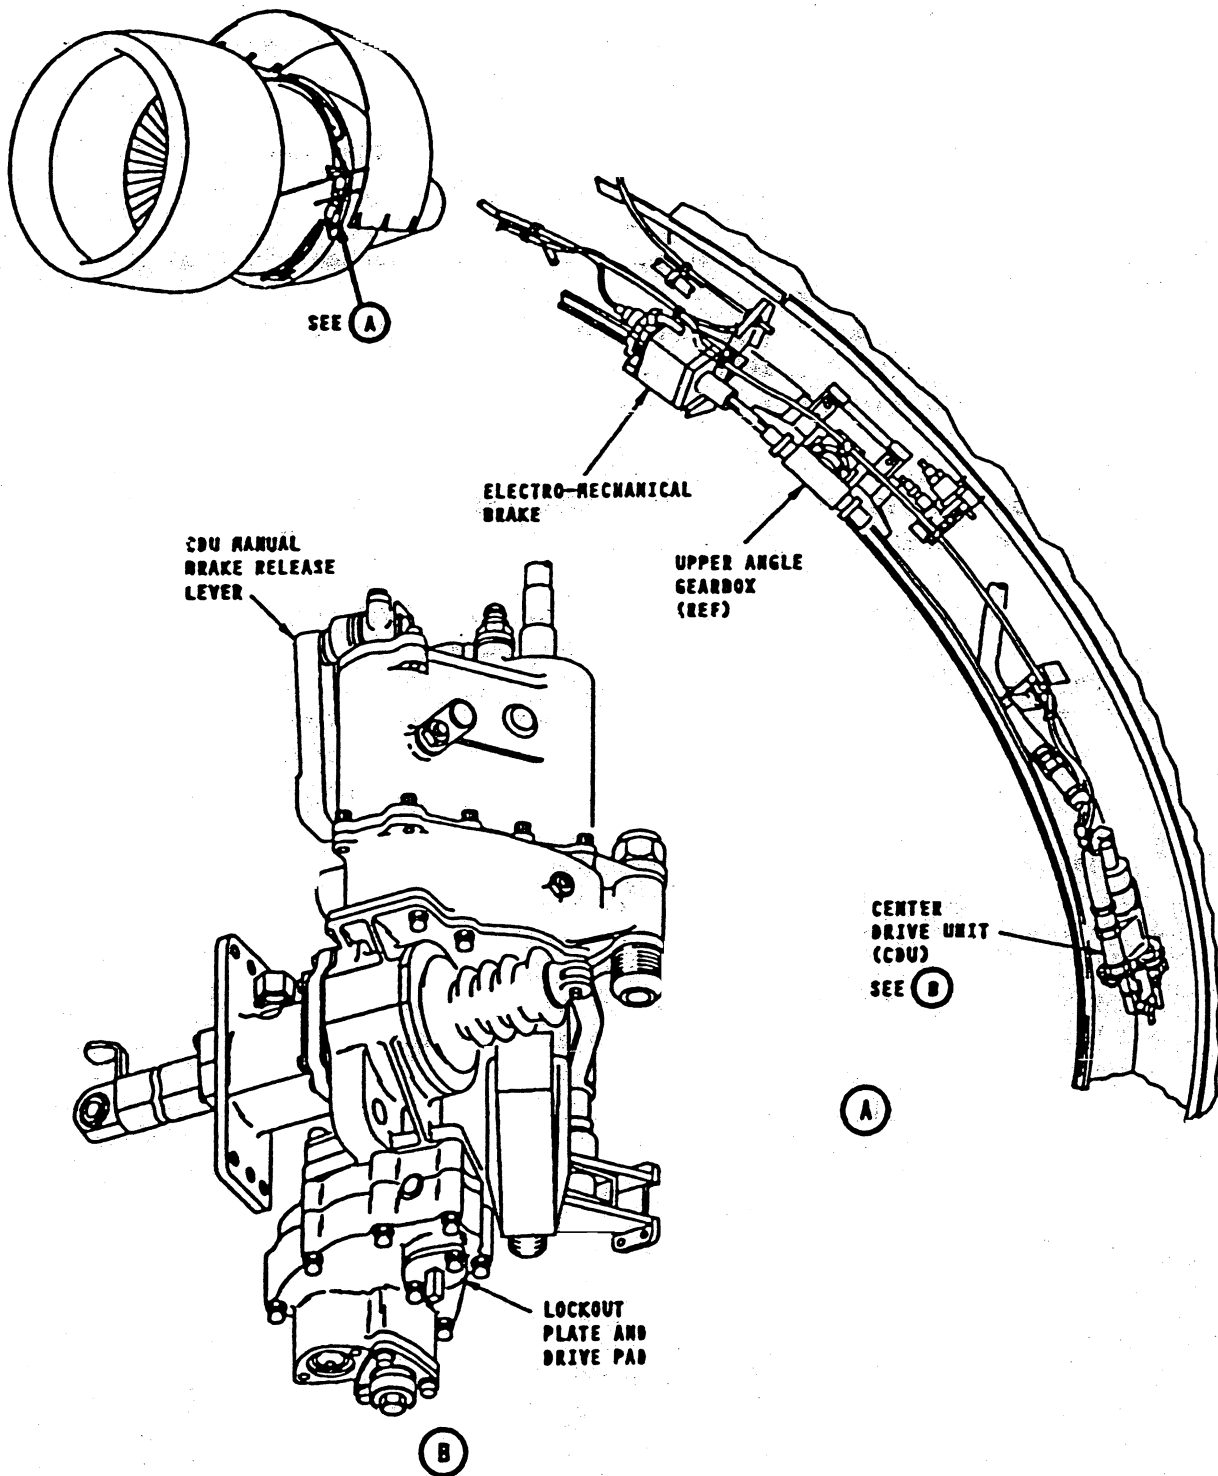
Electro-Mechanical Brake and CDU Cone Brake Torque Check
Figure 1

1. This procedure contains steps to do a check of the holding torque of the CDU cone brake.

Caution: Do not use more than 100 pound-inches of torque when you do this check. Excessive torque will damage the CDU.

Note: The cone brake prevents movement in the extend direction only. If you try to measure the holding torque in the retract direction, you will get a false reading.

(8) If the torque is less than 15 pound-inches, you must replace the CDU.
