**[Docket No. 2002-SW-17-AD; Amendment 39-13330; AD 2003-20-12]**

#### **Airworthiness Directives; Eurocopter France Model AS 350B3, SA-365N, N1, AS-365N2, AS 365N3, and EC 155B Helicopters**

**ACTION:** Final rule.

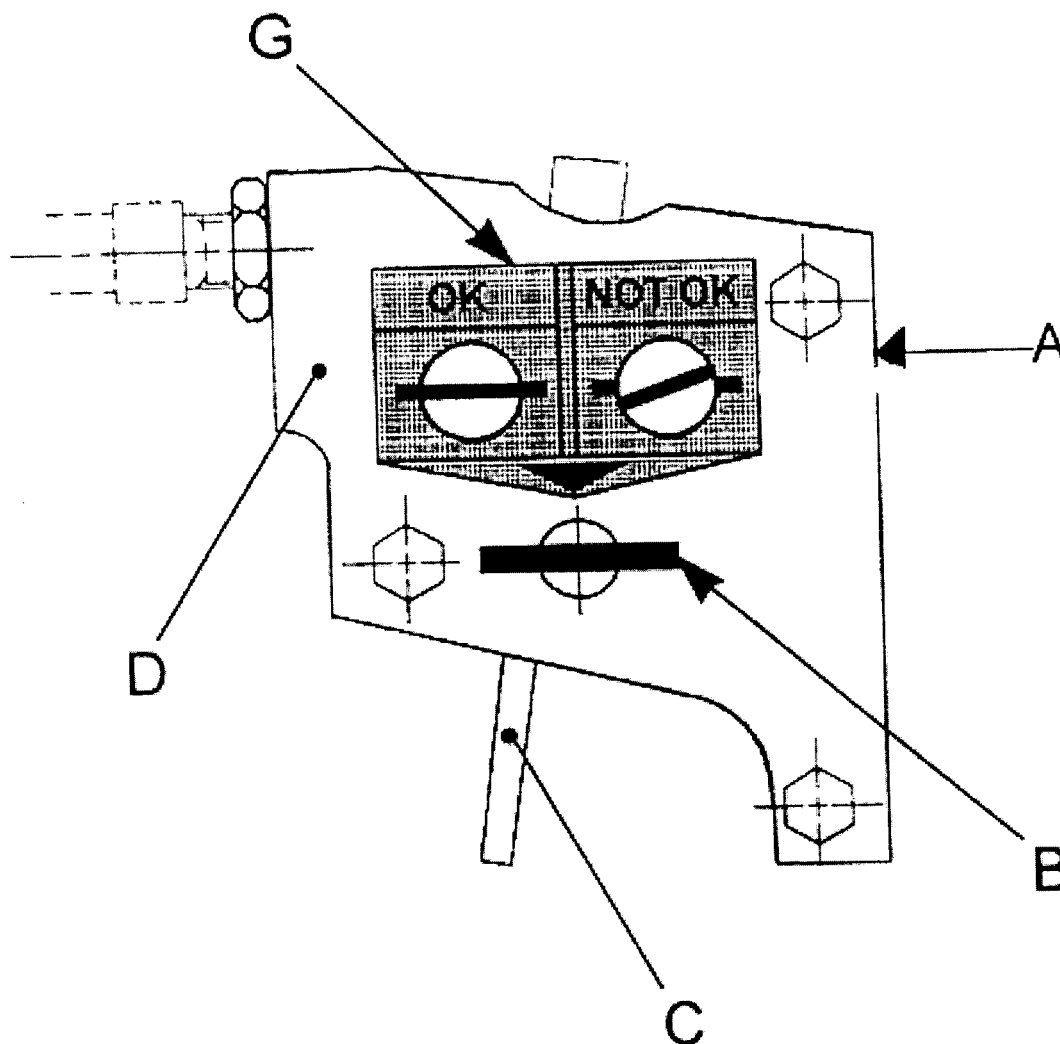
(a) For cargo hook, P/N AS-21-5-7, with Amendment B incorporated, before the first use of the cargo hook on each day that the cargo hook is used, check for corrosion on the locking catch as follows. Amendment B has been incorporated if the letter "B" is marked on the amendment identification plate of the release unit of the cargo hook and placard "G" is installed on the release unit cover plate "D" and reference line "B" is marked over the nut and cover plate as depicted in Figure 1 of this AD. The identification plate "A" is located on cover plate "D", on the opposite side of the electrical connector. See Figure 1:

(3) Determine whether the section of reference line (B) marked on the bolt (A) and the section of reference line (B) marked on the cover plate (D) form a straight line.

(i) If the reference line is straight, the cargo hook is considered airworthy.

(ii) If the reference line is not straight, the cargo hook is unairworthy and may not be used.

(c) For cargo hook, P/N AS-21-5-7, without Amendment B, before the next sling load flight, incorporate Amendment B to the cargo hook in accordance with the
