[Docket No. 2000-SW-12-AD; Amendment 39-13354; AD 2003-22-06]

**Airworthiness Directives; Eurocopter France Model AS350B, B1, B2, B3, BA, C, D, D1, and AS355E, F, F1, F2, and N Helicopters**

##### 2003-22-06 Eurocopter France:

Amendment 39-13354. Docket No. 2000-SW-12-AD. Supersedes AD 98-24-35, Amendment 39-10921, Docket No. 98-SW-41-AD.

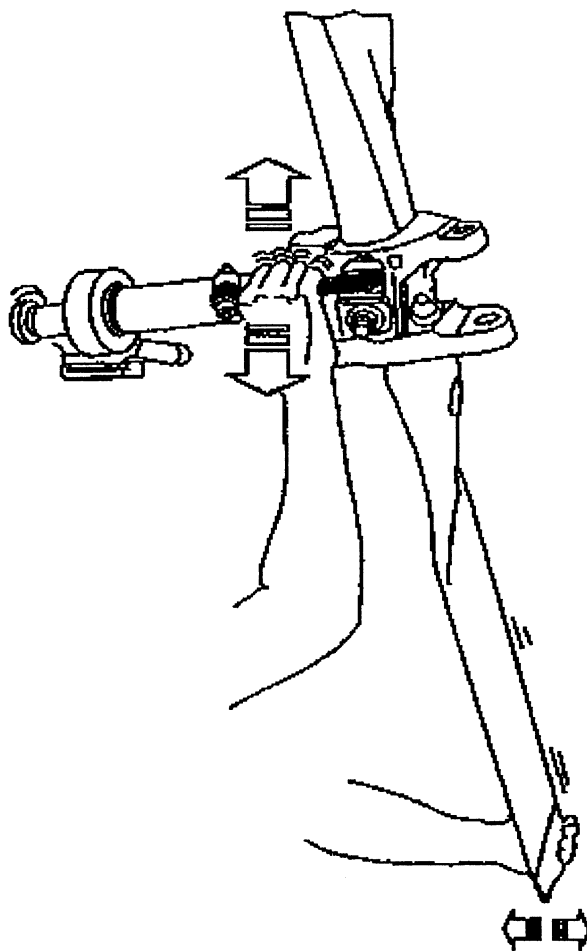
Figure 1: Manual Check for Play of the Tail Rotor Pitch Control Rod

(a) Before the first flight of each day, place the tail rotor pedals in the neutral position. If the helicopter is fitted with a tail rotor load compensator, discharge the accumulator as described in the rotorcraft flight manual. Check the bearing for play on the helicopter, by observation and feel, by slightly moving the tail rotor blade in the flapping axis while monitoring the bearing for movement. See the following Figure 1 of this AD:

(1) If the Teflon cloth is coming out of its normal position within the bearing, totally or partially, or if there is discoloration or scoring on the bearing, the bearing is unairworthy.

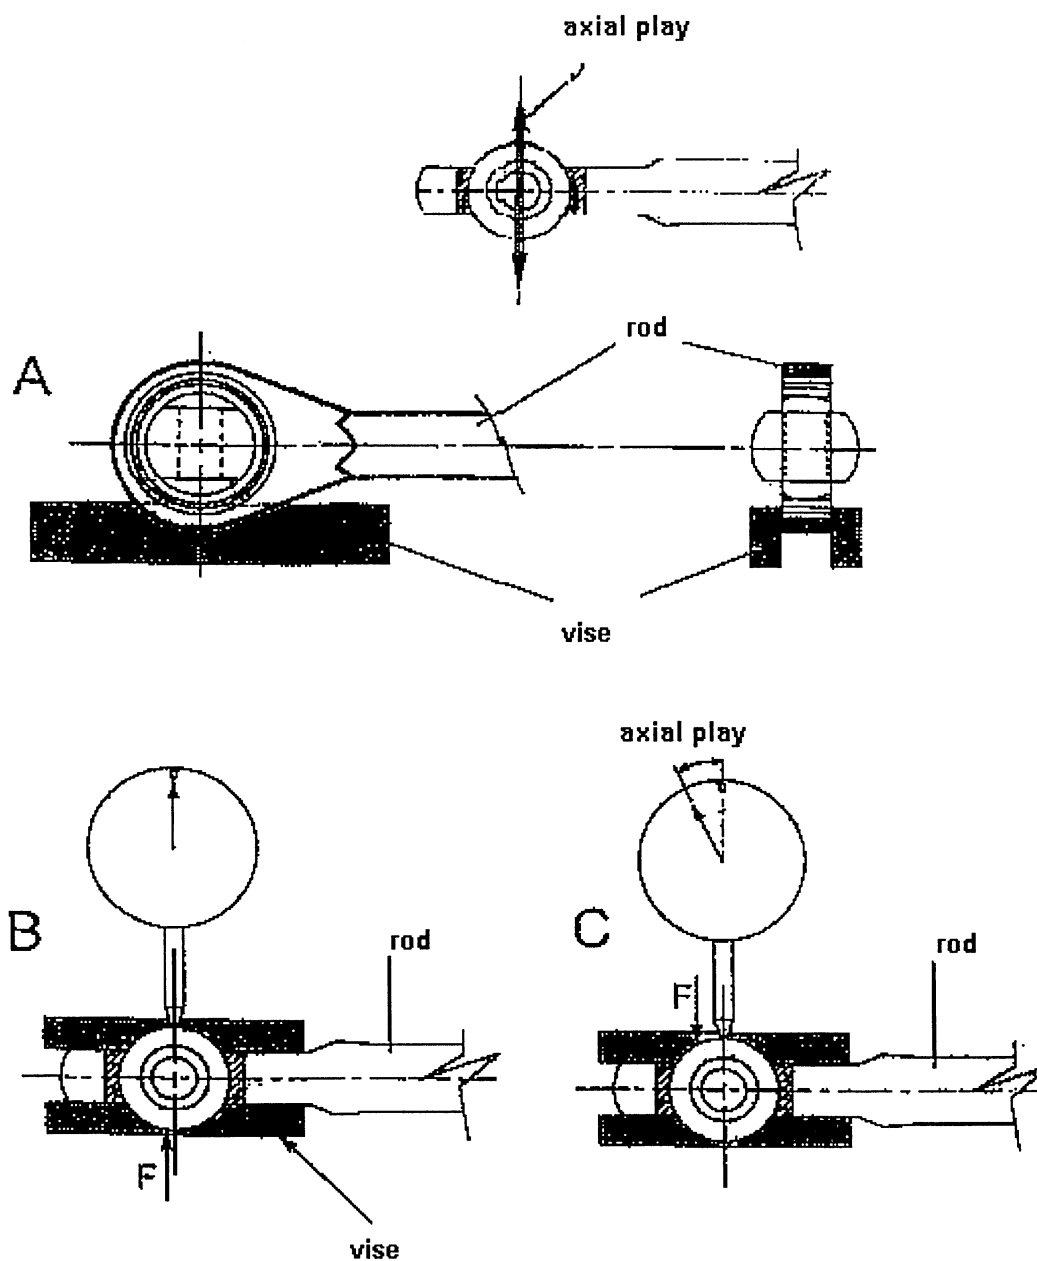
Figure 2: Measurement of the Axial Play (A) of the Bearing

(b) If a pilot or mechanic detects play, a mechanic must remove the control rod from the helicopter, and using a dial indicator, measure the bearing wear according to the following and as shown in Figures 2 and 3 of this AD:

(2) Mount the control rod in a vise as shown in Figure 2 of this AD.

(3) Using a dial indicator, take axial play readings by moving the spherical bearing in the direction F (up and down) as shown in Figure 2 of this AD.

(7) If the radial play exceeds 0.008 inch or axial play exceeds 0.016 inch, replace the control rod with an airworthy control rod before further flight.

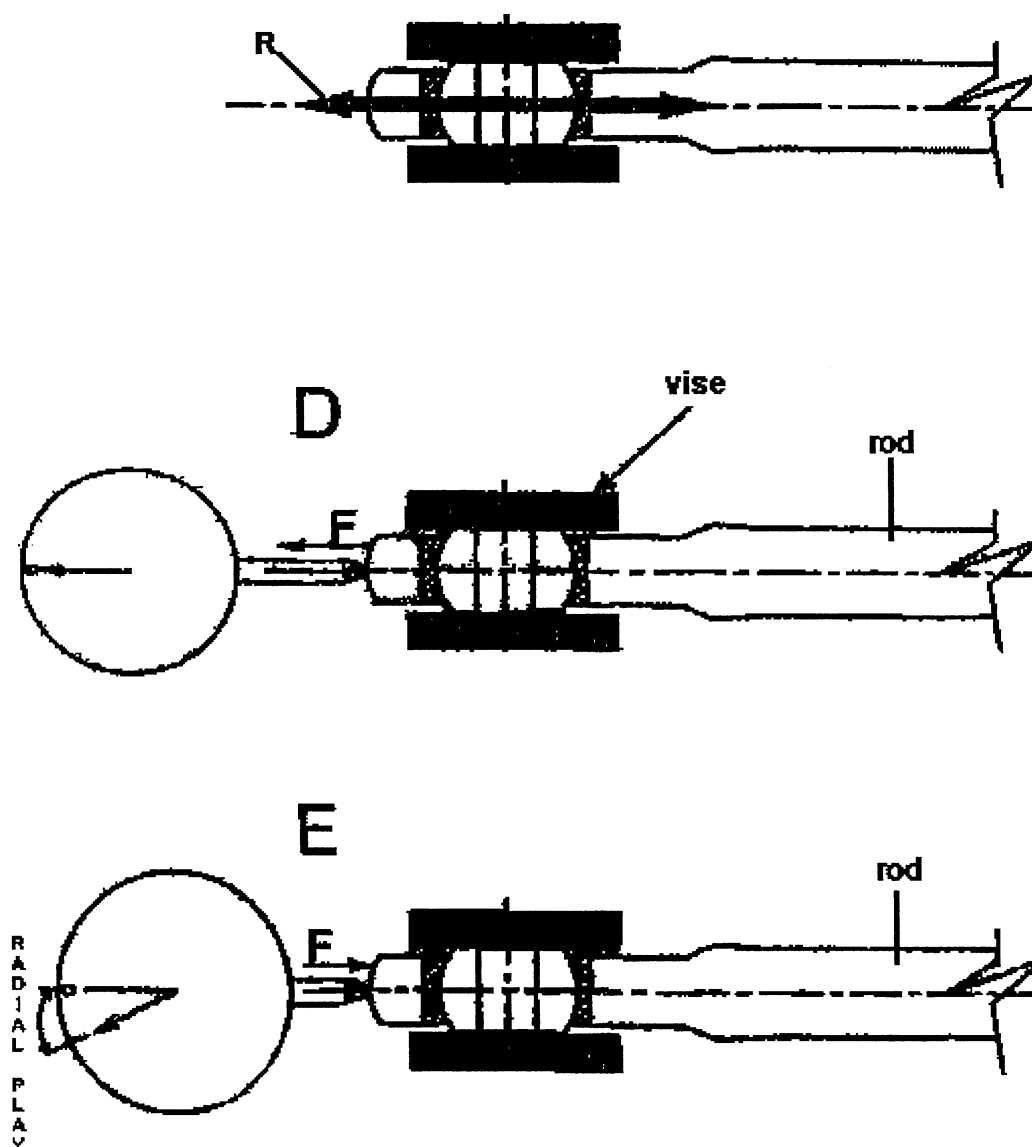
Figure 3: Measurement of the Radial Play (R) of the Bearing

(4) Mount the bearing in a vise as shown in Figure 3 of this AD.

(5) Using a dial indicator, take radial play measurements by moving the control rod in the direction F as shown in Figure 3 of this AD.
