[Docket No. 2003-NM-209-AD; Amendment 39-13353; AD 2003-19-51]

Airworthiness Directives; Bombardier Model CL-600-2C10 (Regional Jet Series 700 & 701) and CL-600-2D24 (Regional Jet Series 900) Series Airplanes

2003-19-51 Bombardier, Inc. (Formerly Canadair): Amendment 39-13353. Docket 2003-NM-209-AD.

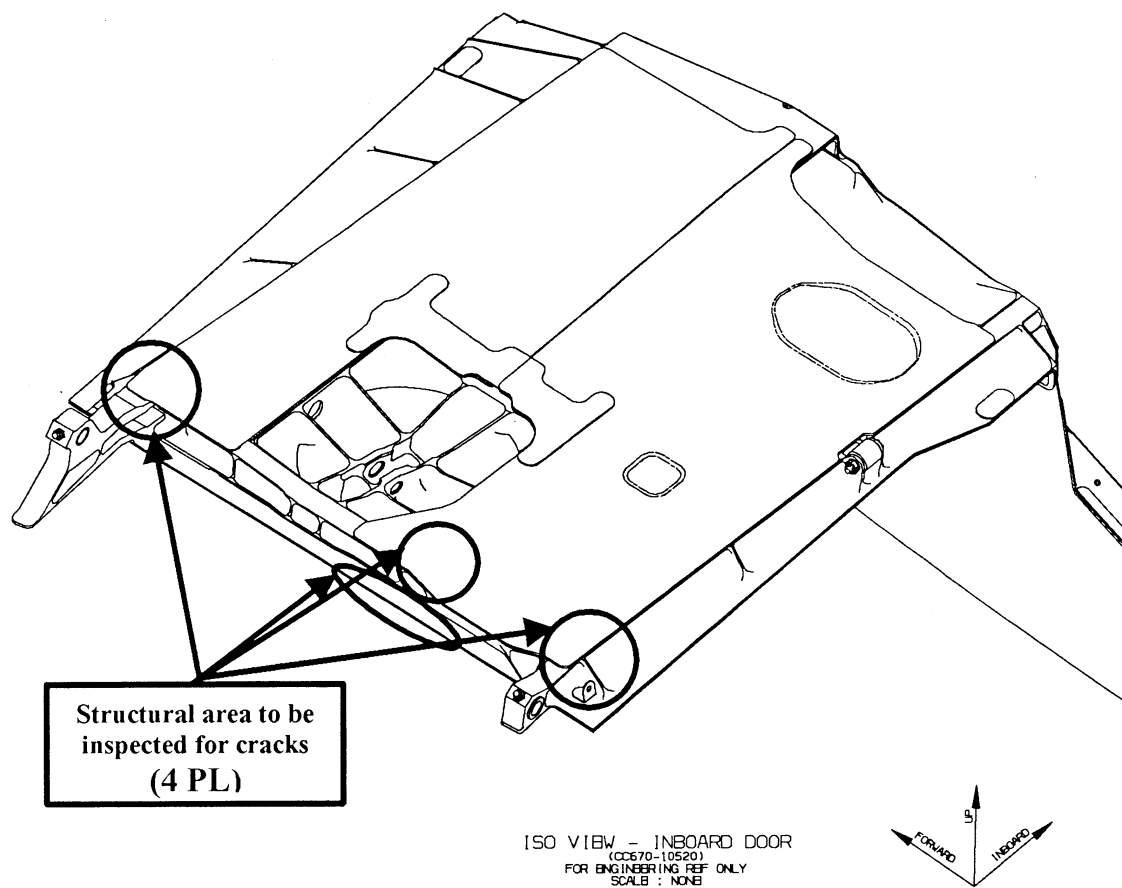
Figure 1
LH side shown
RH side opposite

(b) Perform detailed inspections of the lower panel, P/N CC670-10520, of the left- and right-hand MLG doors for the conditions and in the areas specified in paragraphs (b)(1), (b)(2), (b)(3), and (b)(4) of this AD; and Figures 1, 2, and 3 of this AD.

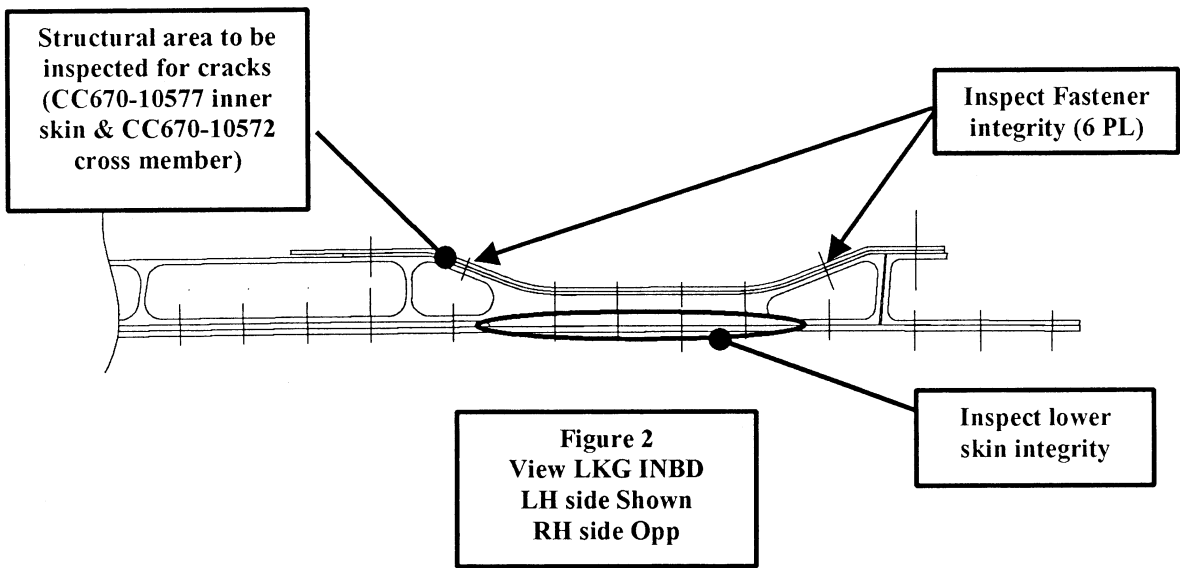
(1) Inspect the cross member, part number (P/N) CC670-10572, of the MLG door lower panel for cracking or deformation, in accordance with Figure 2 of this AD.

(2) Inspect the inner skin, P/N CC670-10577, of the MLG door lower panel at the cross member (P/N CC670-10572) for cracking or deformation, or pulled or missing fasteners, in accordance with Figure 2 of this AD.

(3) Inspect the outer skin, P/N CC670-10574, of the MLG door lower panel at the cross member (P/N CC670-10572) for cracking or deformation, or pulled or missing fasteners, in accordance with Figure 2 of this AD.

(d) If any cracking or deformation, or pulled or missing fastener, as applicable, is found during any inspection in accordance with paragraph (b) or (c) of this AD: Before further flight, accomplish paragraph (d)(1), (d)(2), or (d)(3) of this AD.

(1) Repair the damage in accordance with a method approved by either the Manager, New York Aircraft Certification Office (ACO), FAA; or Transport Canada Civil Aviation (or its delegated agent); and accomplish repetitive inspections in accordance with a method and at a repetitive interval approved by same.

(2) Replace the lower panel assembly, P/N CC670-10520, of the affected MLG door with a new or serviceable lower panel assembly having the same P/N, in accordance with Task Cards 32-12-01-000-801-A01 and 32-12-01-400-801-A01 of the CRJ 700/900 Series Regional Jet Aircraft Maintenance Manual; and repeat the inspections specified in paragraph (b) of this AD at intervals not to exceed 100 flight cycles.
