[Docket No. 2003-NE-52-AD; Amendment 39-13381; AD 2003-24-12]

Airworthiness Directives; Pratt & Whitney JT9D-3A, -7, -7A, -7F, -7H, -7AH, and -7J Turbofan Engines

2003-24-12 **Pratt & Whitney:** Amendment 39-13381. Docket No. 2003-NE-52-AD.

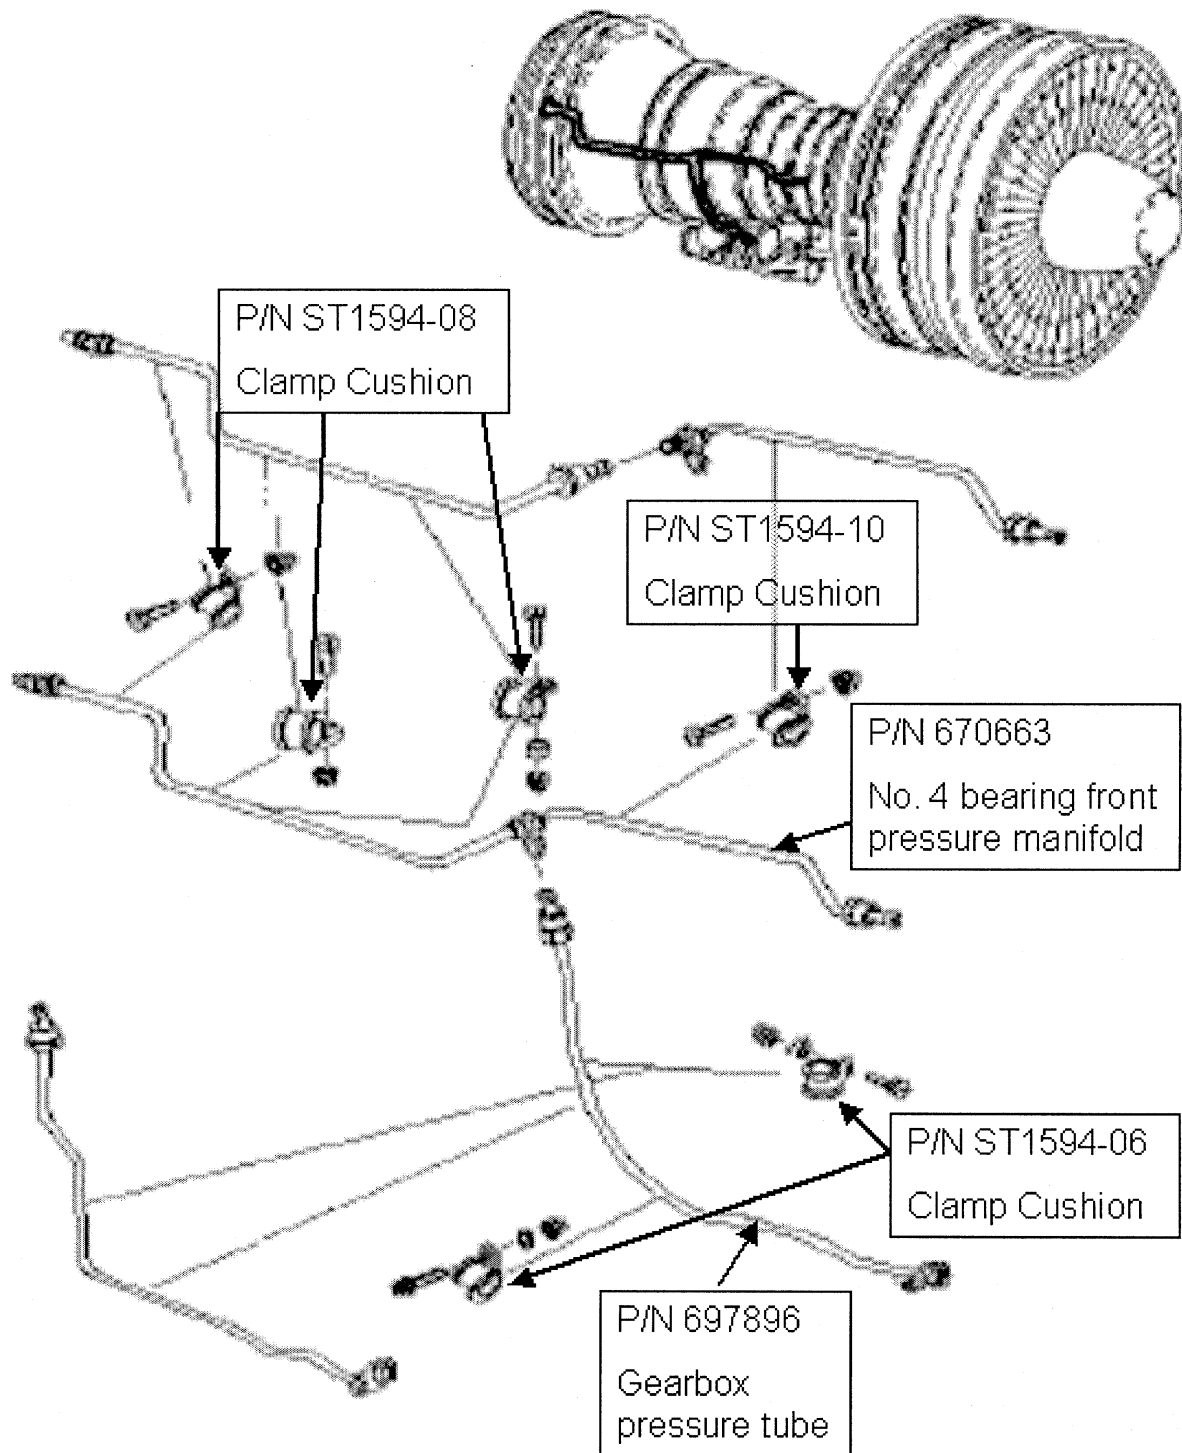
(f) Visually inspect the clamp assemblies, P/Ns ST1594-06, ST1594-08, and ST1594-10, that attach the gearbox pressure tube and the No. 4 bearing front pressure manifold to the engine. Replace clamp assemblies before

- (1) Droop in the No. 4 bearing front pressure manifold.
- (2) Cracks, wear, or distortion in clamp metal.
- (3) Clamp cushions that are worn, compacted, cracked, coming apart in chunks, deteriorated, or missing. A reddish powder found around the clamp is an indication of deterioration.

(h) If the gearbox pressure tube, No. 4 bearing front pressure manifold, or clamp assemblies are not properly positioned, then correctly position them before further flight, as shown in the following Figure 1 of this AD.
