[Docket No. 98–NM–300–AD; Amendment 39–14355; AD 2005–22–11]

Airworthiness Directives; Mitsubishi Model YS–11 Airplanes, and Model YS–11A–200, YS–11A–300, YS–11A–500, and YS–11A–600 Series Airplanes

2005-22-11 Mitsubishi Heavy Industries, LTD.: Amendment 39-14355. Docket 98-NM-300-AD.

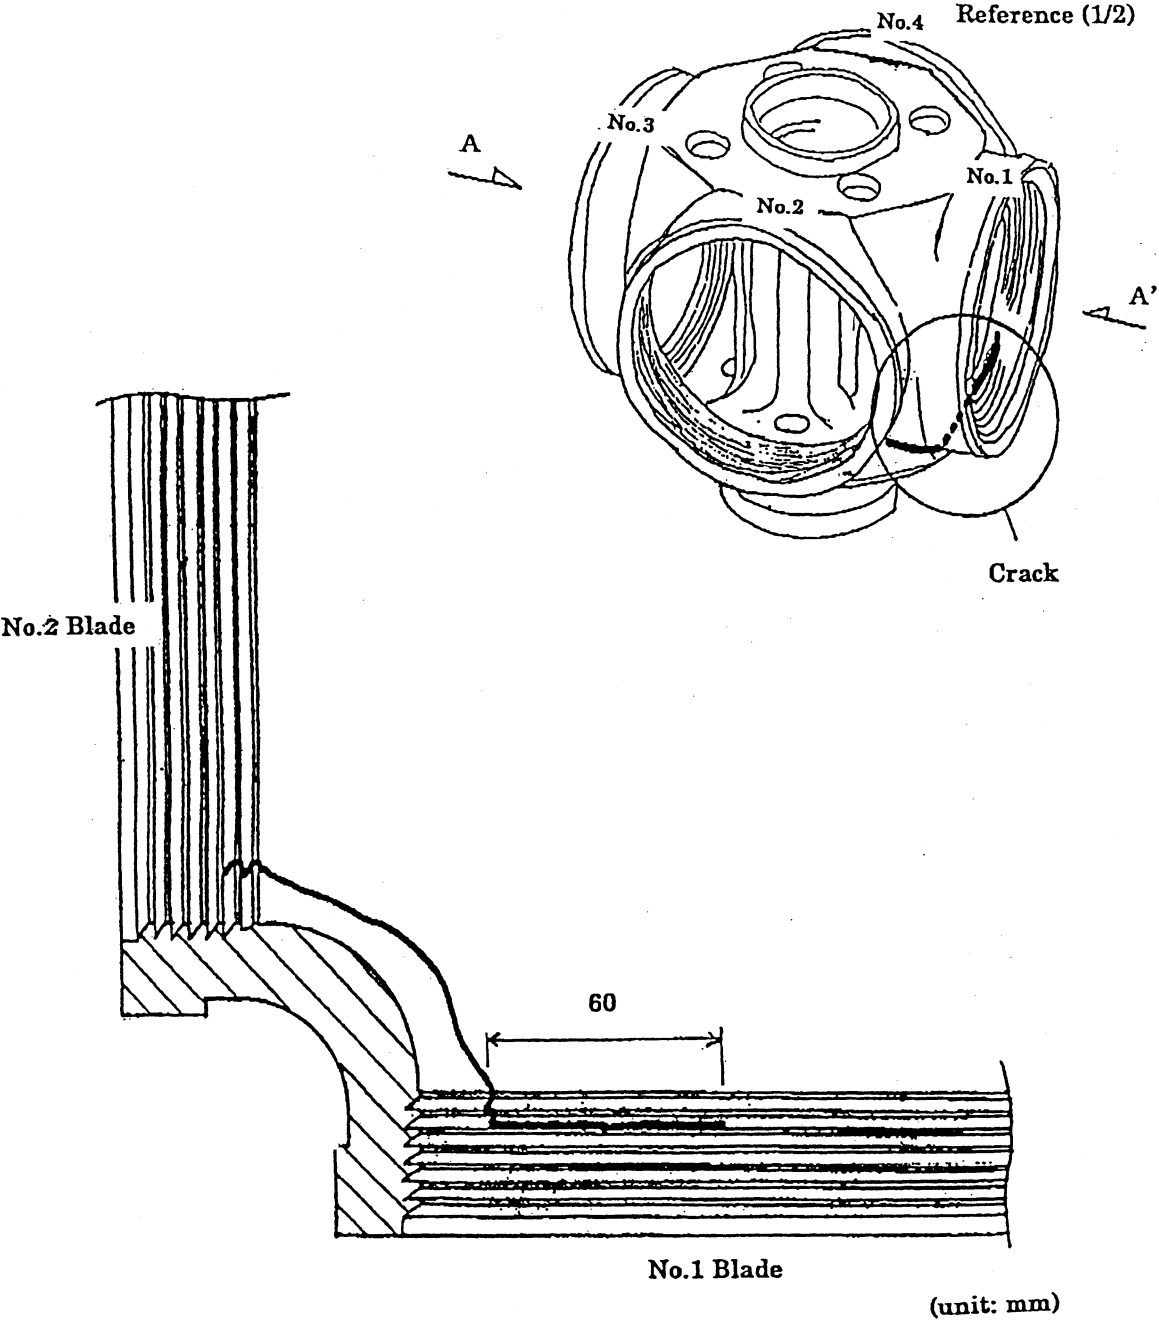
HUB CRACK - VIEW FROM TOP

(a) Within 25 flight hours or 30 days after the effective date of this AD, whichever occurs first, remove the spinner and perform a detailed inspection for cracking of the propeller hub in the crack area shown in Figure 1 of this AD.

(Cut A - A')

(2) If any crack is detected, prior to further flight, replace the hub with a new hub according to a method approved by either the Manager, Los Angeles Aircraft Certification Office (ACO), FAA; or the Japan Civil Aviation Bureau (JCAB) (or its delegated agent). Chapter 61 of the Nihon Aeroplane

Manufacturing Company YS-11 and YS-11A Aircraft Maintenance Manuals is one approved method. Repeat the actions required by paragraph (a) of this AD thereafter at intervals not to exceed 25 flight hours.
