**[Docket No. FAA-2011-0450; Directorate Identifier 2011-CE-010-AD; Amendment 39-16758; AD 2011-15-11]**

**Airworthiness Directives; Cessna Aircraft Company (Cessna) Models 337, 337A (USAF 02B), 337B, 337C, 337D, 337E, T337E, 337F, T337F, 337G, T337G, M337B, F 337E, FT337E, F 337F, FT337F, F 337G, and FT337GP Airplanes**

**ACTION:** Final rule.

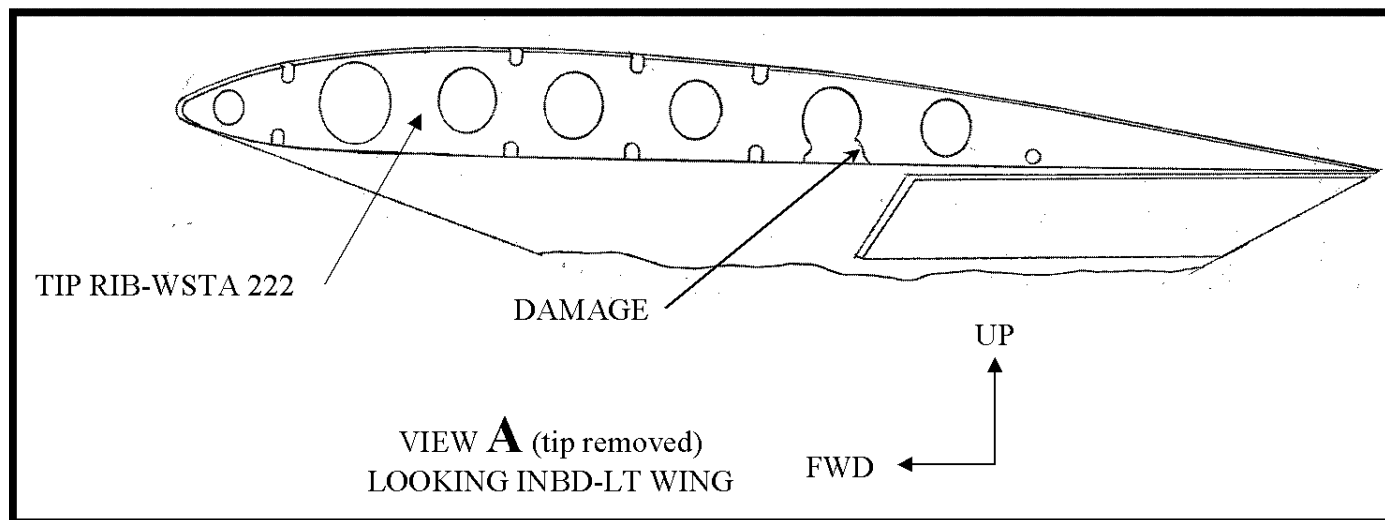
Figure 2

(11) Inspect rib at WSTA 222 for damage. Trimming of the rib may have been done to allow installation of fuel lines (See View A, Figure 2). Repair in accordance with AC 43.13-1B, Chapter 4, paragraph 4-58(g) and Figure 4-14, or by using another FAA-approved method that restores equivalent strength of the wing rib.

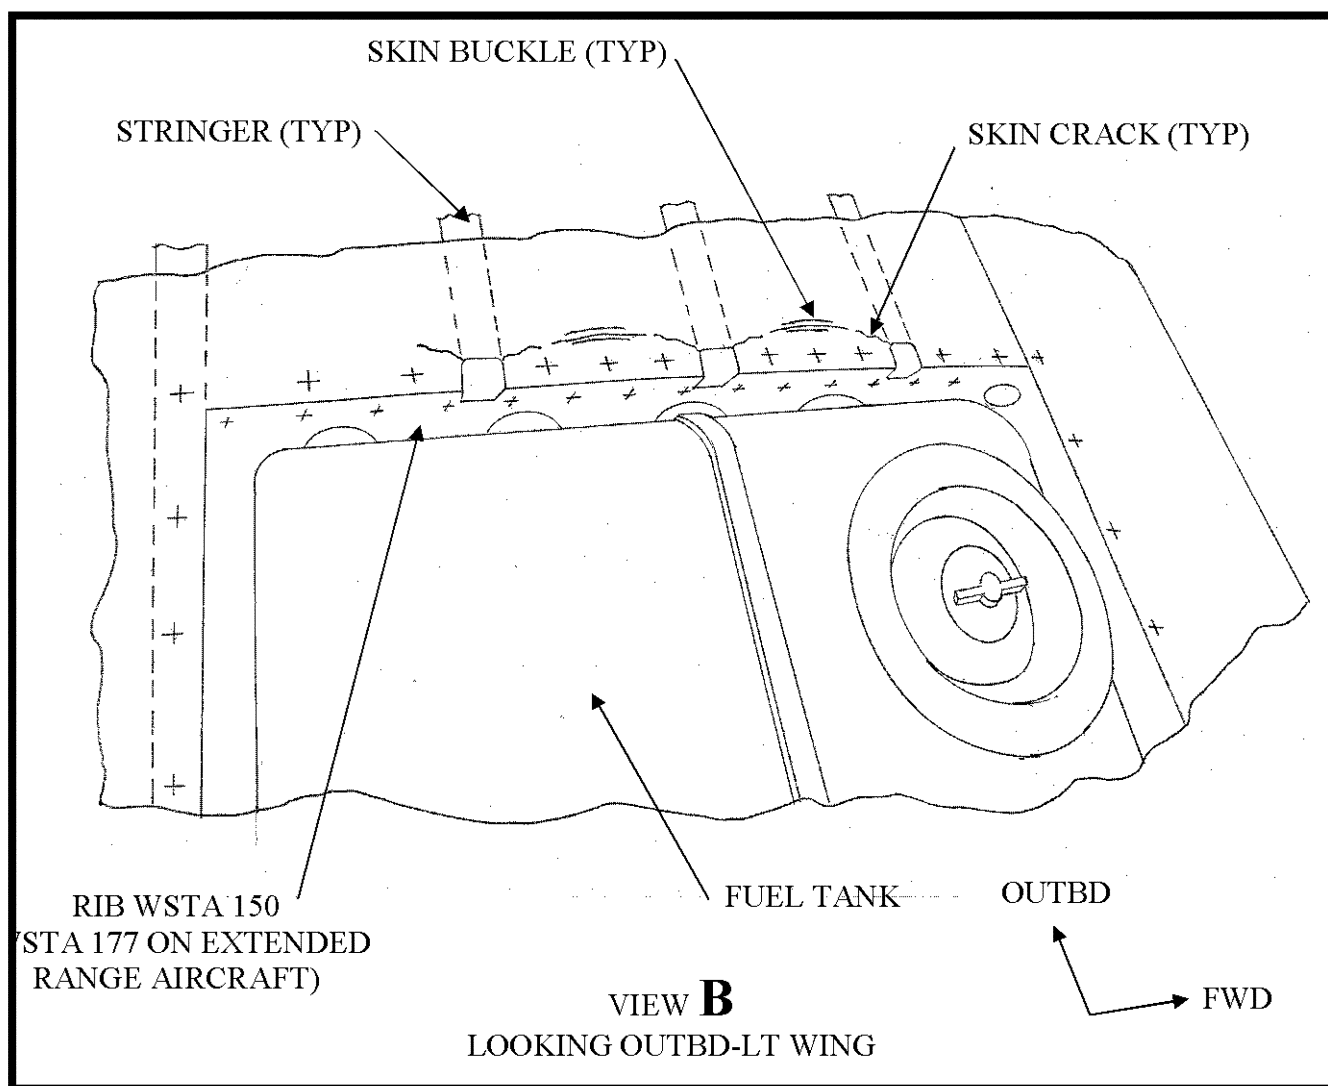
Figure 3

- (1) Wrinkles in upper wing skins, from the outboard edge on the fuel tank access covers (WSTA 150 or 177) to the WSTA 222 (See View B, Figure 3).
- (2) Wrinkles in the upper wing skins from WSTA 55 to 66, adjacent to the booms (See View E, Figure 6).
- (3) Cracking of the upper wing skins. Pay particular attention to any wrinkles, the radius between stiffeners at WSTA 150 (under fuel tank covers), and unreinforced access holes (See View B, Figure 3).
- (4) Working (smoking) rivets outboard of the wing tank access covers.
- (5) Fasteners with less than two diameters edge distance.
- (6) Fasteners with less than four diameters center to center spacing.
- (7) Looseness of attachments of the tip extension to the wing and wing tip to wing extension when pushing up and down on the tip.

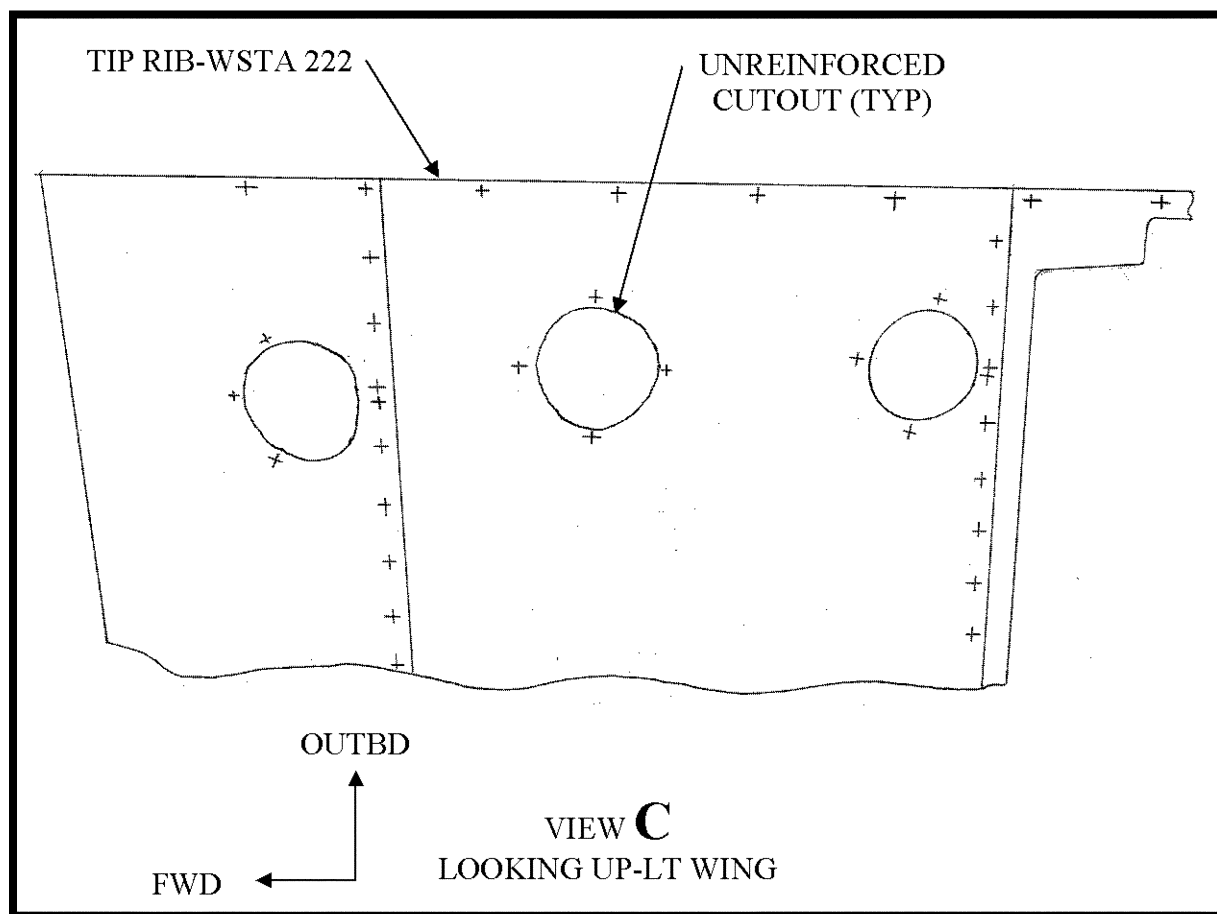
Figure 4

(13) Inspect wing skins for unreinforced cutouts. (See View C, Figure 4).

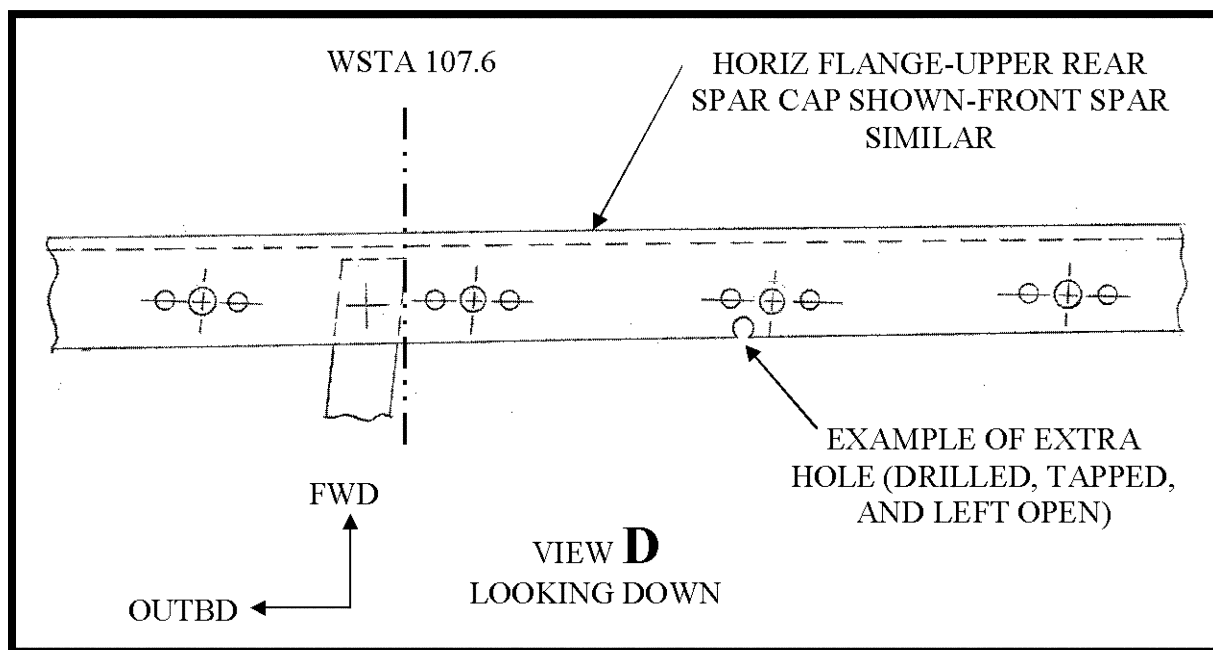
Figure 5

(14) Inspect the upper spar cap horizontal flanges for open holes (See View D, Figure 5).

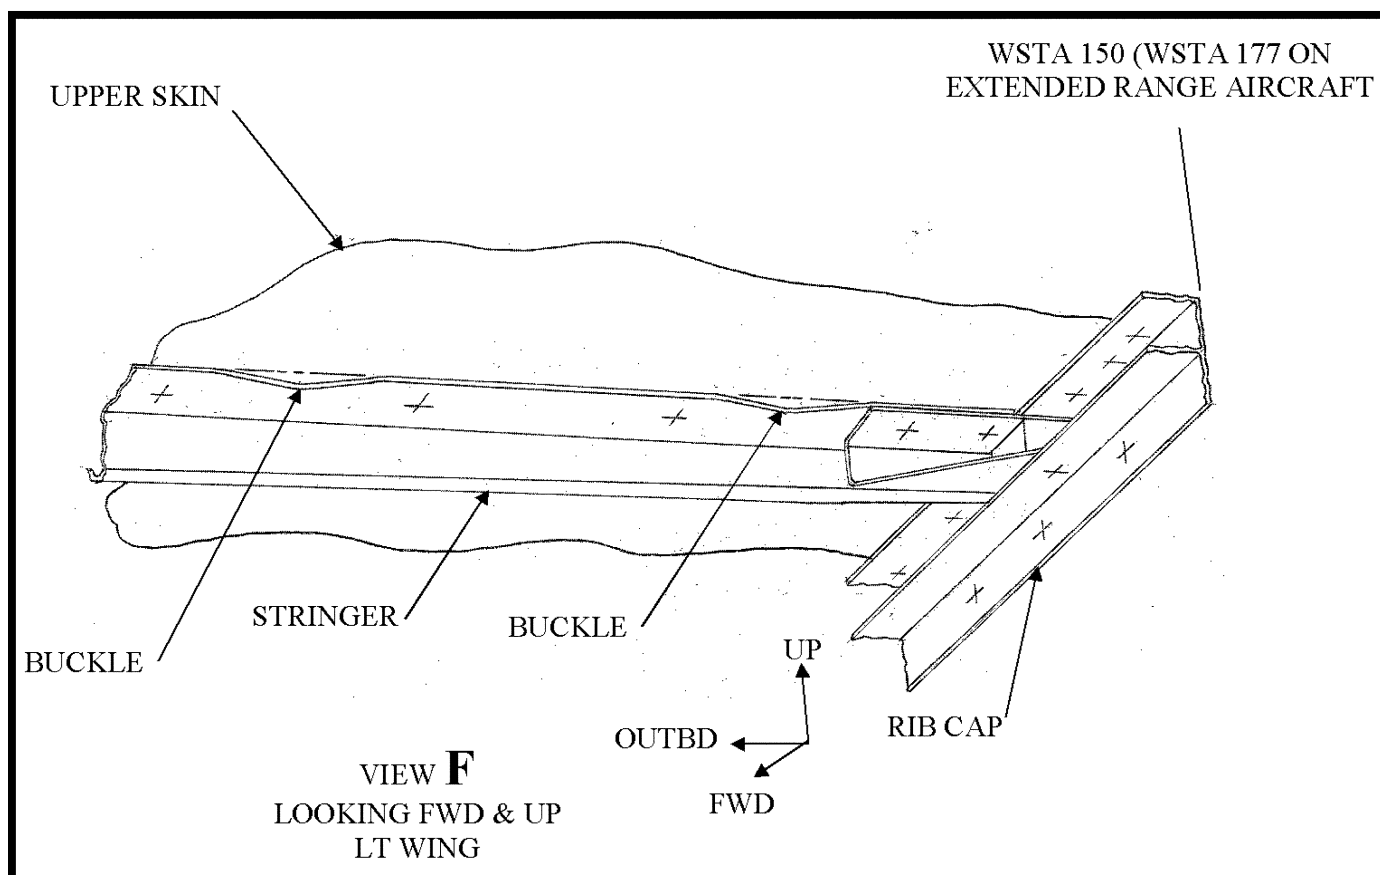
Figure 7

(10) Inter-rivet buckling of the stringers attached to the upper surface skin, outboard of the fuel tank access covers (See View F, Figure 7).
