[Docket No. FAA–2011–0994; Directorate Identifier 2010–NM–143–AD; Amendment 39–16949; AD 2012–03–08]

**Airworthiness Directives; Bombardier, Inc. Airplanes**

**ACTION:** Final rule.

**2012–03–08 Bombardier Inc.:** Amendment 39–16949; Docket No. FAA–2011–0994; Directorate Identifier 2010–NM–143–AD.

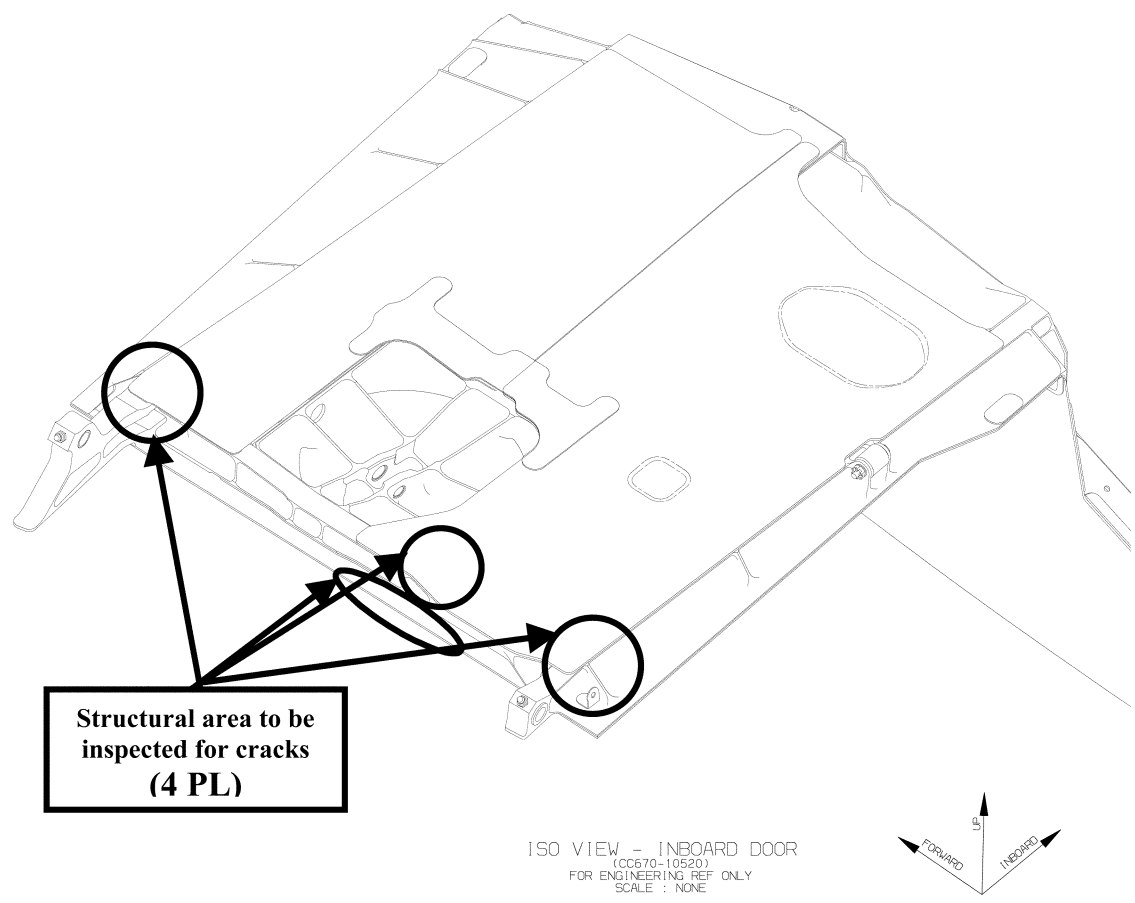
**Figure 1**  
**LH side shown**  
**RH side opposite**

(1) Inspect the cross member, P/N CC670–10572, of the MLG door lower panel for cracking or deformation, in accordance with Figure 2 of this AD.

(2) Inspect the inner skin, P/N CC670–10577, of the MLG door lower panel at the cross member (P/N CC670–10572) for cracking or deformation, or pulled or missing fasteners, in accordance with Figure 2 of this AD.

(3) Inspect the outer skin, P/N CC670–10574, of the MLG door lower panel at the cross member (P/N CC670–10572) for cracking or deformation, or pulled or missing fasteners, in accordance with Figure 2 of this AD.

(4) Inspect the forward member, P/N CC670–10570, and aft member, P/N CC670–10571, of the MLG door lower panel for cracking or deformation, or pulled or missing fasteners, in accordance with Figure 3 of this AD. Figures 1 through 3 of this AD follow.

If any cracking or deformation, or pulled or missing fastener, as applicable, is found during any inspection done in accordance with paragraph (h) or (i) of this AD: Before further flight, accomplish paragraph (j)(1), (j)(2), or (j)(3) of this AD.

(1) Repair the damage in accordance with a method approved by either the Manager, New York Aircraft Certification Office (ACO), FAA; or Transport Canada Civil Aviation (TCCA) (or its delegated agent); and accomplish repetitive inspections in accordance with a method and at a repetitive interval approved by same.

(2) Replace the lower panel assembly, P/N CC670-10520, of the affected MLG door with

a new or serviceable lower panel assembly having the same P/N, according to a method approved by either the Manager, New York ACO, FAA; or TCCA (or its delegated agent). Repeat the inspections specified in paragraph (h) of this AD at intervals not to exceed 100 flight cycles.

(3) Remove the lower panel assembly, P/N CC670-10520, of the affected MLG door, and accomplish paragraph (j)(3)(i) or (j)(3)(ii) of this AD, as applicable.
