## DEPARTMENT OF TRANSPORTATION

[Docket No. FAA-2012-0182; Directorate Identifier 2012-CE-005-AD; Amendment 39-16958; AD 2012-03-52]

#### **Airworthiness Directives; Mooney Aviation Company, Inc. (Mooney) Airplanes**

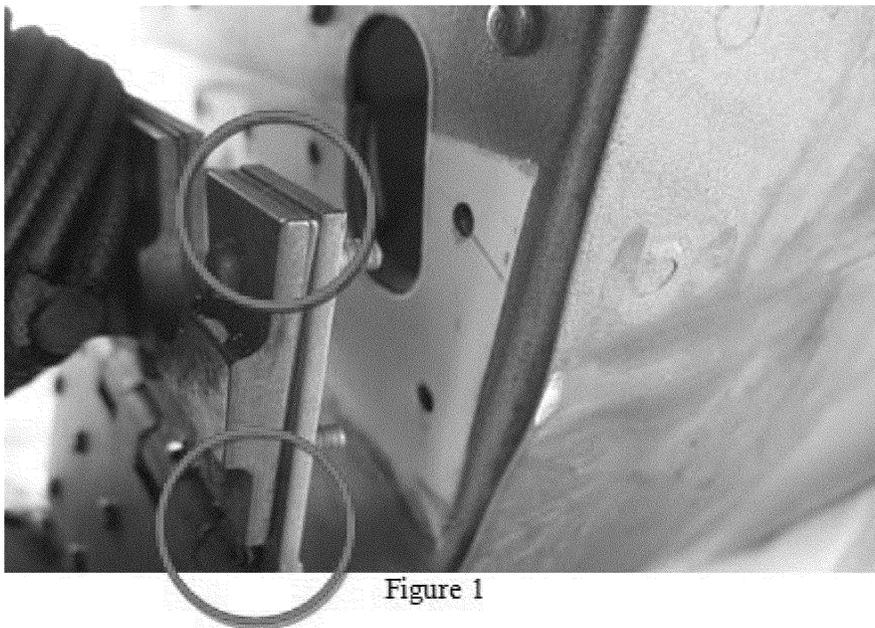
Figure 1

This aircraft was immediately inspected, and all 10 swaged collars that hold the tail trim assembly together had become unattached.

Mooney inspected several other aircraft and found that on one airplane the filler plate was incorrectly installed. The filler plate was not correctly installed between the aft side of the hinge and the bulkhead. Instead, the filler plate was located on the forward side of the hinge between the hinge and trim fitting. It was then noted the incident aircraft had the same issue, as shown in the upper circle of figure 1.

Because the hinge has a lip on the bottom, on the side toward the bulkhead (as shown in the bottom circle of figure 1), if the filler plate is not installed correctly, the hinge will not fit flush against the bulkhead, the Huck Bolt fasteners will not fit perpendicular to the bulkhead, and the collars will not swage properly. The condition also causes excessive tension pre-load on the Huck Bolts.

The incident aircraft was manufactured in 2008. Mooney has determined the incorrect installation was a manufacturing quality escape during production.

If during the inspection required in paragraph (g) of this AD you find incorrect positioning or improper attachment of the trim fitting, hinge, and filler plate of the tail pitch trim assembly; and/or you find loose or improperly installed Huck Bolt fasteners, before further flight, contact Mooney for FAA-approved repair instructions and perform the repair. Use the contact information found in paragraph (n)(2) of this AD.
