[Docket No. FAA-2012-0896; Directorate Identifier 2010-SW-070-AD; Amendment 39-17173; AD 2012-17-10]

### Airworthiness Directives; Various Restricted Category Helicopters

**2012–17–10 Various Restricted Category Helicopters:** Amendment 39–17173; Docket No. FAA–2012–0896; Directorate Identifier 2010–SW–070–AD.

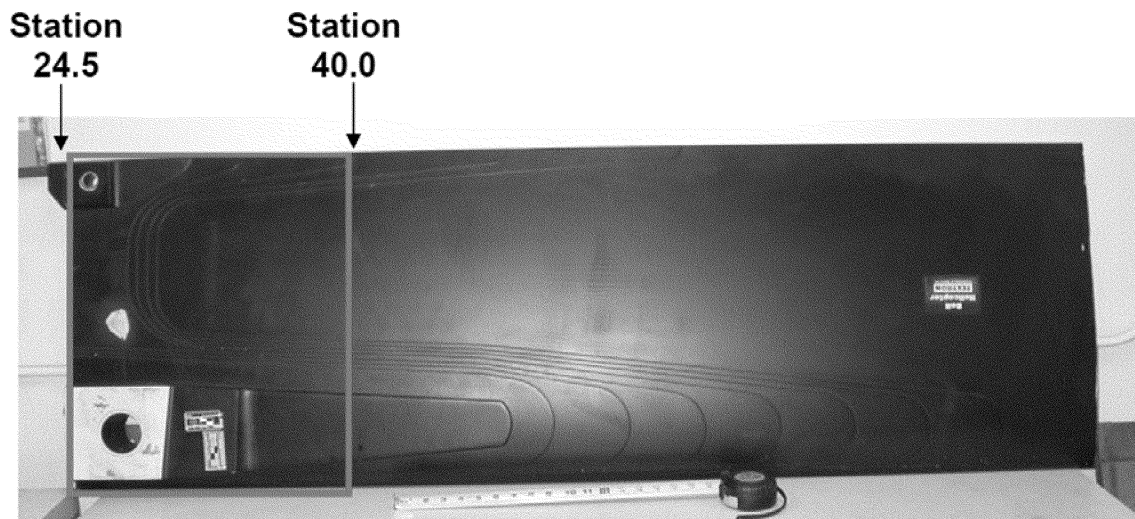
(ii) Using a 3x power or higher magnifying glass and a bright light, on each affected M/R blade, in an area from blade stations 24.5 to 40, including the entire width of the M/R blade chord, as depicted in Figure 1 to Paragraph (e) of this AD:

(A) Visually inspect the upper and lower grip plates and doublers of the M/R blade for an edge void, any corrosion, or a crack.

(B) Visually inspect the remaining upper and lower surfaces of the M/R blade for an edge void, any corrosion, or a crack.

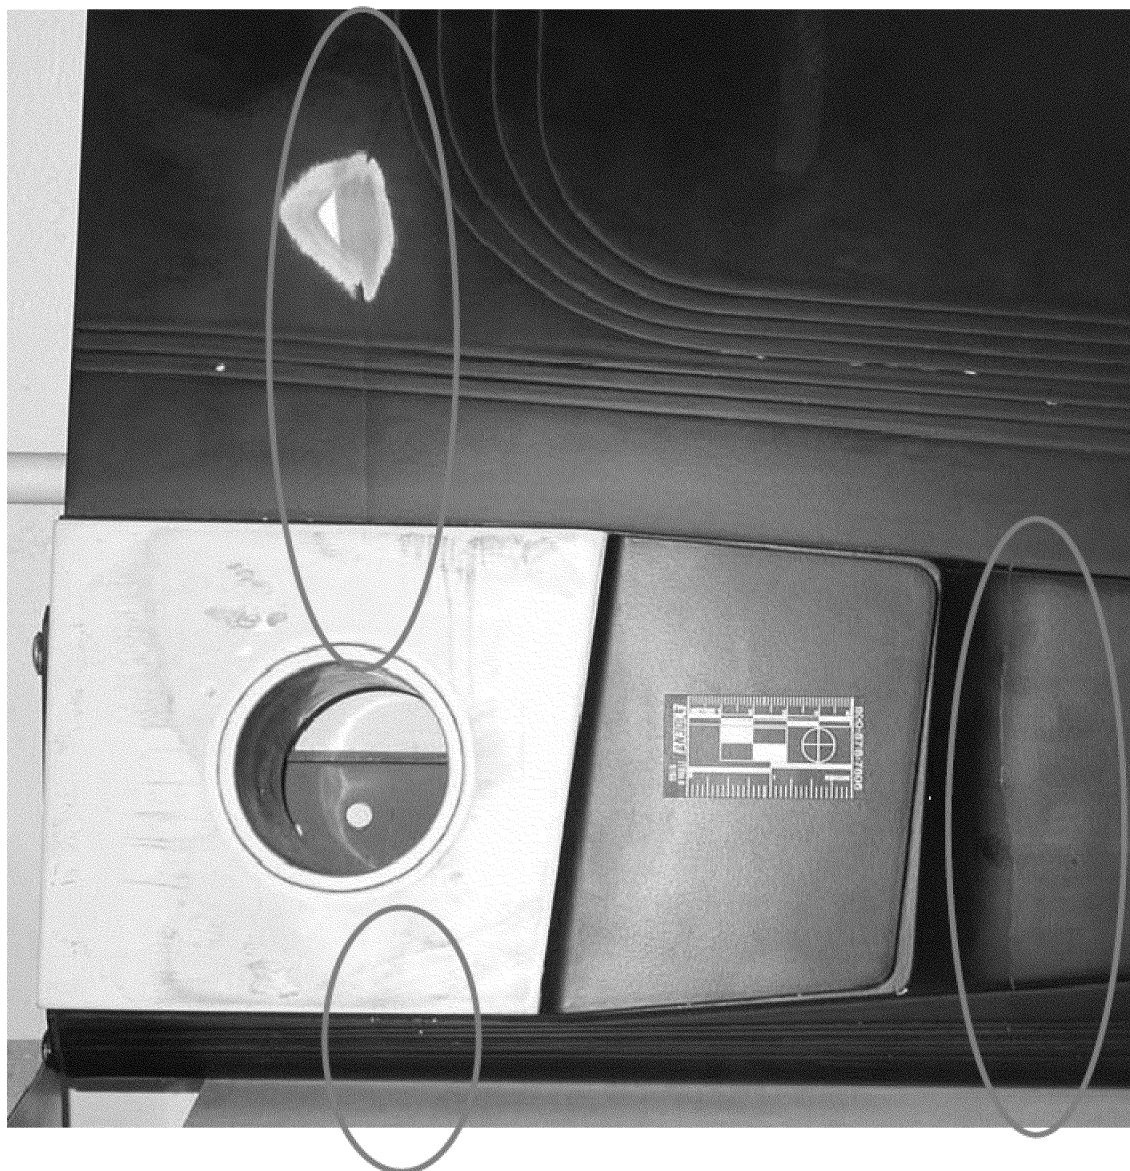
**Note 2 to paragraph (e)(1)(ii):** Crack indications on an actual M/R blade are shown in Figure 2 to Paragraph (e) of this AD.

(v) If there is a crack in any grip plate or doubler, replace the M/R blade with an airworthy M/R blade.

(vi) If there is a crack in the M/R blade skin, replace the M/R blade with an airworthy M/R blade, or repair the M/R blade if the damage is within the maximum repair damage limits.
