[Docket No. FAA-2012-1297; Directorate Identifier 2012-SW-100-AD; Amendment 39-17285; AD 2012-25-04]

Airworthiness Directives; Eurocopter France Helicopters

2012–25–04 Eurocopter France:

This AD defines the unsafe condition as severe vibrations due to failure of laminated half-bearings (bearings). This condition could result in failure of the tail rotor and subsequent loss of control of the helicopter.

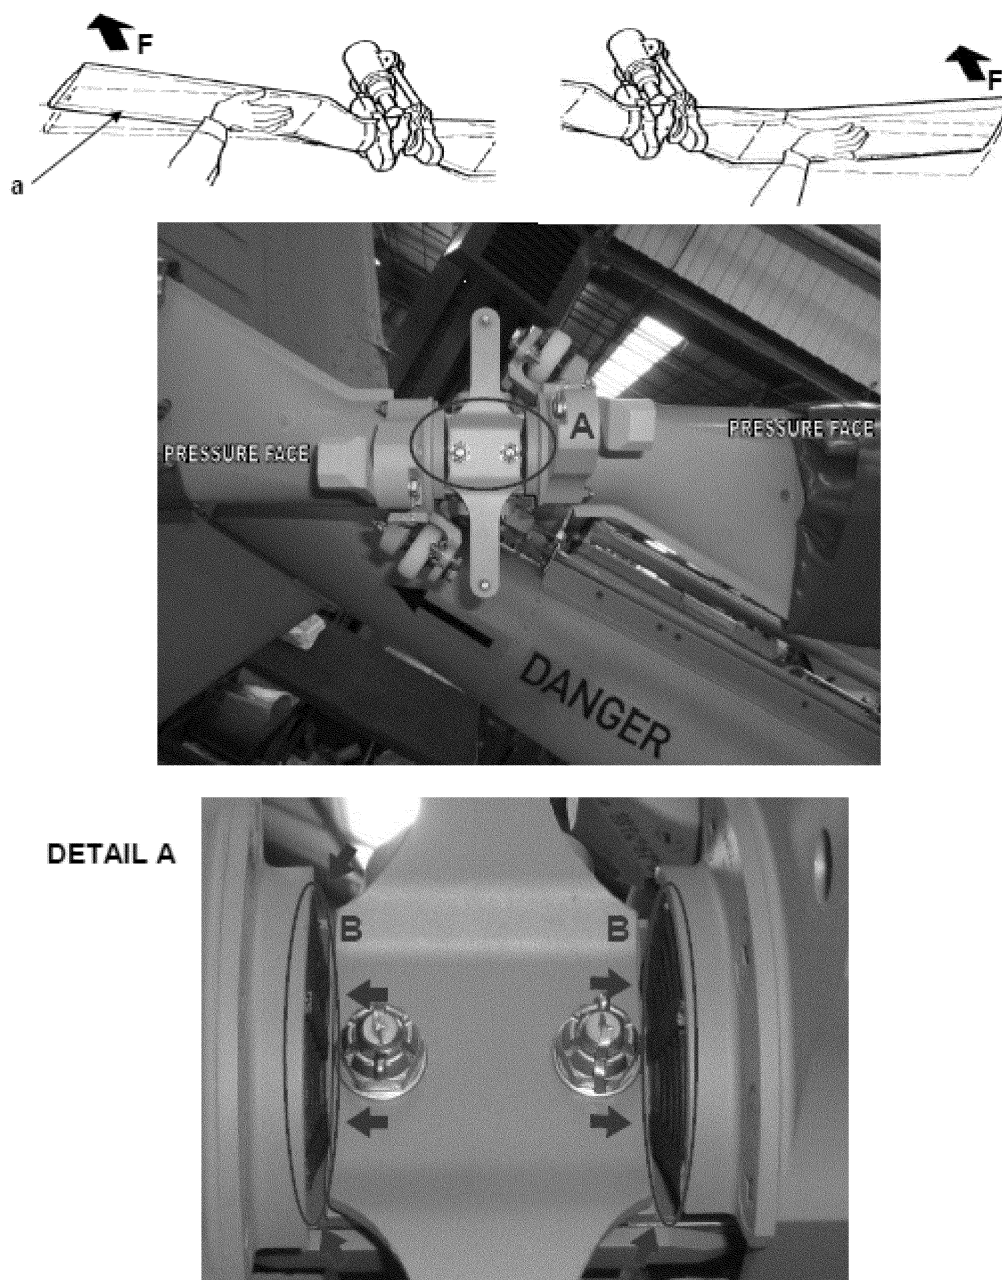
(iii) While maintaining the load, check all the visible faces of the bearings (front and side faces) in area B of DETAIL A of Figure 1 to paragraph (f) of this AD for separation between the elastomer and metal parts, a crack in the elastomer, or an extrusion (see example in Figure 2 to paragraph (f) of this AD). A flashlight may be used to enhance the check.

(5) If there is an extrusion on any bearing, before further flight, replace the four bearings with airworthy bearings.

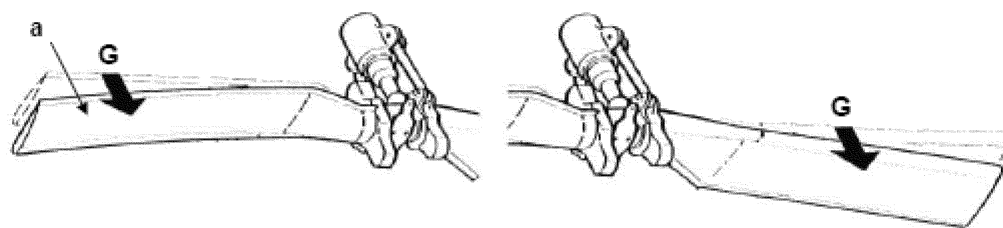
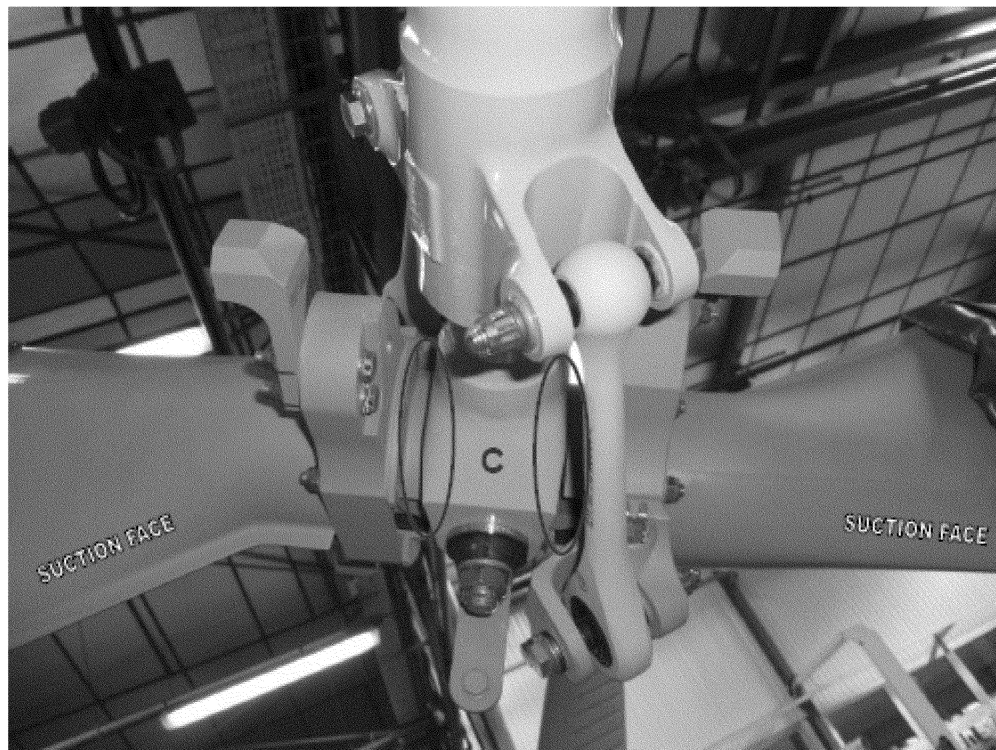
(vi) While maintaining the load, check visible faces of Area C as shown in Figure 3 to paragraph (f) of this AD for any extrusion. A flashlight may be used to enhance the check.

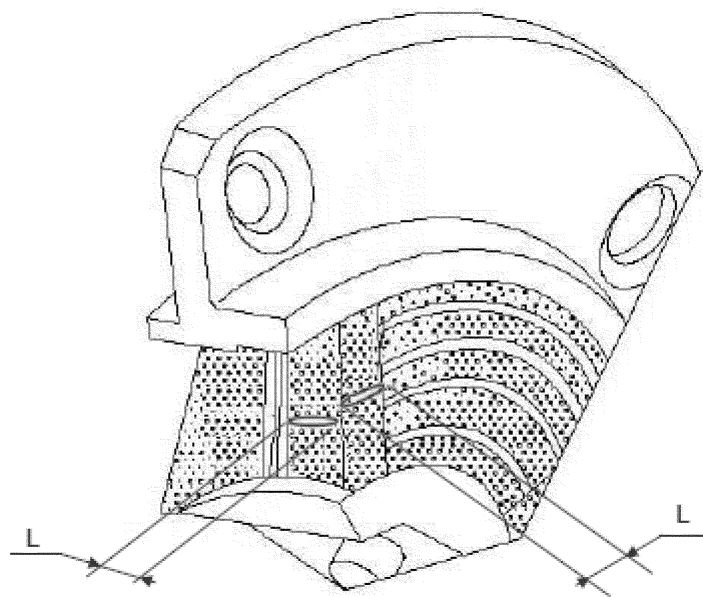
Figure 4 to paragraph (f)

(6) If there is a separation or a crack on the pressure side bearing, measure the separation or the crack. If the separation or crack is greater than 5 millimeters (.196 inches) as indicated by dimension “L” in Figure 4 to paragraph (f), before further flight, replace the four bearings with airworthy bearings.
