[Docket No. FAA-2013-0725; Directorate Identifier 98-CE-01-AD]

Airworthiness Directives; Maule Aerospace Technology, Inc. Airplanes

ACTION: Notice of proposed rulemaking (NPRM).

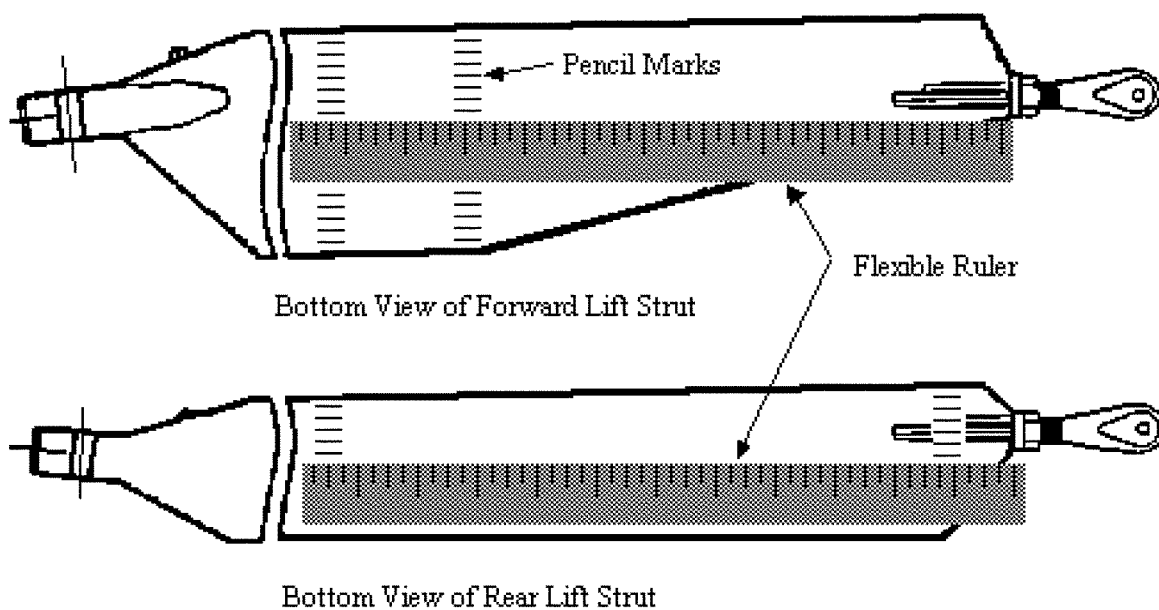
Figure 1

11. Place couplant on an area of the lift strut which is thought to be free of corrosion and “ring” the transducer to surface. Minor adjustments to the signal and gate settings may be required to account for coupling improvements resulting from the paint layer. The thickness gate level should be set just high enough so as not to be triggered by irrelevant signal noise. An area on the upper surface of the lift strut above the inspection area would be a good location to complete this step and should produce a thickness reading between 0.034-inch and 0.041-inch.

8. A measurement of 0.024-inch or less shall require replacement of the strut prior to further flight.
