[Docket No. FAA-2014-0337; Directorate Identifier 2013-SW-029-AD]

#### Airworthiness Directives; Various Restricted Category Helicopters

**ACTION:** Notice of proposed rulemaking (NPRM).

#### Various Restricted Category Helicopters:

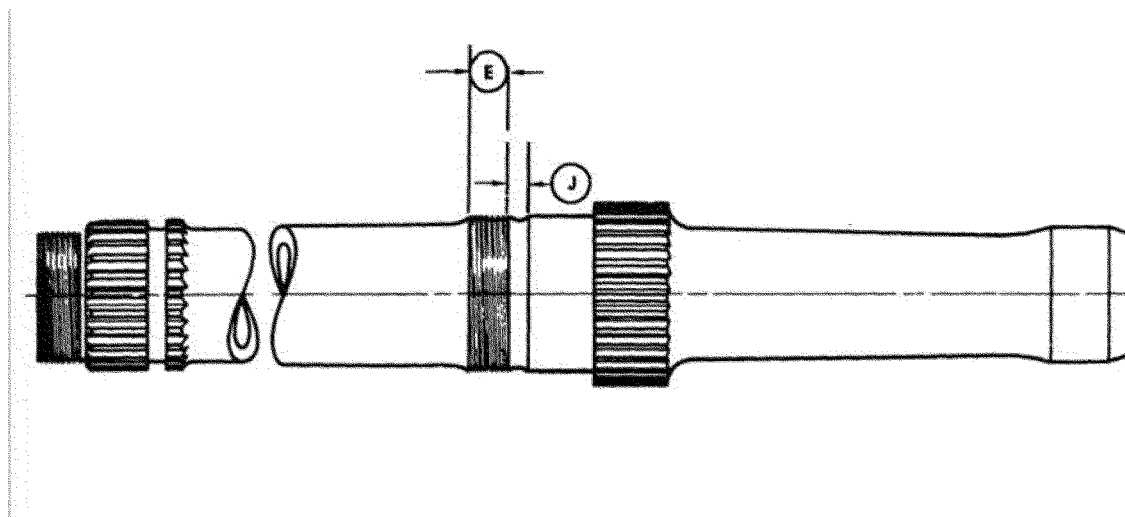
This AD defines the unsafe condition as a crack in the main rotor mast, which could result in failure of the mast and subsequent loss of control of the helicopter.

(i) Remove any surface rust with a wire brush or steel wool and, using a 10X or higher power magnifying glass, inspect the areas of the mast as shown in area E and area J of Figure 1 to Paragraph (f) of this AD for pitting, corrosion, or a crack.

(2) If there is a crack, pitting, or corrosion, before further flight, replace the mast with an airworthy mast.
