**[Docket No. FAA-2014-0034; Directorate Identifier 2013-SW-006-AD; Amendment 39-17948; AD 2014-16-24]**

**Airworthiness Directives; Airbus Helicopters Deutschland GmbH (Previously Eurocopter Deutschland GbmH) (Airbus Helicopters) Helicopters**

**2014–16–24 Airbus Helicopters**

This AD defines the unsafe condition as a crack in the MRH shaft flange, which could result in failure of the MRH and subsequent loss of control of the helicopter.

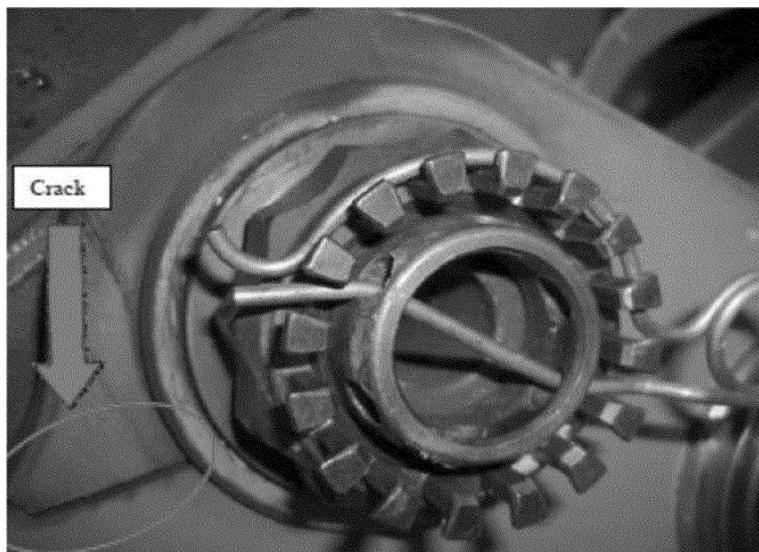
Figure 1 to Paragraph (f)(1)

(1) Before further flight, and thereafter at intervals not to exceed 6 hours time-in-service (TIS), check the MRH shaft lower flange and the visible area of the MRH shaft upper flange for a crack. Figures 1 and 2 to Paragraph (f)(1) of this AD are examples of cracks that have been discovered in the MRH shaft lower flange. The actions required by this paragraph may be performed by the owner/operator (pilot) holding at least a private pilot certificate, and must be entered into the aircraft records showing compliance with this AD in accordance with 14 CFR 43.9 (a)(1) through (4) and 14 CFR 91.417(a)(2)(v). The record must be maintained as required by 14 CFR 91.417, 121.380, or 135.439.

(3) If there is a crack in the upper or lower MRH shaft flange, before further flight, replace that MRH shaft with an airworthy MRH shaft. Replacing the MRH shaft with an MRH shaft having a P/N listed in paragraph
