## DEPARTMENT OF TRANSPORTATION

[Docket No. FAA–2015–1937; Directorate Identifier 2014–SW–067–AD; Amendment 39–18171; AD 2015–11–08]

#### Airworthiness Directives; Agusta S.p.A. (Agusta) Helicopters

**2015–11–08 Agusta S.p.A. Helicopters (Agusta):** Docket No. FAA–2015–1937; Amendment 39–18171, Directorate Identifier 2014–SW–067–AD.

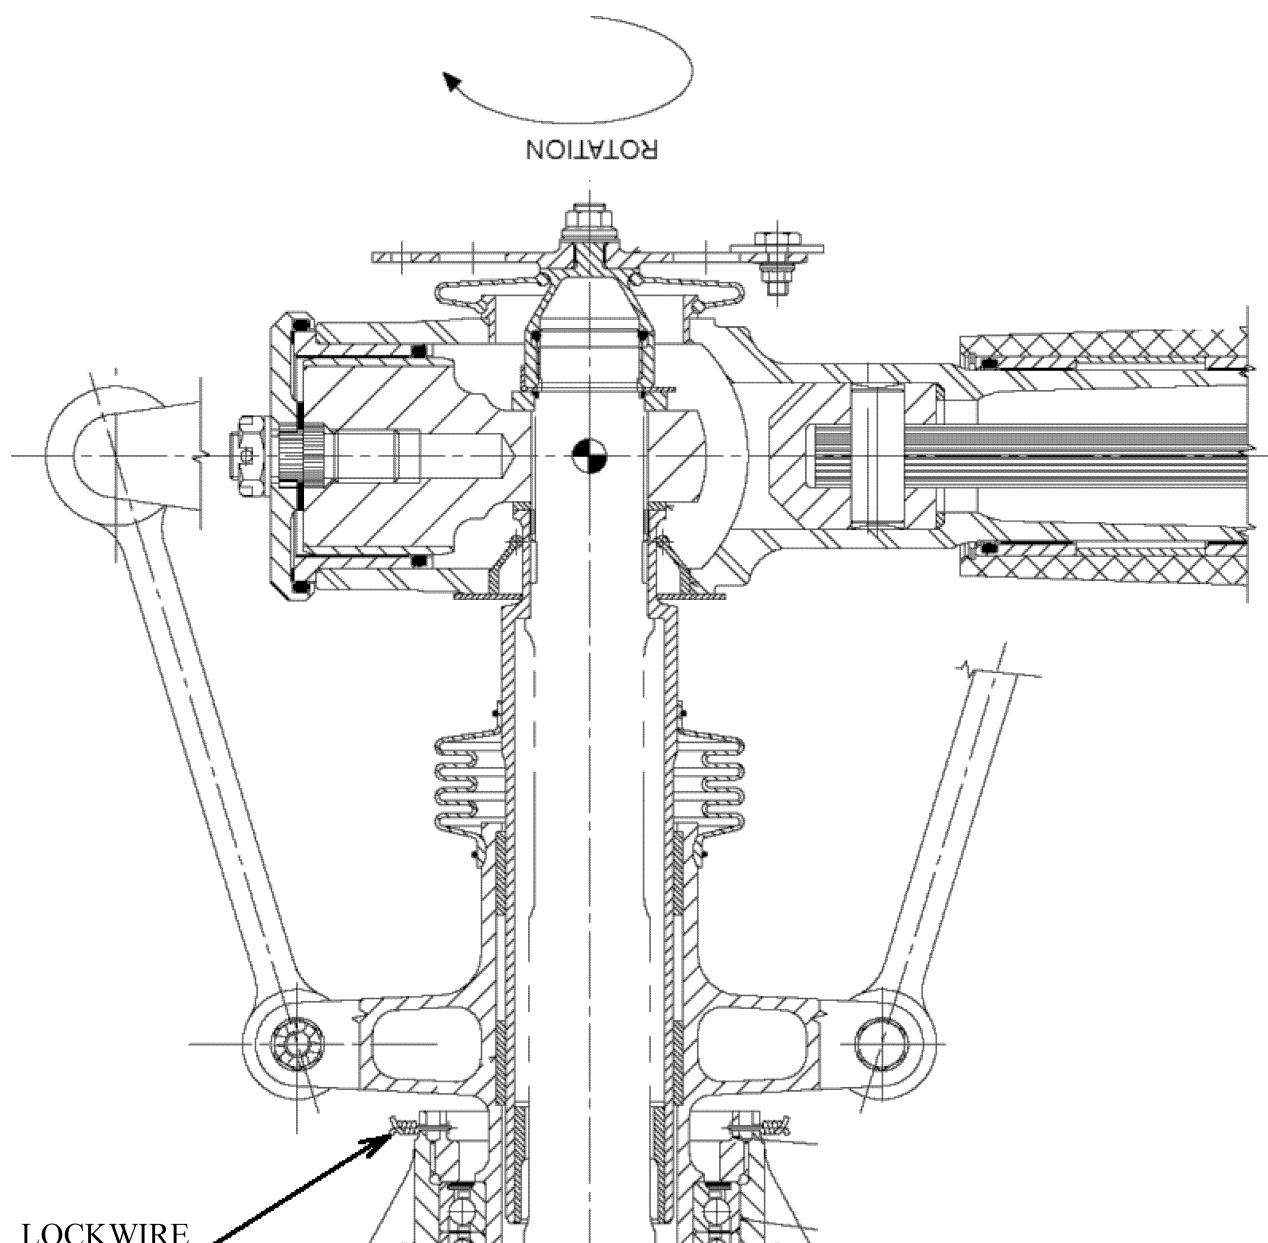
**Figure 1 of paragraph (f)(1)**

This AD defines the unsafe condition as a missing or broken lock wire securing the tail rotor (T/R) duplex bearing locking nut (locking nut). This condition could result in loosening of the locking nut, failure of the T/R, and subsequent loss of control of the helicopter.

(1) Within 24 hours and thereafter before the first flight of each day or at intervals not exceeding 24 hours, whichever occurs later, check each lock wire securing the T/R locking nut to the housing. The location of the housing wire is depicted in Figure 1 to paragraph (f)(1) of this AD.

(4) If one or both lock wires are missing or damaged, before further flight, remove and reassemble the housing and slider group of the T/R rotating controls.
