[Docket No. FAA-2016-9254; Directorate Identifier 2015-CE-030-AD]

Airworthiness Directives; Piper Aircraft, Inc. Airplanes

ACTION: Notice of proposed rulemaking (NPRM).

Piper Aircraft, Inc.: Docket No. FAA–2016–9254; Directorate Identifier 2015–CE–030–AD.

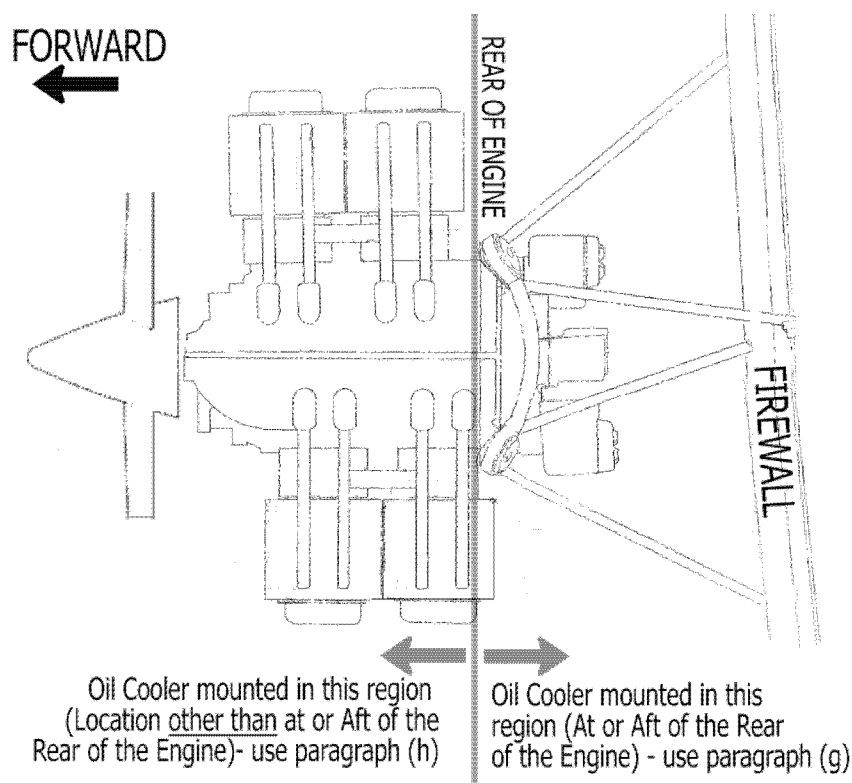
Figure 1 to paragraphs (g) and (h) of this AD: Oil cooler

For applicable airplanes with the oil cooler mounted at or aft of the rear of the engine (See figure 1 to paragraphs (g) and (h)): Within the next 100 hours time-in-service (TIS) after February 5, 1996 (the effective date retained from AD 95-26-13), and repetitively thereafter at intervals not to exceed 100 hours TIS, inspect the oil cooler hose assembly for oil soaked in the fire sleeve of the oil hose assembly, a brownish or whitish color of the fire sleeve of the oil hose assembly, and any evidence of brittleness or deterioration of the fire sleeve of the oil hose assembly as a result of heat or oil seepage.

(1) If any of the conditions described in paragraph (g) of this AD are found on the oil cooler hose assembly during the inspection required in paragraph (g) of this AD, before further flight, replace the oil cooler hose assembly with TSO-C53a Type D oil cooler hose assembly or TSO-C53a Type C oil cooler hose assembly that has been inspected following paragraph (g) of this AD and found to be airworthy.

(2) Replacement of the oil cooler hose assembly with TSO-C53a Type D oil cooler hose assembly is terminating action for this AD.

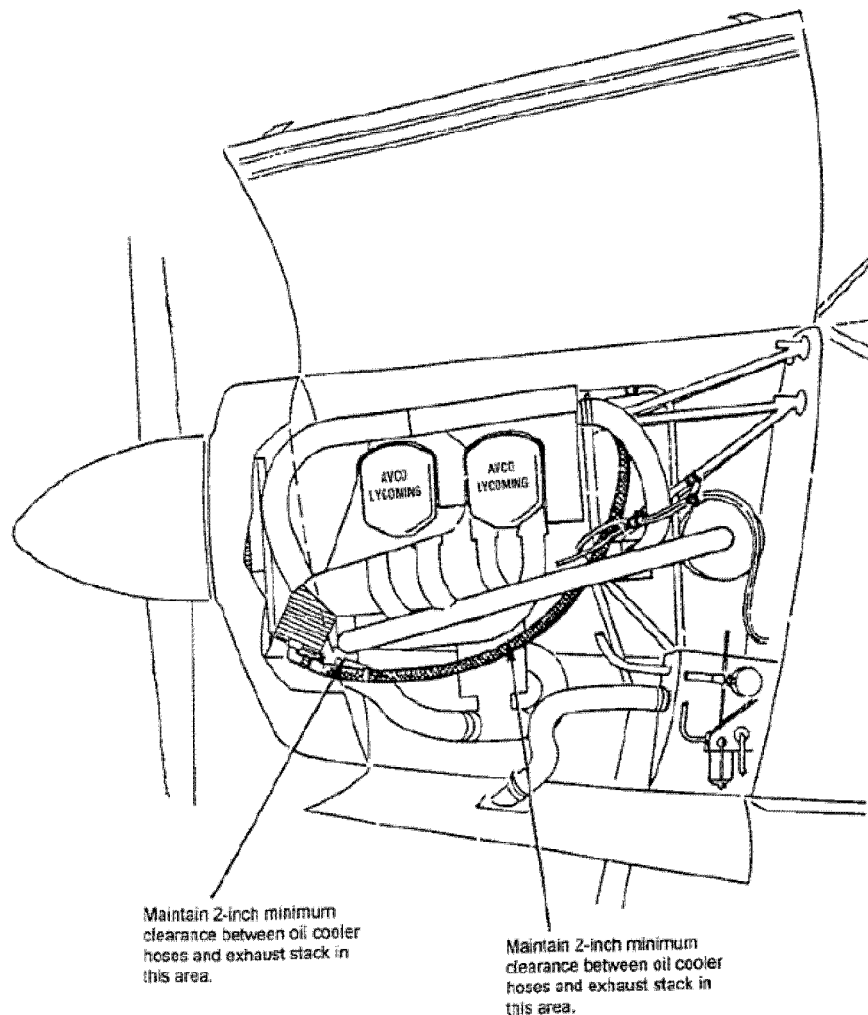
Figure 2 to paragraph (h) of this AD: Acceptable clearances

(i) The oil cooler hose assemblies pass underneath and behind the electrical ground cable and in front of the lower of the two engine mount.

(ii) The oil cooler hose assemblies are secured to the engine mount strut and a clearance of at least 2 inches exists between the oil cooler hose assemblies and the exhaust stack.

(iii) Oil cooler hose assemblies with a minimum outer diameter of 0.75 inch are installed with a bend radius of at least 6.5 inches.

(3) Within the next 100 hours TIS after February 5, 1996 (the effective date retained from AD 95-26-13) and each time the oil cooler hose assembly is replaced for any reason or inspected following paragraph (h)(1) inspect to ensure the installation conditions in paragraphs (h)(3)(i) through (iii) of this AD are met. If the conditions listed in paragraphs (h)(3)(i) through (iii) of this AD are not met, before further flight, make any necessary adjustments. Please see figure 2 to paragraph (h) of this AD for additional information.

(3) Replacement of the oil cooler hose assembly with TSO-C53a Type D oil cooler hose assembly and meeting the installation conditions listed in paragraphs (h)(3)(i) through (iii) of this AD terminate the requirements of this AD.
