[Docket No. 96-CE-09-AD; Amendment 39-9872; AD 97-01-01]

Airworthiness Directives; The New Piper Aircraft, Inc. PA24, PA28R, PA30, PA32R, PA34, and PA39 Series Airplanes

ACTION: Final rule.

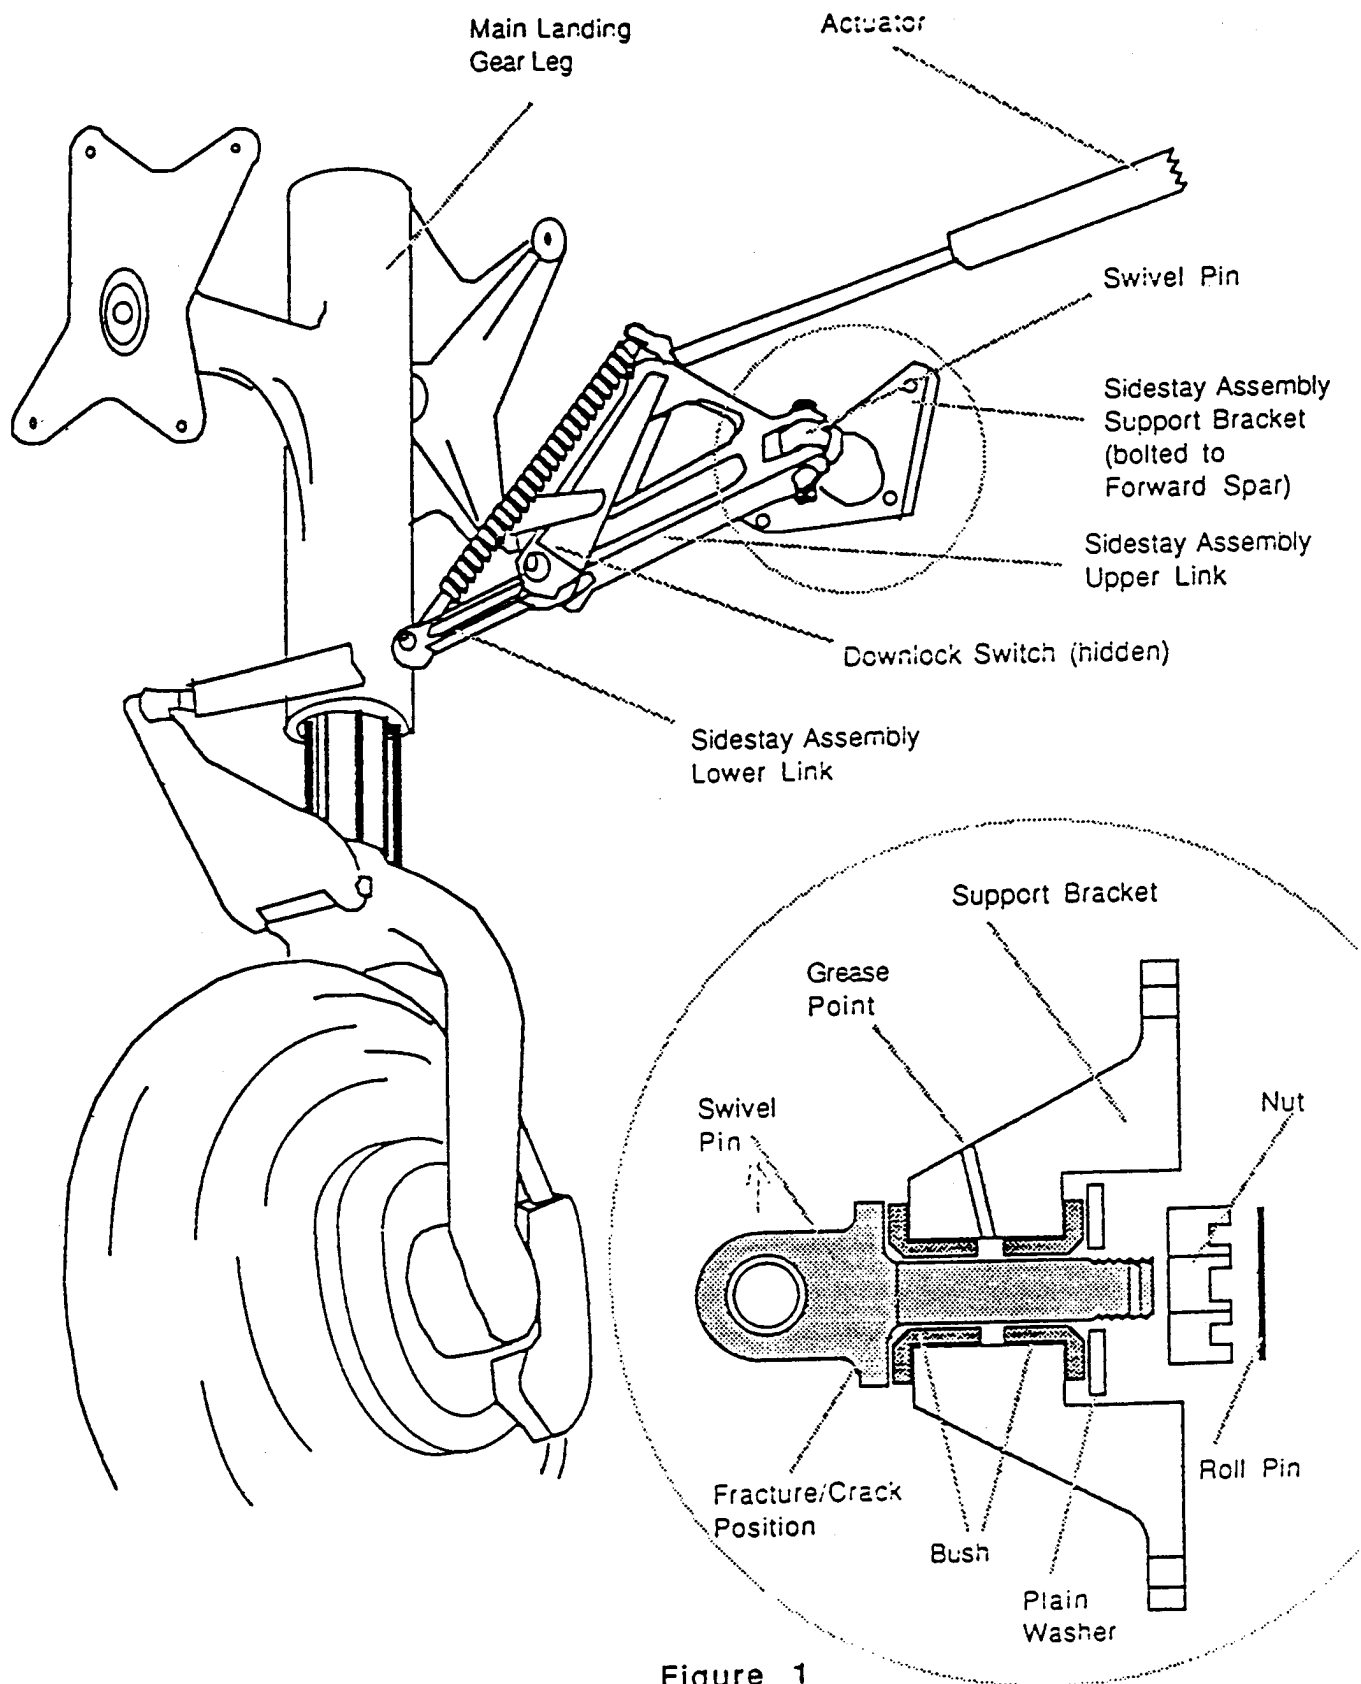
**Figure 1**

(a) Remove both the left and right main gear sidebrace studs from the airplane in accordance with the instructions contained in the Landing Gear section of the maintenance manual, and inspect each main gear sidebrace stud for cracks, using Type I (fluorescent) liquid penetrant or magnetic

particle inspection methods. Figure 1 of this AD depicts the area of the sidebrace stud shank where the sidebrace stud is to be inspected.

(1) For any main gear sidebrace stud found cracked, prior to further flight, replace the cracked stud with an FAA-approved serviceable part (part numbers referenced in the table in paragraph (b) of this AD or FAA-approved equivalent) in accordance with the instructions contained in the Landing Gear section of the applicable maintenance manual, and accomplish one of the following, as applicable:
