[Docket No. 98-SW-74-AD]

#### Airworthiness Directives; Eurocopter Deutschland GmbH Model EC 135 Helicopters

**ACTION:** Notice of proposed rulemaking (NPRM).

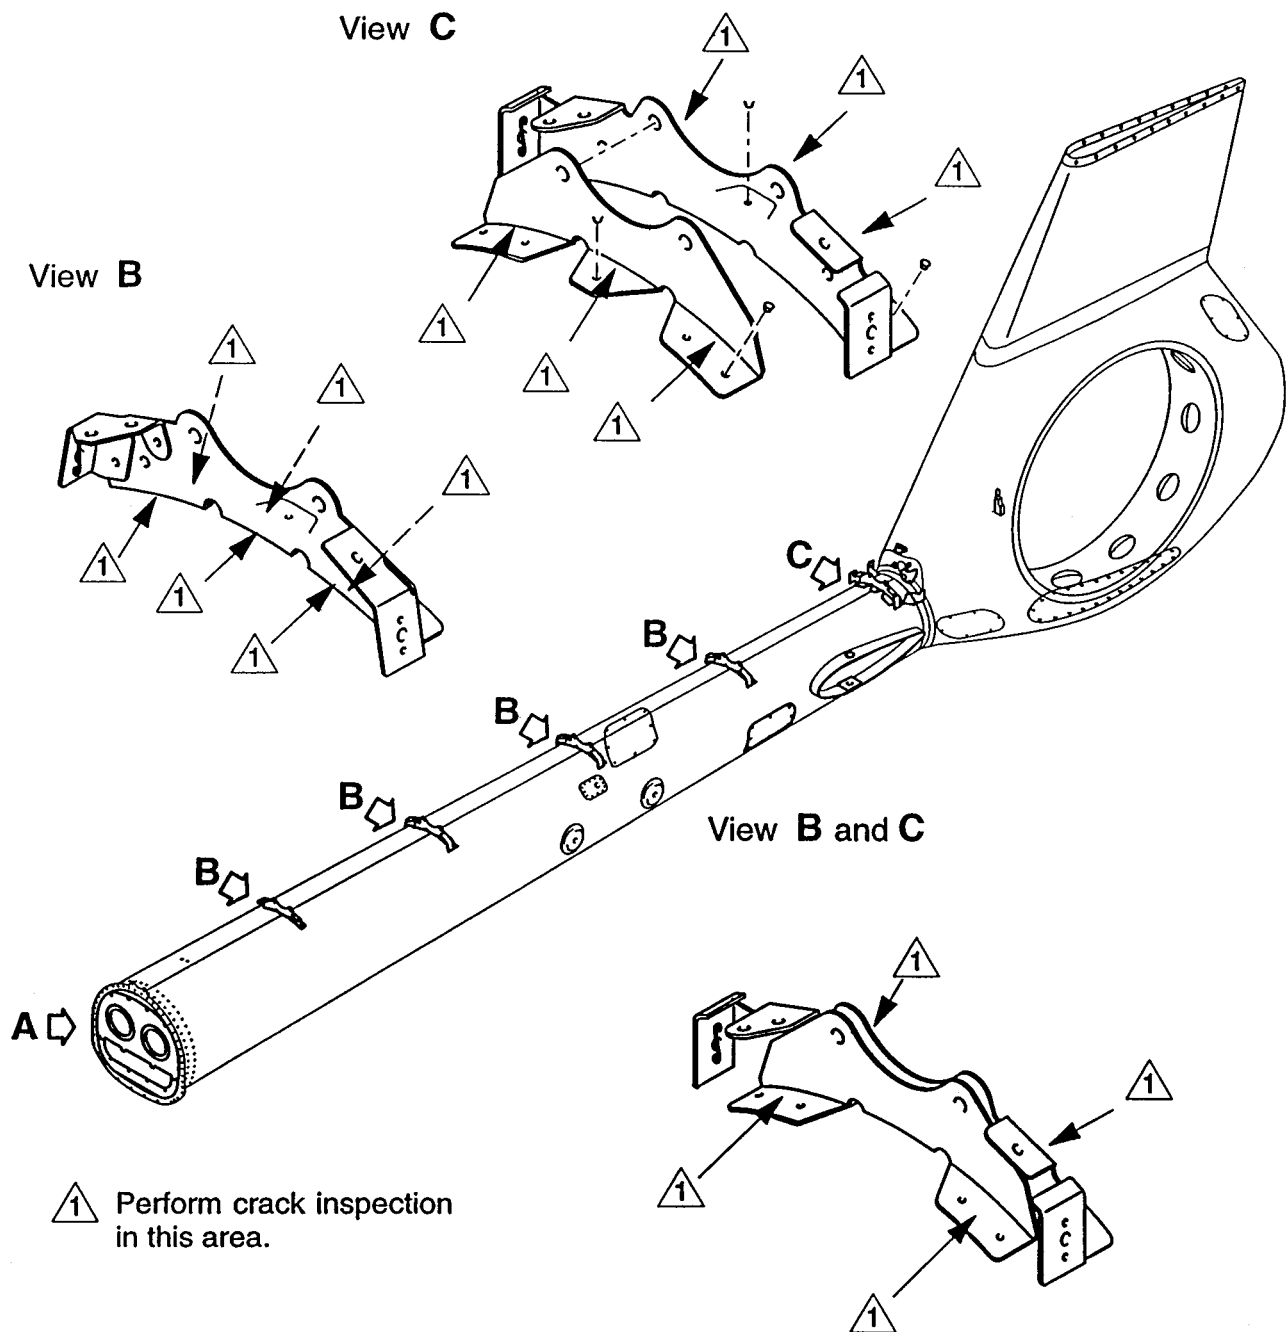
**Figure 1**

Since the issuance of AD 98-15-25, additional reports of misaligned, cracked, or corroded bearing supports, and loose bearing attachment bolts have been received. The original bearing supports have been redesigned to enable more precise alignment with the tail rotor driveshaft and have been strengthened to prevent cracking. In addition, they are now fabricated of corrosion-resistant material. Struts have been added to the tail boom to improve airframe vibration characteristics and further minimize bearing support cracking.

The Luftfahrt-Bundesamt (LBA), the airworthiness authority for the Federal Republic of Germany, notified the FAA that an unsafe condition may exist on ECD Model EC 135 helicopters. The LBA advises that misaligned, corroded, or cracked bearing supports and loose bearing attachment bolts may lead to a tail rotor failure and subsequent loss of the helicopter.

(1) Clean each tail rotor drive shaft bearing support. Using a 6-power or higher magnifying glass and a bright light, visually inspect the attach lugs of the bearing supports B and C (shown in Figure 1) for cracks, particularly in the area extending from the bend radius to the attaching screws and rivets connecting the bearing supports to the tail boom. Before further flight, replace each cracked bearing support with an airworthy bearing support.

(2) Inspect each bearing attach hardware lock plate for bent-open tabs and slippage marks for attach hardware looseness or rotation. Before further flight, replace any loose bearing attach hardware (including lock plates found bent or open due to bolt rotation) with airworthy hardware.
