[Docket No. 98-NM-323-AD; Amendment 39-11487; AD 99-27-06]

Airworthiness Directives; Boeing Model 757-200, -200PF, and -200CB Series Airplanes

Powered by Rolls-Royce RB211-535C/E4/E4B Turbofan Engines

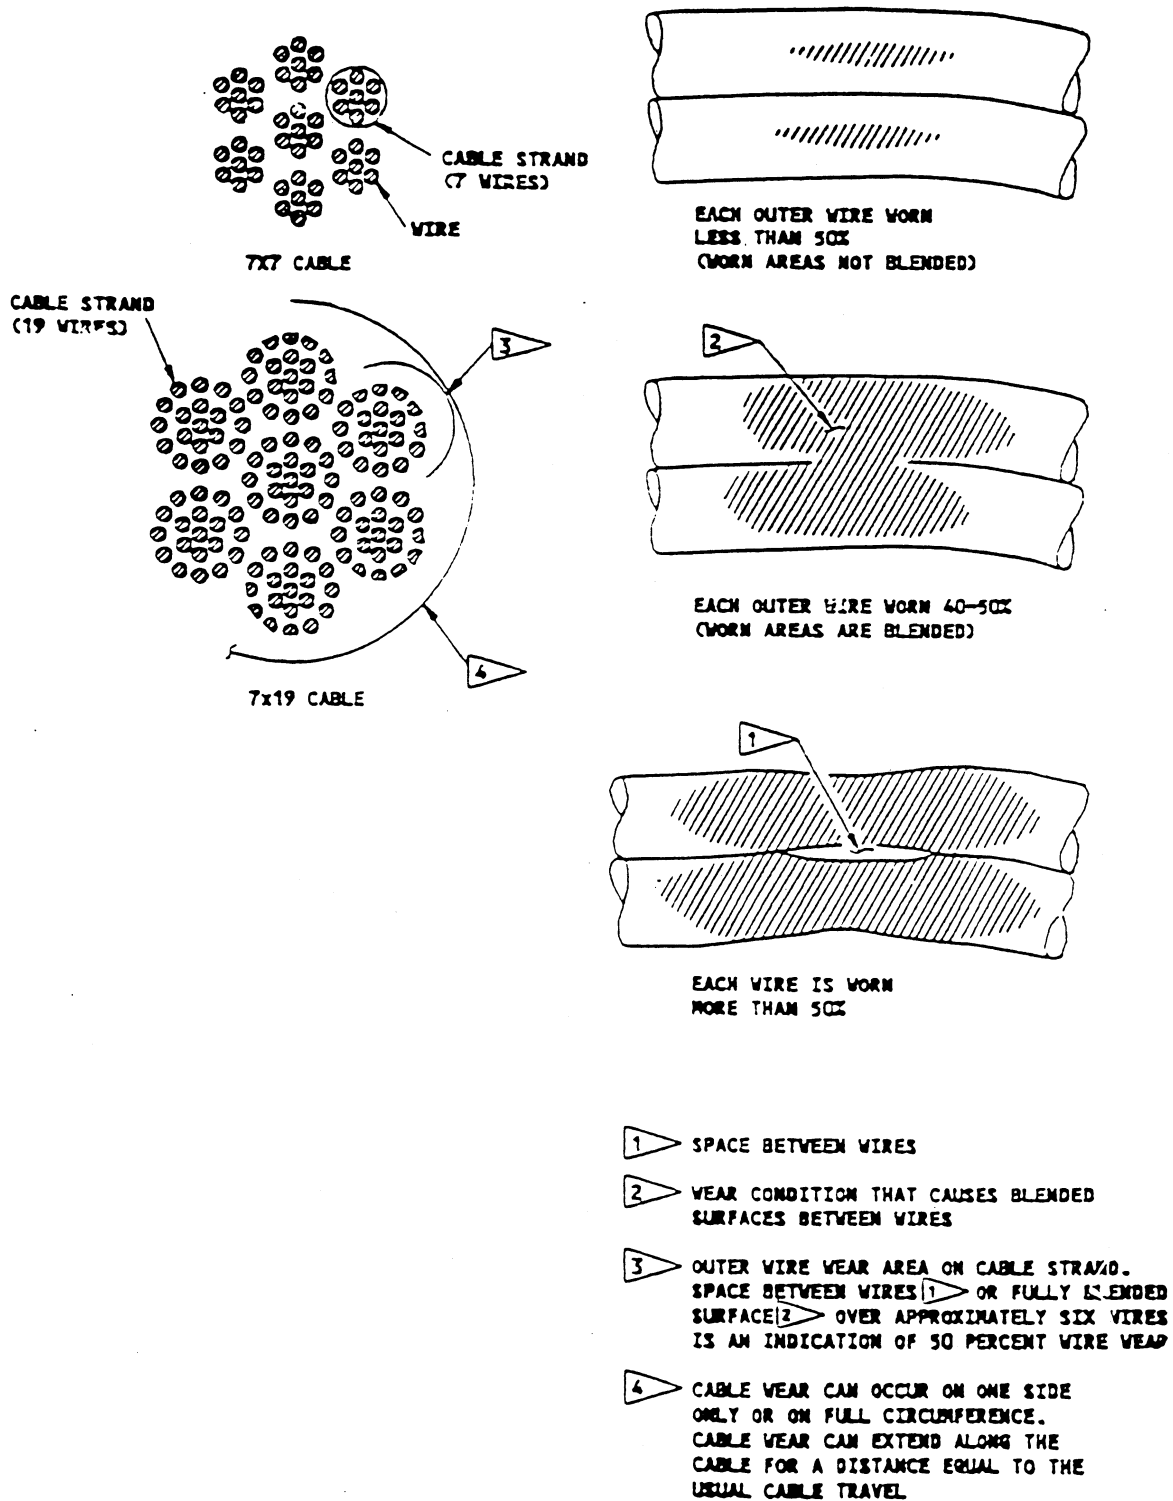
FIGURE 1

(1) One cable strand had worn wires where one wire cross section is decreased by more than 40 percent (see Figure 1), (2) A kink is found, or

Replace the cable assembly if:
