[Docket No. 2003-NM-15-AD; Amendment 39-13124; AD 2003-08-11]

**Airworthiness Directives; Boeing Model 747-100, -200B, -200F, -200C, -100B, -300, -100B SUD, -400, -400D, and -400F Series Airplanes; and Model 747SR Series Airplanes**

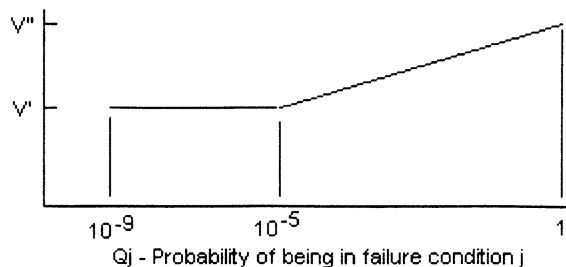
**Figure 3**  
**Clearance speed**

(v) Freedom from aeroelastic instability must be shown up to a speed determined from Figure 3. Flutter clearance speeds VI and VII may be based on the speed limitation specified for the remainder of the flight using the margins defined by § 25.629(b).

VI = Clearance speed as defined by § 25.629(b)(2).

VII = Clearance speed as defined by § 25.629(b)(1).

**Note:** If  $P_j$  is greater than  $10^{-3}$  per flight hour, then the flutter clearance speed must not be less than VII.

(vi) Freedom from aeroelastic instability must also be shown up to VI in Figure 3 above for any probable system failure condition combined with any damage required or selected for investigation by § 25.571(b).
