[Docket No. FAA-2010-1270; Directorate Identifier 2001-NE-50-AD; Amendment 39-16788; AD 2005-25-10R1]

Airworthiness Directives; Dowty Propellers Type R321/4-82-F/8, R324/4-82-F/9, R333/4-82-F/12, and R334/4-82-F/13 Propeller Assemblies

ACTION: Final rule.

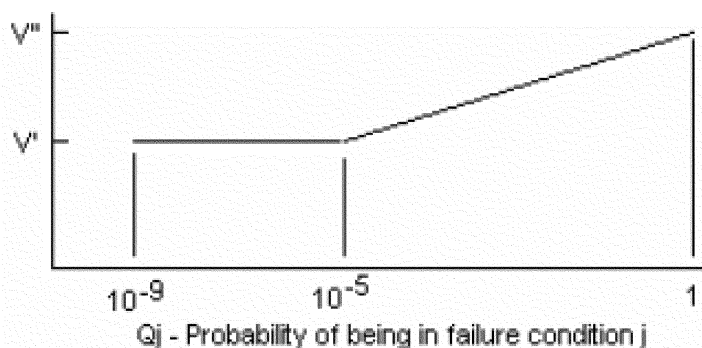
Figure 3. Clearance speed

V' = Clearance speed as defined by Sec. 25.629(b)(2).

V'' = Clearance speed as defined by Sec. 25.629(b)(1).
 $Q_j = (T_j)(P_j)$

Note: If P_j is greater than 10^{-3} per flight hour, then the flutter clearance speed must not be less than V'' .

(v) Freedom from aeroelastic instability must also be shown up to V' in Figure 3, above, for any probable system-failure condition combined with any damage required or selected for investigation by § 25.571(b). Consideration of certain failure conditions may be required by other sections of part 25 regardless of calculated system reliability. Where analysis shows the probability of these failure conditions to be less than 10^{-9} , criteria other than those specified in this paragraph may be used for structural substantiation to show continued safe flight and landing.
