NUCLEAR REGULATORY COMMISSION

Southern California Edison Company, et al.; San Onofre Nuclear Generating Station, Units 2 and 3; Issuance of Director's Decision Under 10 CFR 2.206

Director's Decision Under 10 CFR 2.206

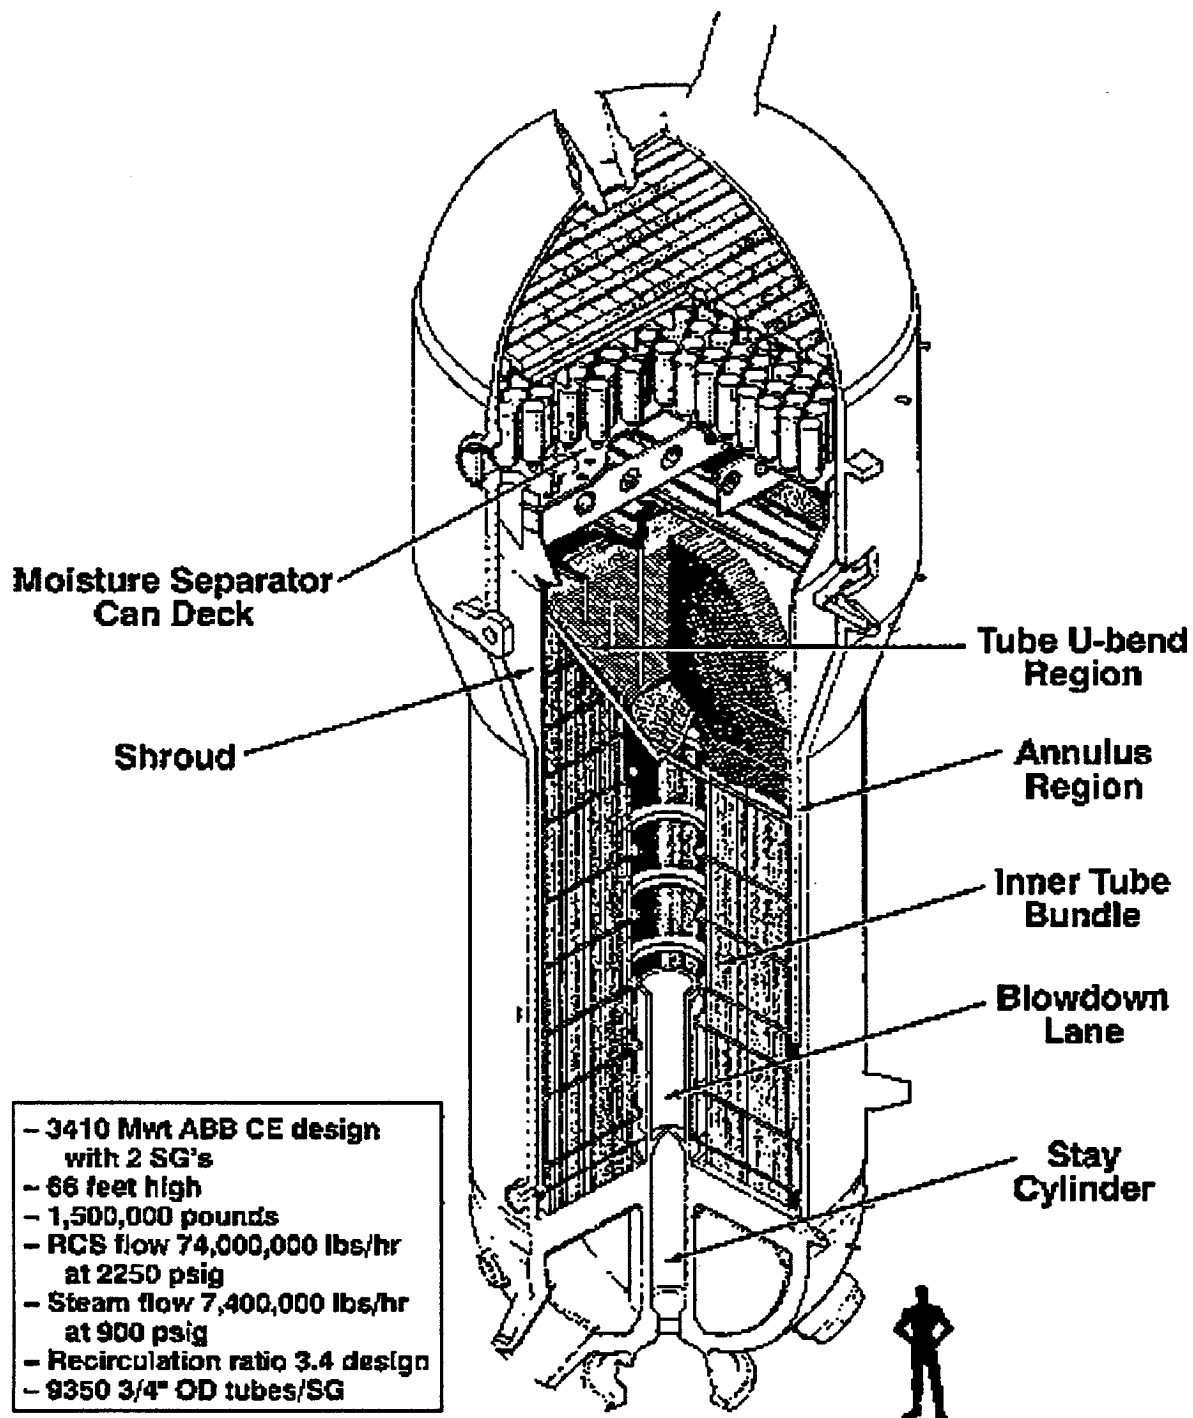
Figure 1

For the individual steam generator tube analysis, the licensee calculated the maximum loads that could occur assuming that adequate support was not available at two consecutive eggcrate levels (see Figure 1). The staff finds this assumption conservative and acceptable because the licensee has removed from service all tubes where two consecutive eggcrate levels were found degraded to the point where adequate support could not be assured.

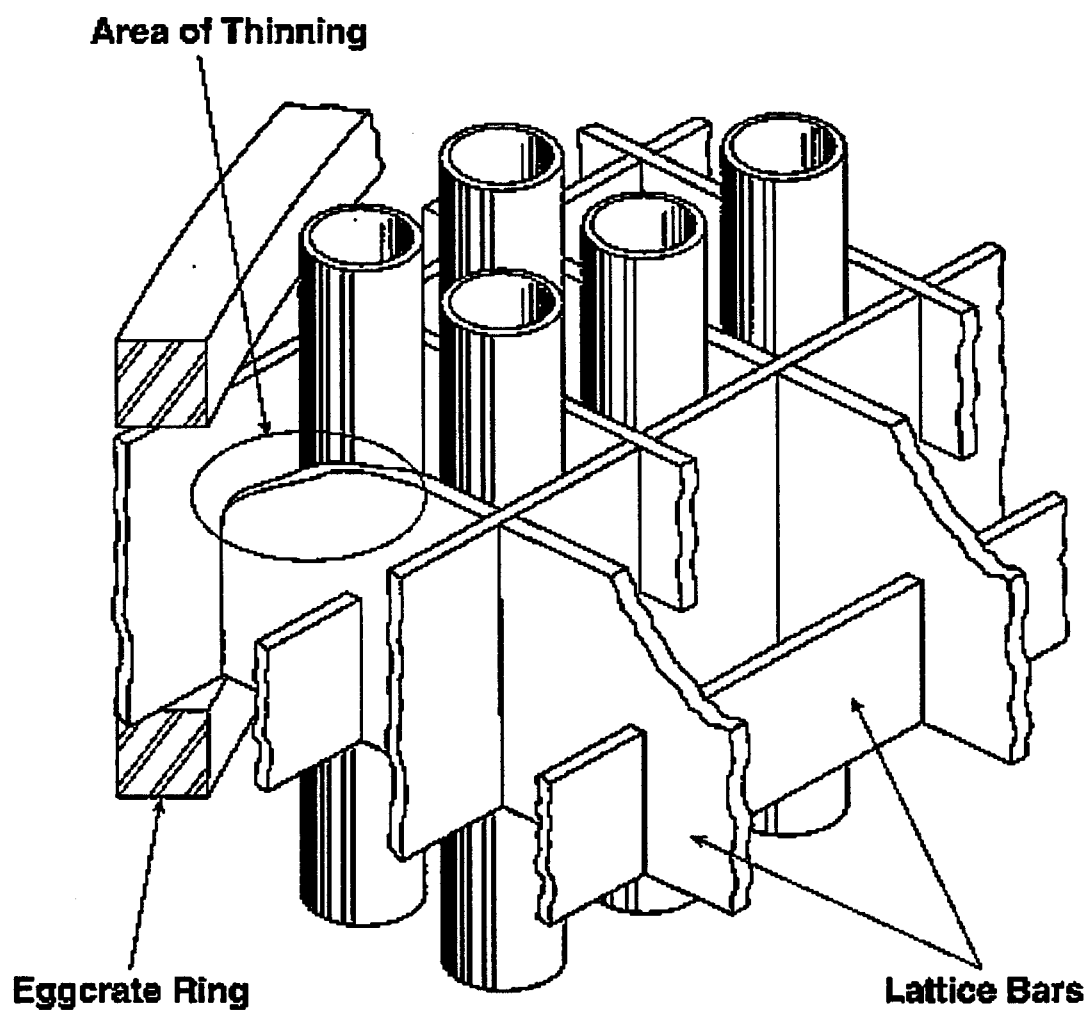
The SONGS units utilize Combustion Engineering Model 3410 recirculating steam generators. This model of steam generator contains 9,350 Inconel 600 (ASME Material Specification SB-163) U-tubes with a nominal diameter and wall thickness of 0.75 and 0.048 inch, respectively. Secondary side tube support structures consist of seven horizontal full eggcrate supports, three horizontal partial eggcrate supports, and upper bundle supports (i.e., two batwing diagonal supports and seven vertical supports). The materials used for fabrication of the steam generator vessels and internals (including tube supports) are low-alloy and carbon steels, respectively. Figure 1 is a simplified cross-sectional diagram of the SONGS steam generators that clearly displays the 10 eggcrate support levels, and Figure 2 is a three-dimensional representation of the steam generators that gives additional structural detail.
