DEPARTMENT OF TRANSPORTATION

Denial of Motor Vehicle Defect Petition, DP00–001

Appendix—Petition Analysis—DP00–001

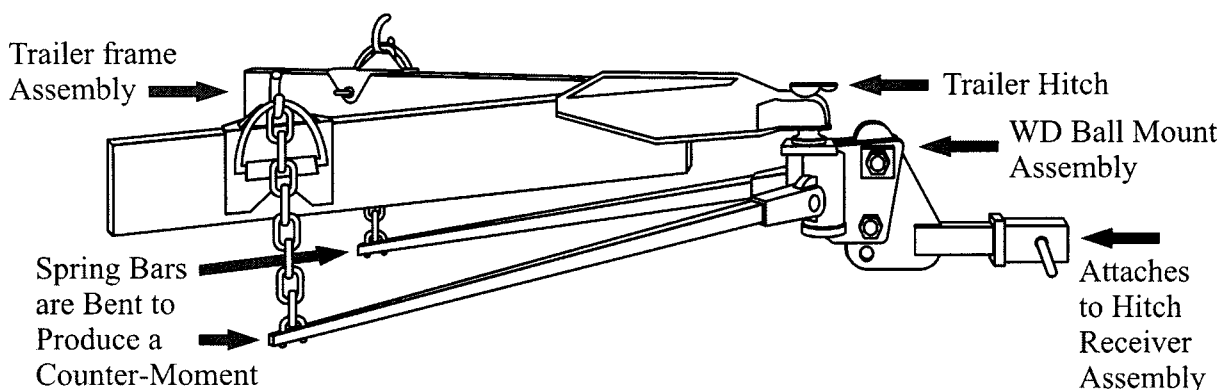
Figure 2. Typical Weight Distributing Hitch System Setup

shown in the set up of Figure 2, the two spring bars are bent upward to apply a counter moment torque to the WD hitch ball mount assembly and redirect or redistribute the point load tongue weight further forward in the tow vehicle. The subject vehicles' hitch receiver has a decal specifying 10,000 lb. towing and 1,000 lb. maximum tongue weight limits when used with the WD hitch system.

the loads to the entire tow vehicle. The WD hitch system's spring bars force both the front and rear wheel fenders equally downward. This aligns the tow vehicle so that it is approximately the same 'attitude' or 'level' as it was before the trailer was hooked up. A poorly installed WD hitch system can cause the tow vehicle's front end to 'lift up' resulting in more weight to the hitch receiver and rear axle. In addition, the ball mount height, spring bar angles, spring bar engagement level, and ball mount receiver bar length can also affect the proper installation and effectiveness of the WD hitch system.
