**[Docket No. FAA-2011-0450; Directorate Identifier 2011-CE-010-AD; Amendment 39-16758; AD 2011-15-11]**

**Airworthiness Directives; Cessna Aircraft Company (Cessna) Models 337, 337A (USAF 02B), 337B, 337C, 337D, 337E, T337E, 337F, T337F, 337G, T337G, M337B, F 337E, FT337E, F 337F, FT337F, F 337G, and FT337GP Airplanes**

**ACTION:** Final rule.

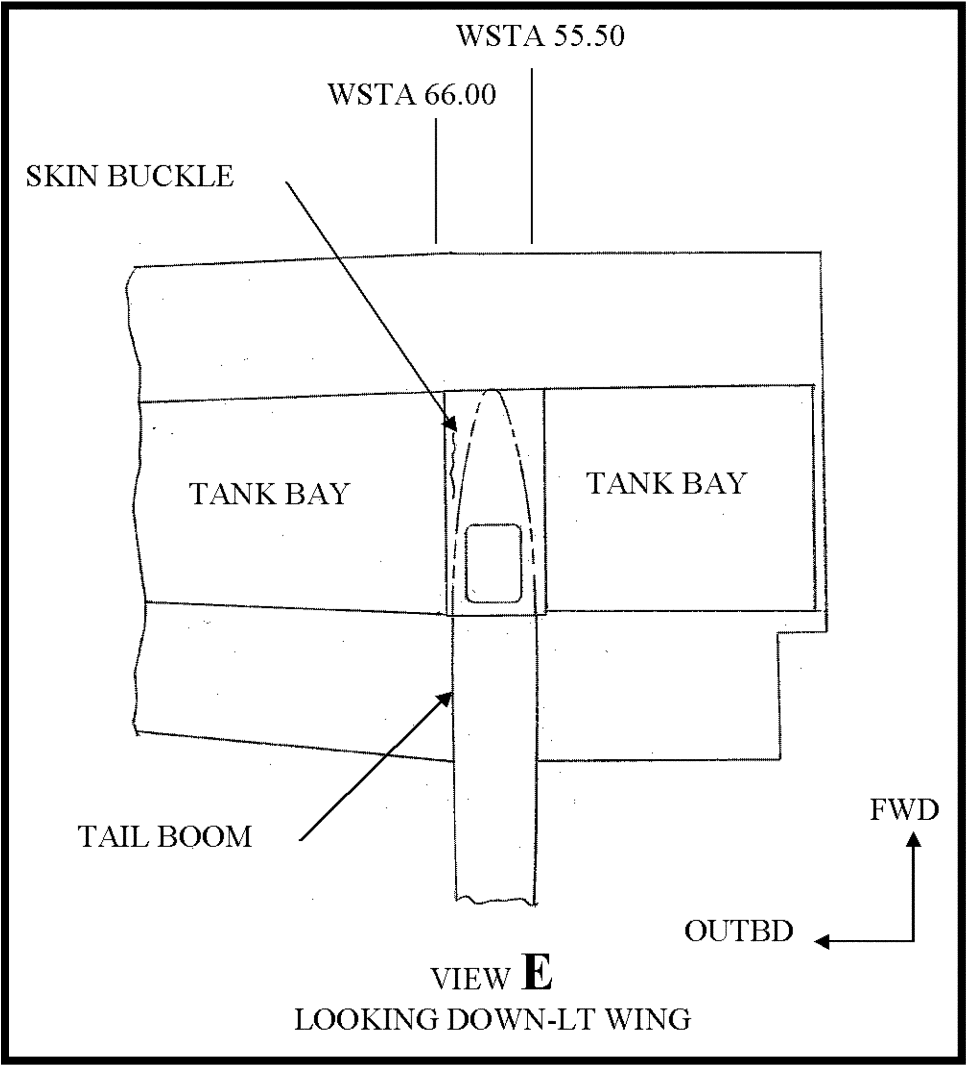
Figure 6

- (1) Wrinkles in upper wing skins, from the outboard edge on the fuel tank access covers (WSTA 150 or 177) to the WSTA 222 (See View B, Figure 3).
- (2) Wrinkles in the upper wing skins from WSTA 55 to 66, adjacent to the booms (See View E, Figure 6).
- (3) Cracking of the upper wing skins. Pay particular attention to any wrinkles, the radius between stiffeners at WSTA 150 (under fuel tank covers), and unreinforced access holes (See View B, Figure 3).
- (4) Working (smoking) rivets outboard of the wing tank access covers.
- (5) Fasteners with less than two diameters edge distance.
- (6) Fasteners with less than four diameters center to center spacing.
- (7) Looseness of attachments of the tip extension to the wing and wing tip to wing extension when pushing up and down on the tip.
